**OFFSITE SANITARY SEWER IMPROVEMENTS  
LASSEN PROPERTY - TRACT 8454  
LIVERMORE, CALIFORNIA**

**GEOTECHNICAL EXPLORATION**

May 12, 2021  
Latest Revision June 2, 2021

**PROJECT NO.**  
13850.001.001

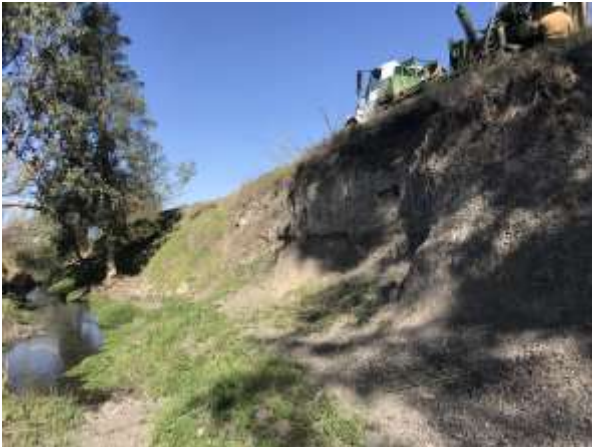
**PHOTO 2.7-1: Downstream View of Arroyo Seco Adjacent to Boring 3-B2**

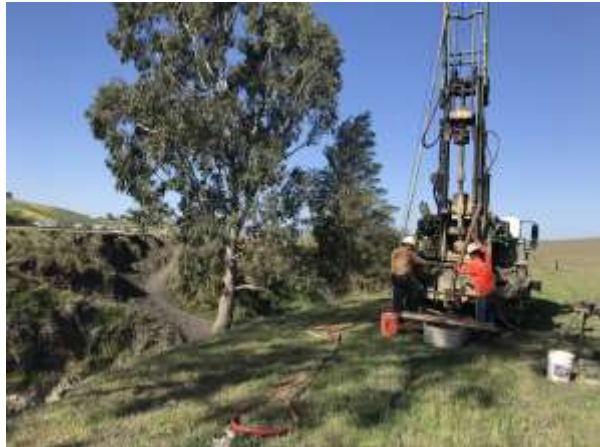
**PHOTO 2.7-2: View Looking Southwest from Boring 3-B2**

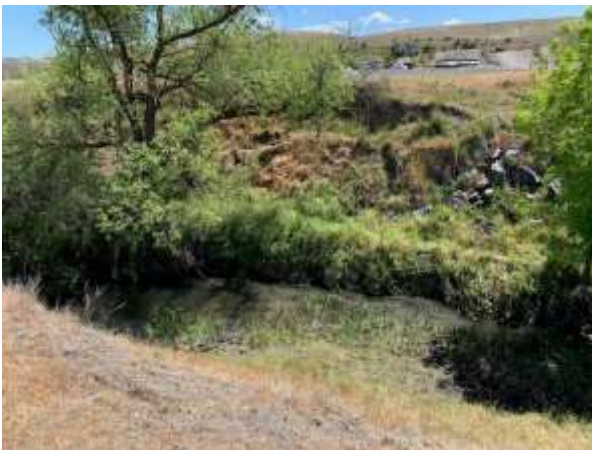
**PHOTO 2.7-3: Shallow Sloughing of Southern Bank West of Proposed Bridge and East of Revetment Associated with Abandoned Bridge**

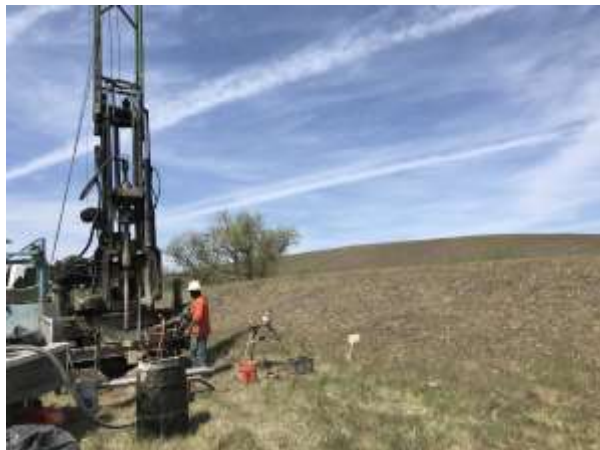
**PHOTO 2.7-4: Fill Berm Adjacent to Boring 3-B1**

Although non-engineered fills can undergo excessive settlement under new fill or building loads, we anticipate the sewer will be installed deeper than the fill and therefore won't be subject to impacts from the fill. However, the contractor should be aware of this existing fill and anticipate variable conditions compared to the native soil conditions on site. In the former Arroyo Seco drainage, this could potentially include the presence of younger and less dense soil. Refer to Section 5.3 for additional recommendations related to reuse of existing soil associated with this fill.

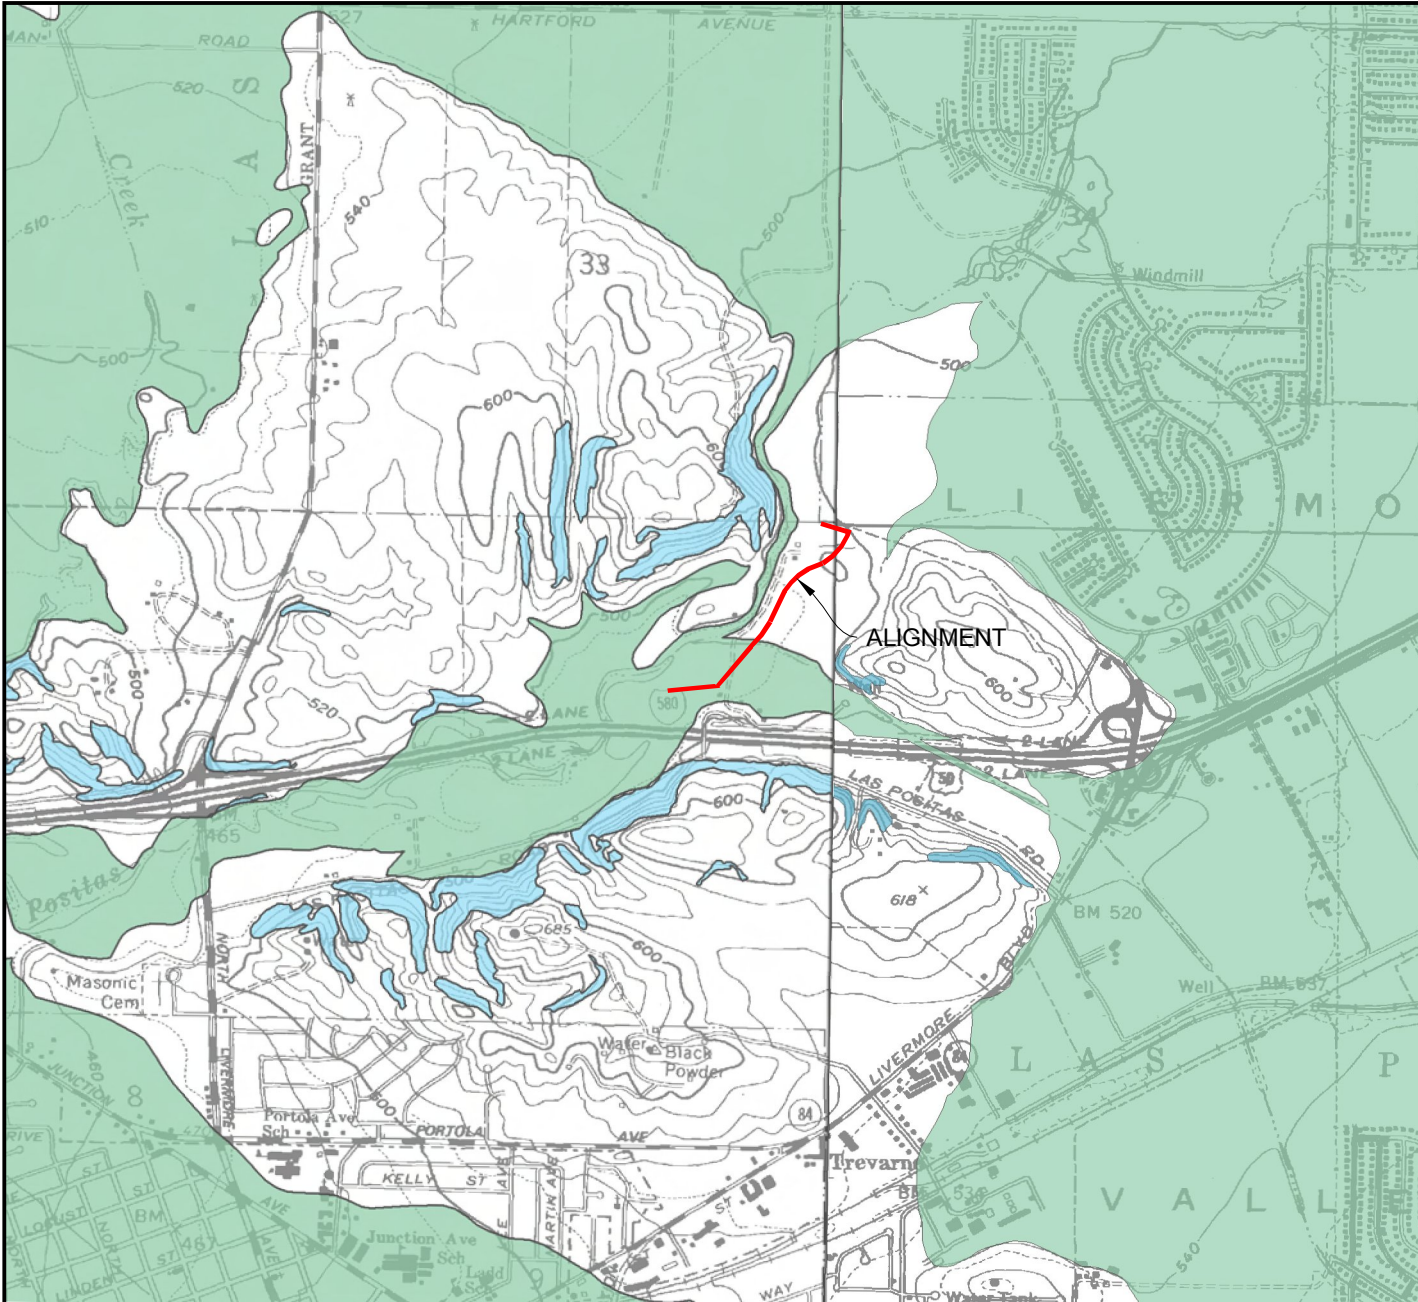
<b>SEISMIC HAZARD ZONES MAP</b> <b>OFFSITE SANITARY SEWER TRACT 8454 - LASSEN ROAD PROPERTY</b> <b>LIVERMORE, CALIFORNIA</b>	PROJECT NO.: 13850.001.001	FIGURE NO. <div style="font-size: 2em; font-weight: bold; text-align: center;">5</div>
		SCALE: AS SHOWN	
	DRAWN BY: LL	CHECKED BY: MMG

The Seismic Hazard Zone Map, illustrated in Figure 5, indicates the southern portion of the alignment extends through a zone mapped as a liquefaction-hazard zone. Witter (2006) maps the liquefaction hazard within the Arroyo Seco as very-high susceptibility of liquefaction, high near Las Colinas Road, and moderate within the majority of the alignment.

South of the Arroyo Seco, the alignment is within an area mapped with a potential for liquefaction on Figure 5. Knudsen et al (2000) and Witter (2006) mapped this southern portion of the alignment as being within a moderate to very high liquefaction susceptible area. We encountered loose to medium dense sand below the groundwater in this area in Borings 3-B8, 1-B7, and 1-B8 that we judge to be Holocene-aged. Based on the relatively discontinuous nature of the sand and thickness of non-liquefiable capping layer at the surface, we anticipate the risk of liquefaction-induced surface rupture or lateral spreading in these areas is relatively low. Following

Earthquake-induced landsliding involves lateral ground movements caused by seismic shaking. The Seismic Hazard Zone Map, Figure 5, indicates the site is outside of an Earthquake-Induced landslide zone. We anticipate that the risk of earthquake-induced landsliding to be low along the alignment.

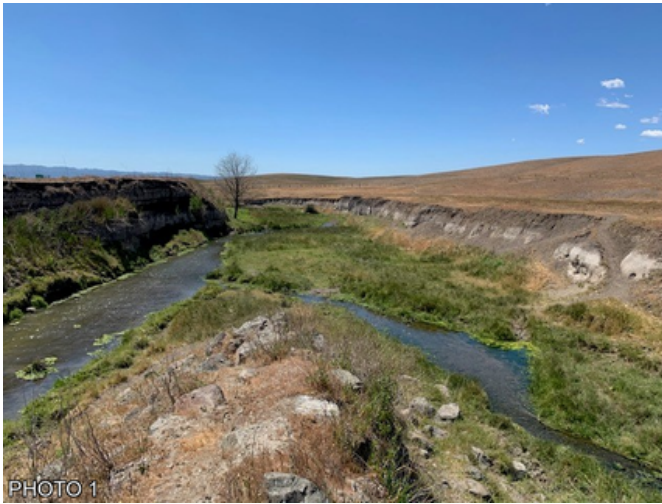
CONFLUENCE

The proposed alignment is located approximately 200 feet upstream of the Arroyo Seco confluence with Arroyo Las Positas. We observed that approximately 50 feet upstream of the confluence, the Arroyo Seco creek banks have been armored with rock revetment at an abandoned bridge crossing. In the area of the proposed alignment, the creek bed appears to have formed a step-pool and riffle system. Visible flowing water was approximately 1 foot deep and moving at a velocity estimated at less than 1 foot per second. Photos from our reconnaissance are shown on Figure 6. As previously discussed in Section 2.2, the Arroyo Seco drainage appears to have been anthropomorphically modified in the area of the project. The channel bed and banks have a consistent geometry throughout the reach, and the bottom of the channel appears to be over widened. Based on our site observations, neither localized bed erosion nor widespread systematic downcutting of the creek bed appeared to be occurring in this reach of Arroyo Seco. Moreover, existing armorment downstream of the project may stabilize any scour in the reach of the proposed project.
