ANNUAL NOTICE OF PROPOSED WORK FOR 2022 STREAM MAINTENANCE PROJECTS

CITY OF LIVERMORE STREAM MAINTENANCE PROGRAM

March 2022

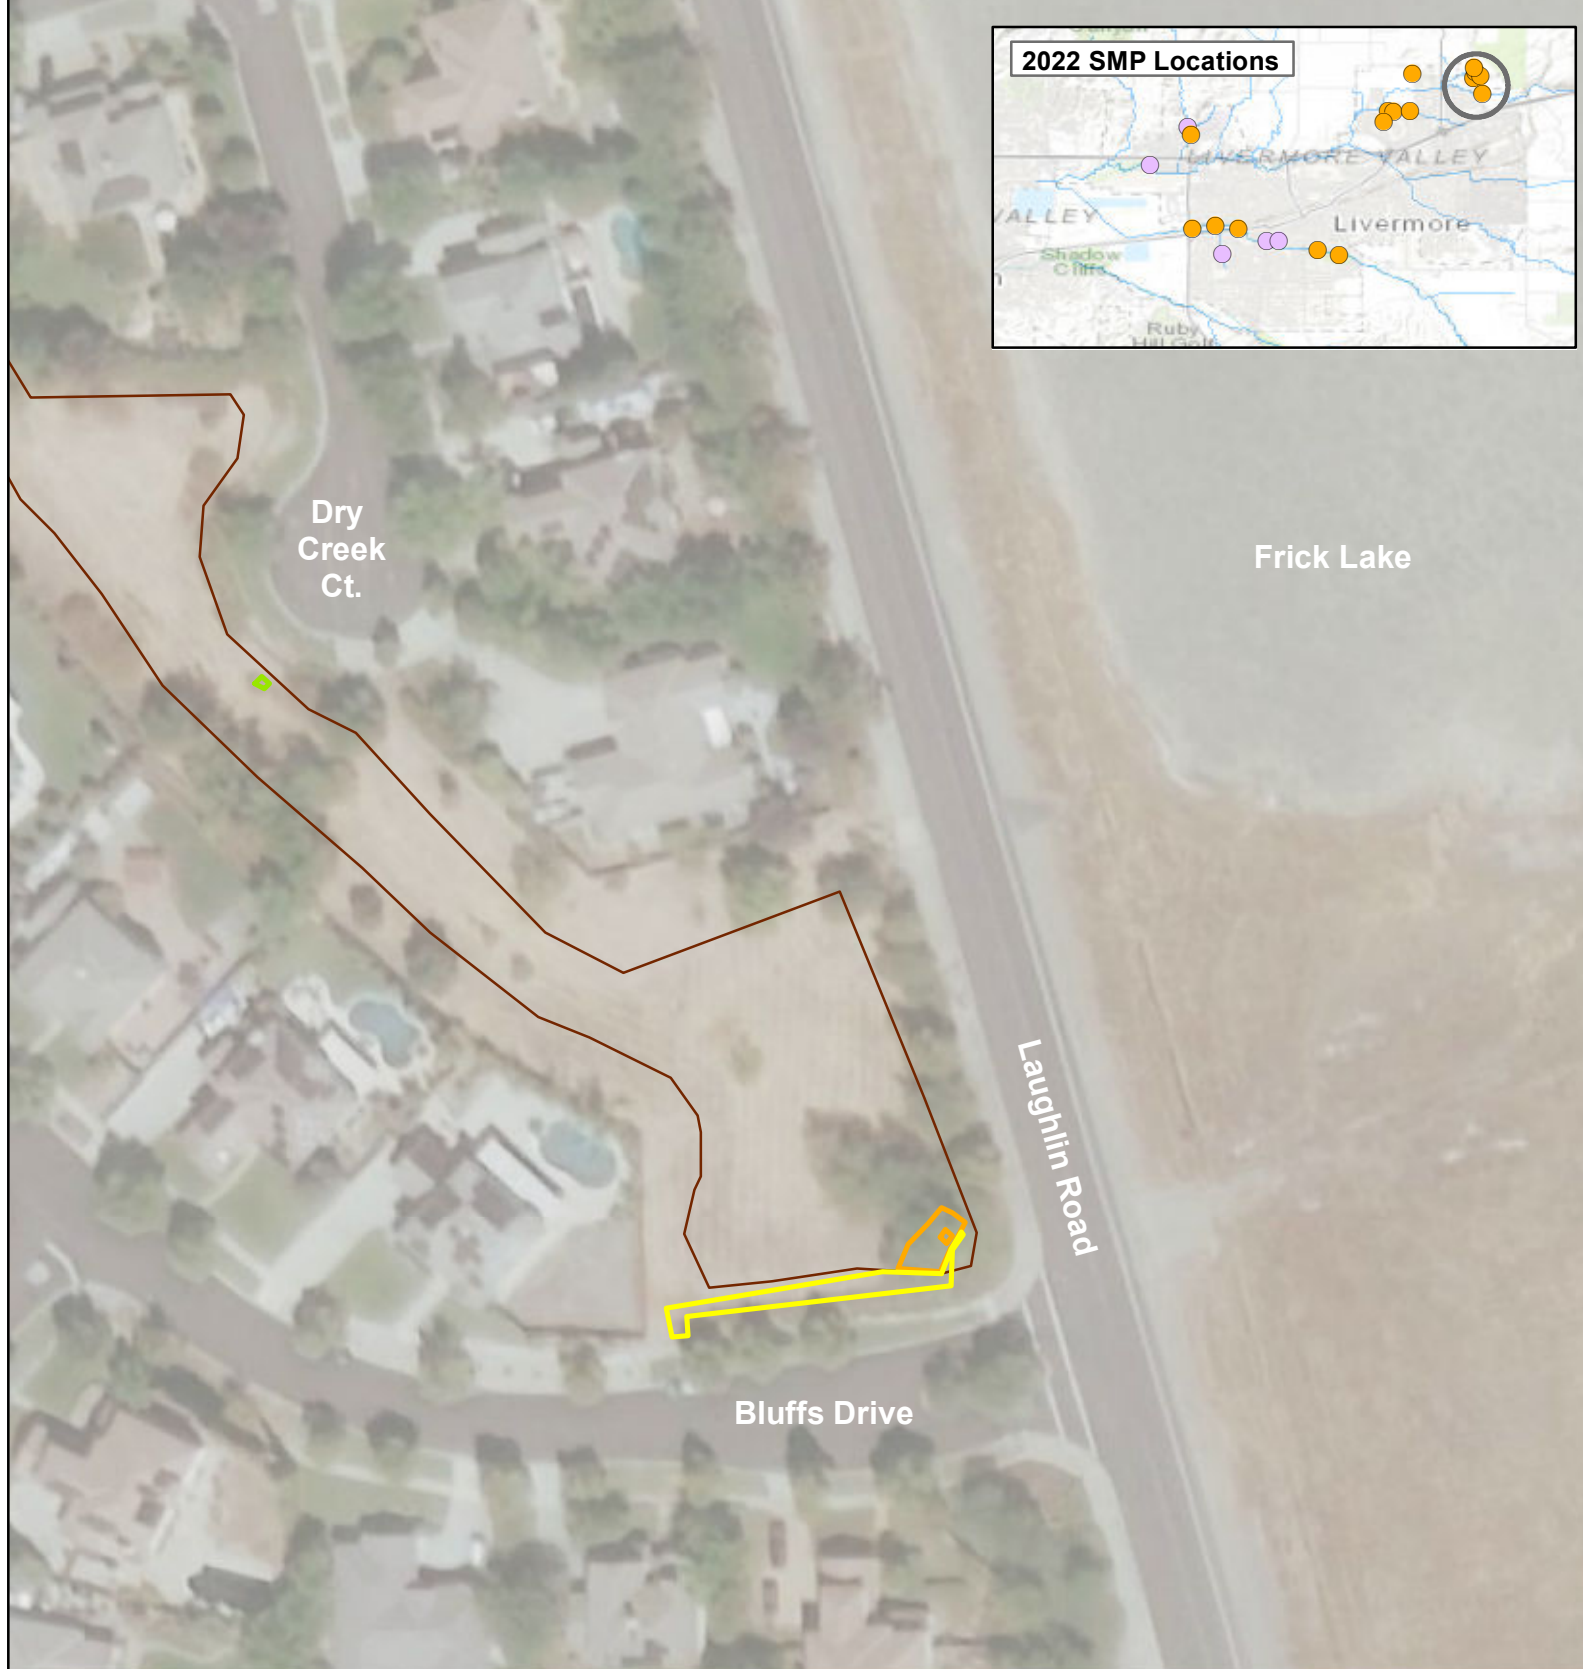
Figure A-1
Site 46 - The Bluffs Neighborhood
City of Livermore
2022 Stream Maintenance Program
March 2022

- 46 - Access
- 46 - Pampas Grass Removal
- 46 - Permanent Outfall Maintenance
- 46 - Temporary Outfall Maintenance
- Unnamed Stormwater Basin

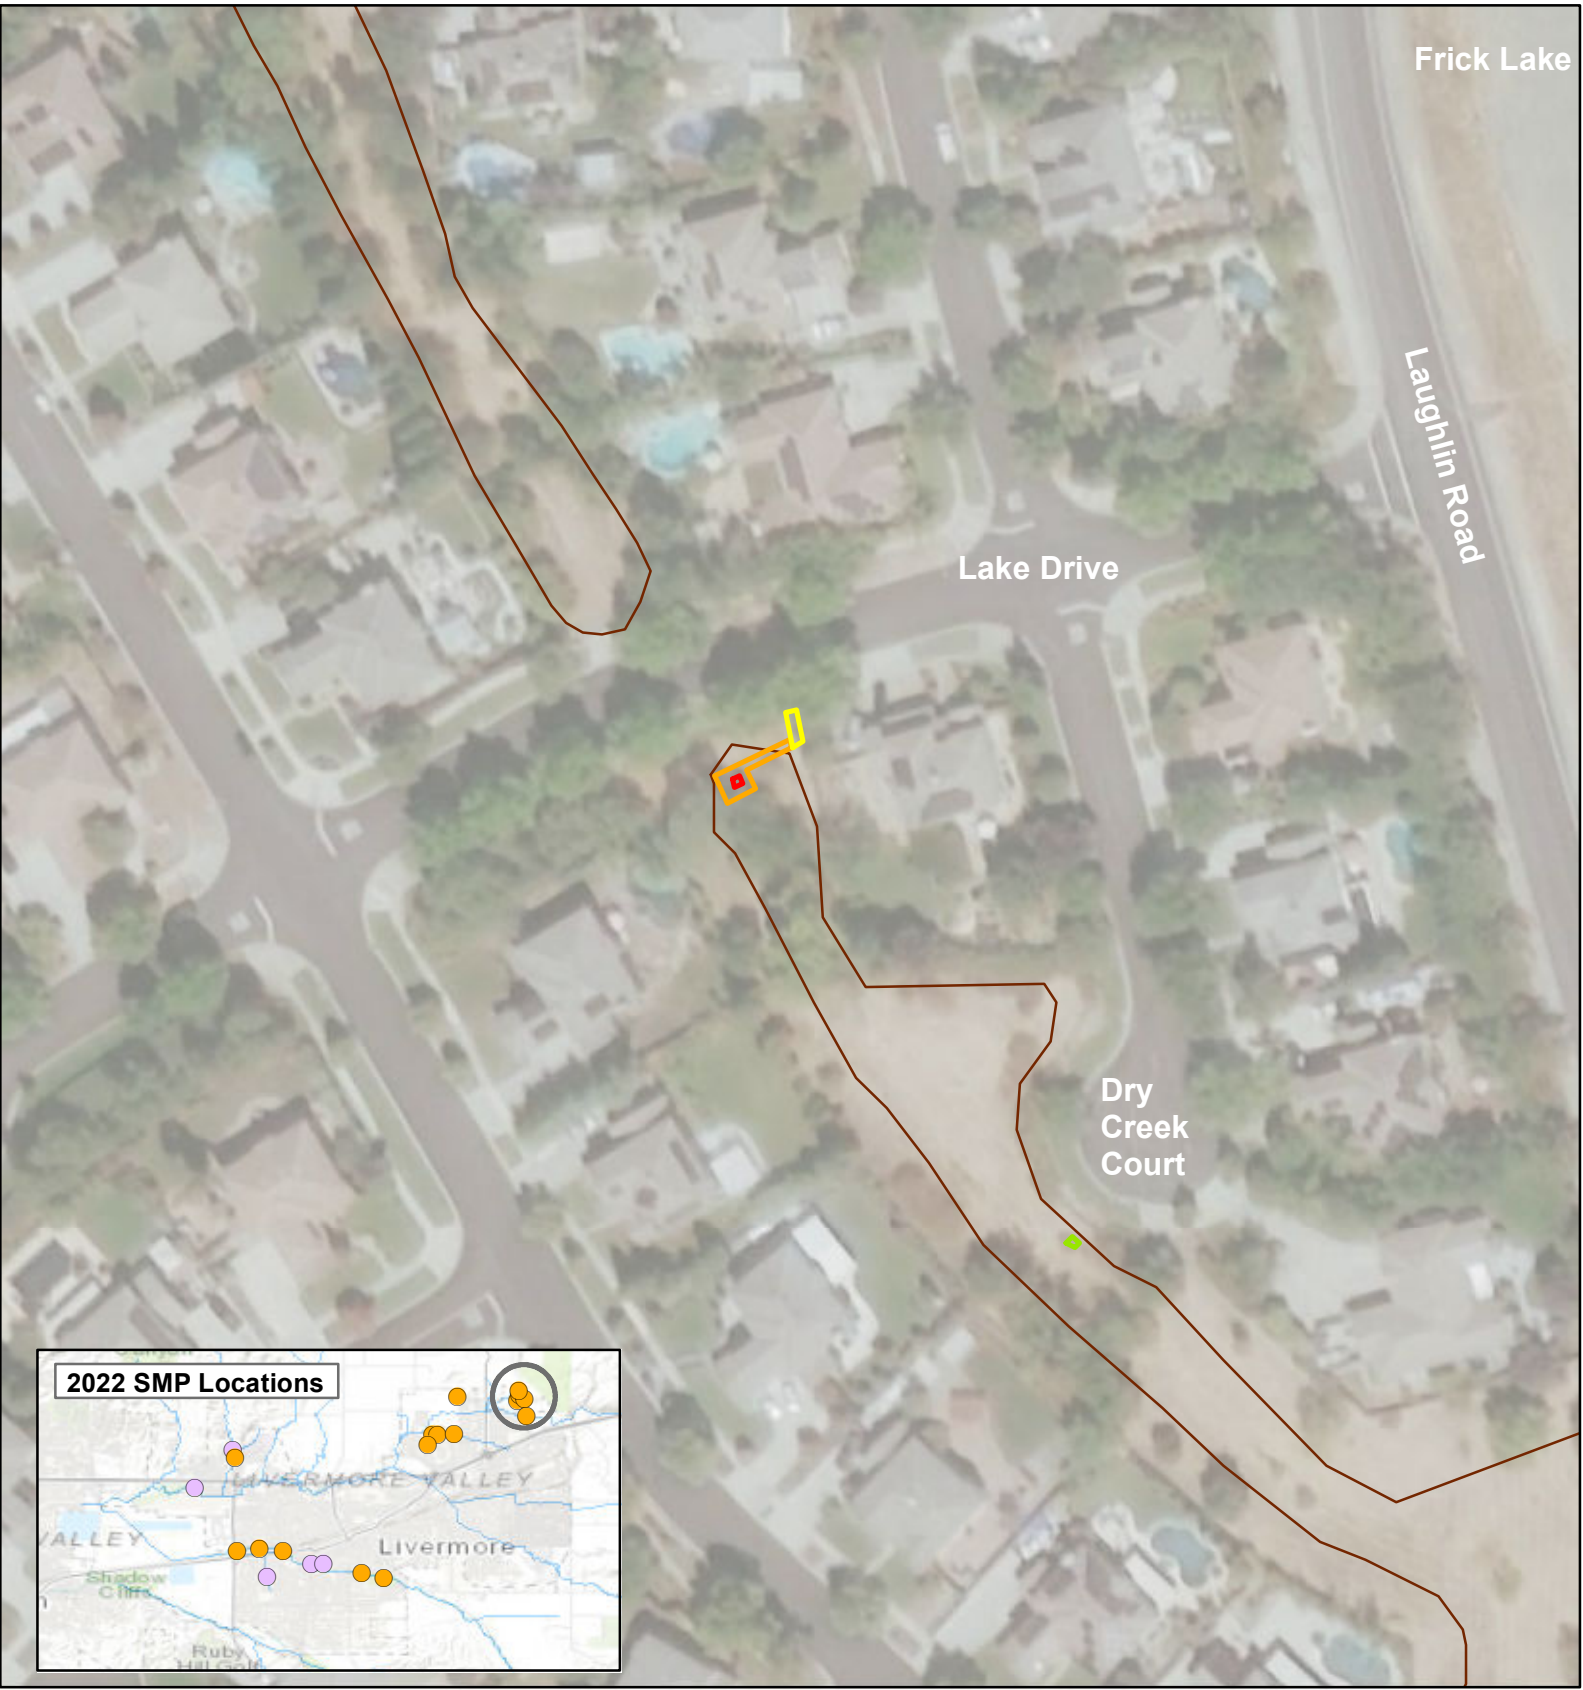
Figure A-2
Site 47 - The Bluffs Neighborhood
City of Livermore
2022 Stream Maintenance Program
March 2022

- 46 - Pampas Grass Removal
- 47 - Access
- 47 - Permanent Outfall Maintenance
- 47 - Temporary Outfall Maintenance
- Unnamed Stormwater Basin

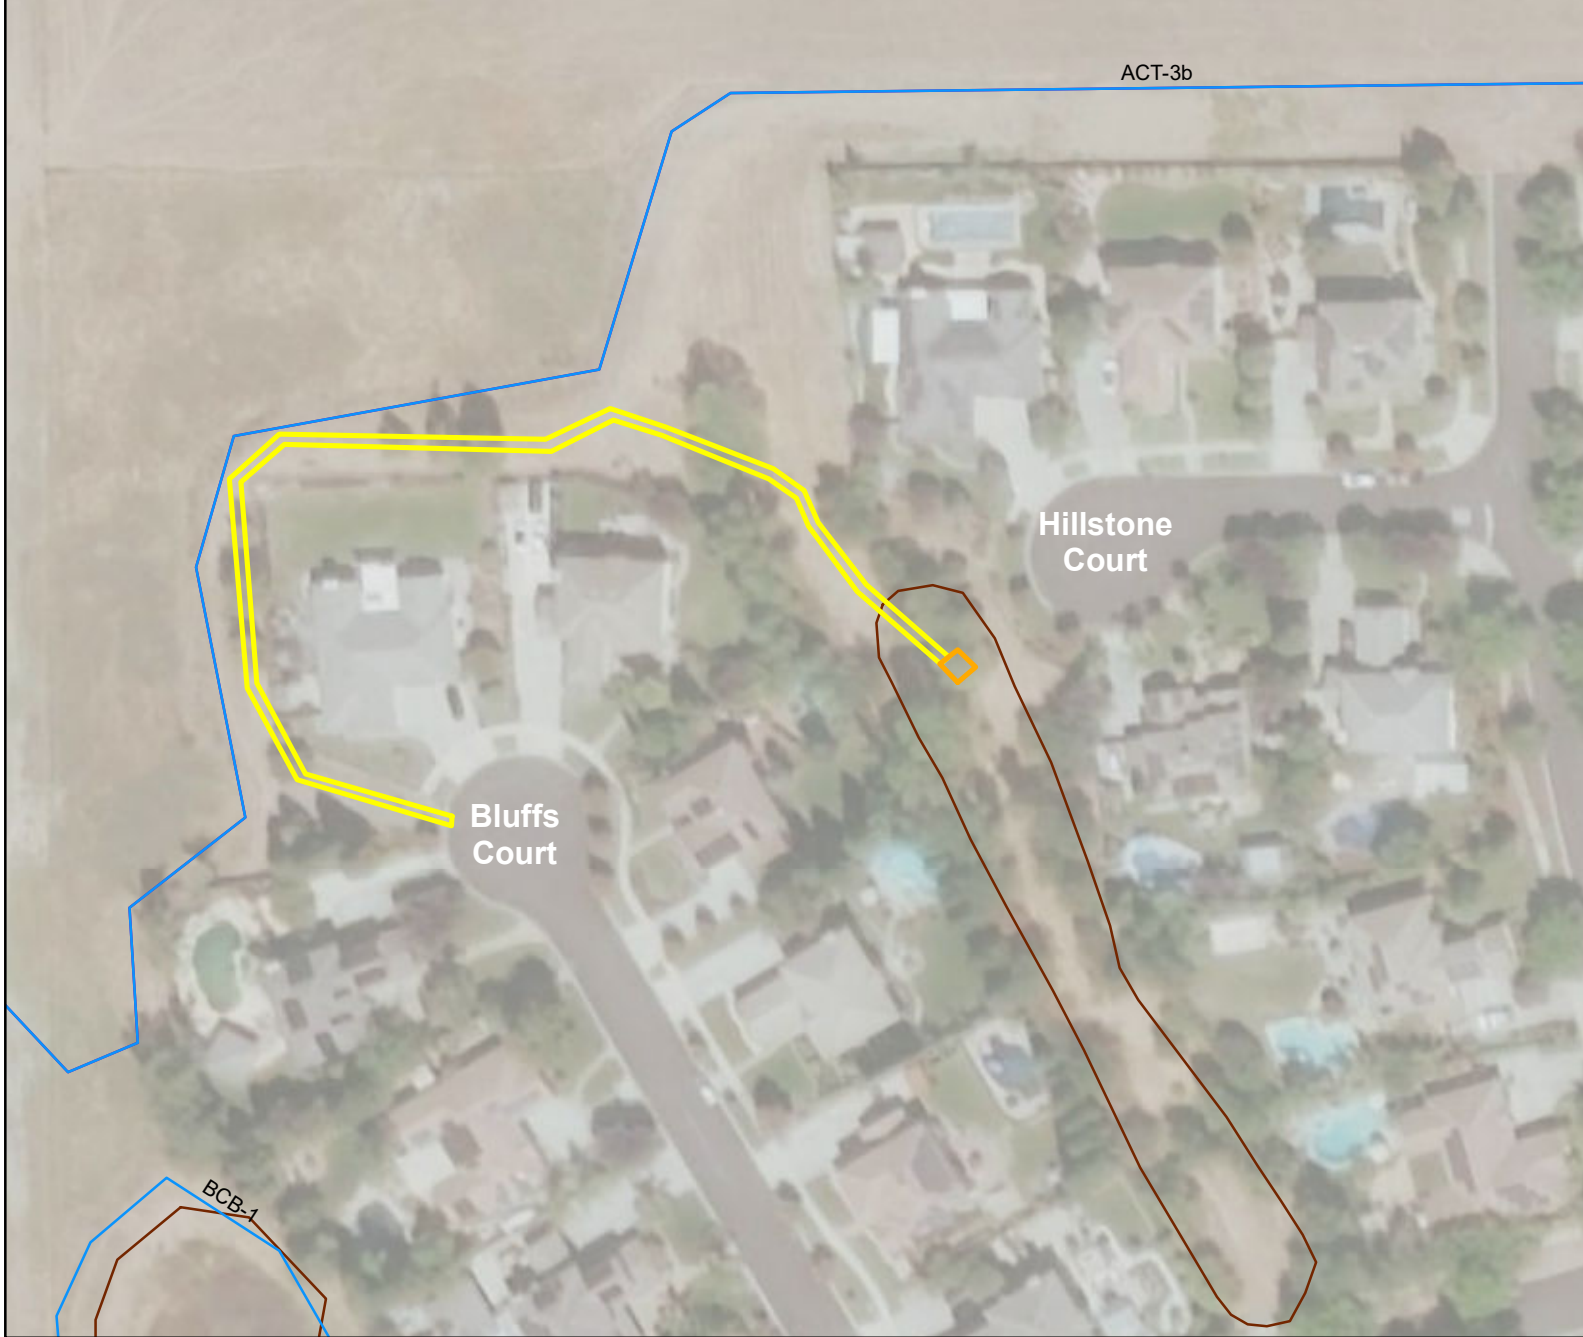
Figure A-4
Site 56 - The Bluffs Neighborhood
City of Livermore
2022 Stream Maintenance Program
March 2022

- 56 - Access
- 56 - Temporary (Outfall Sediment and Vegetation Removal)
- Unnamed Stormwater Basin

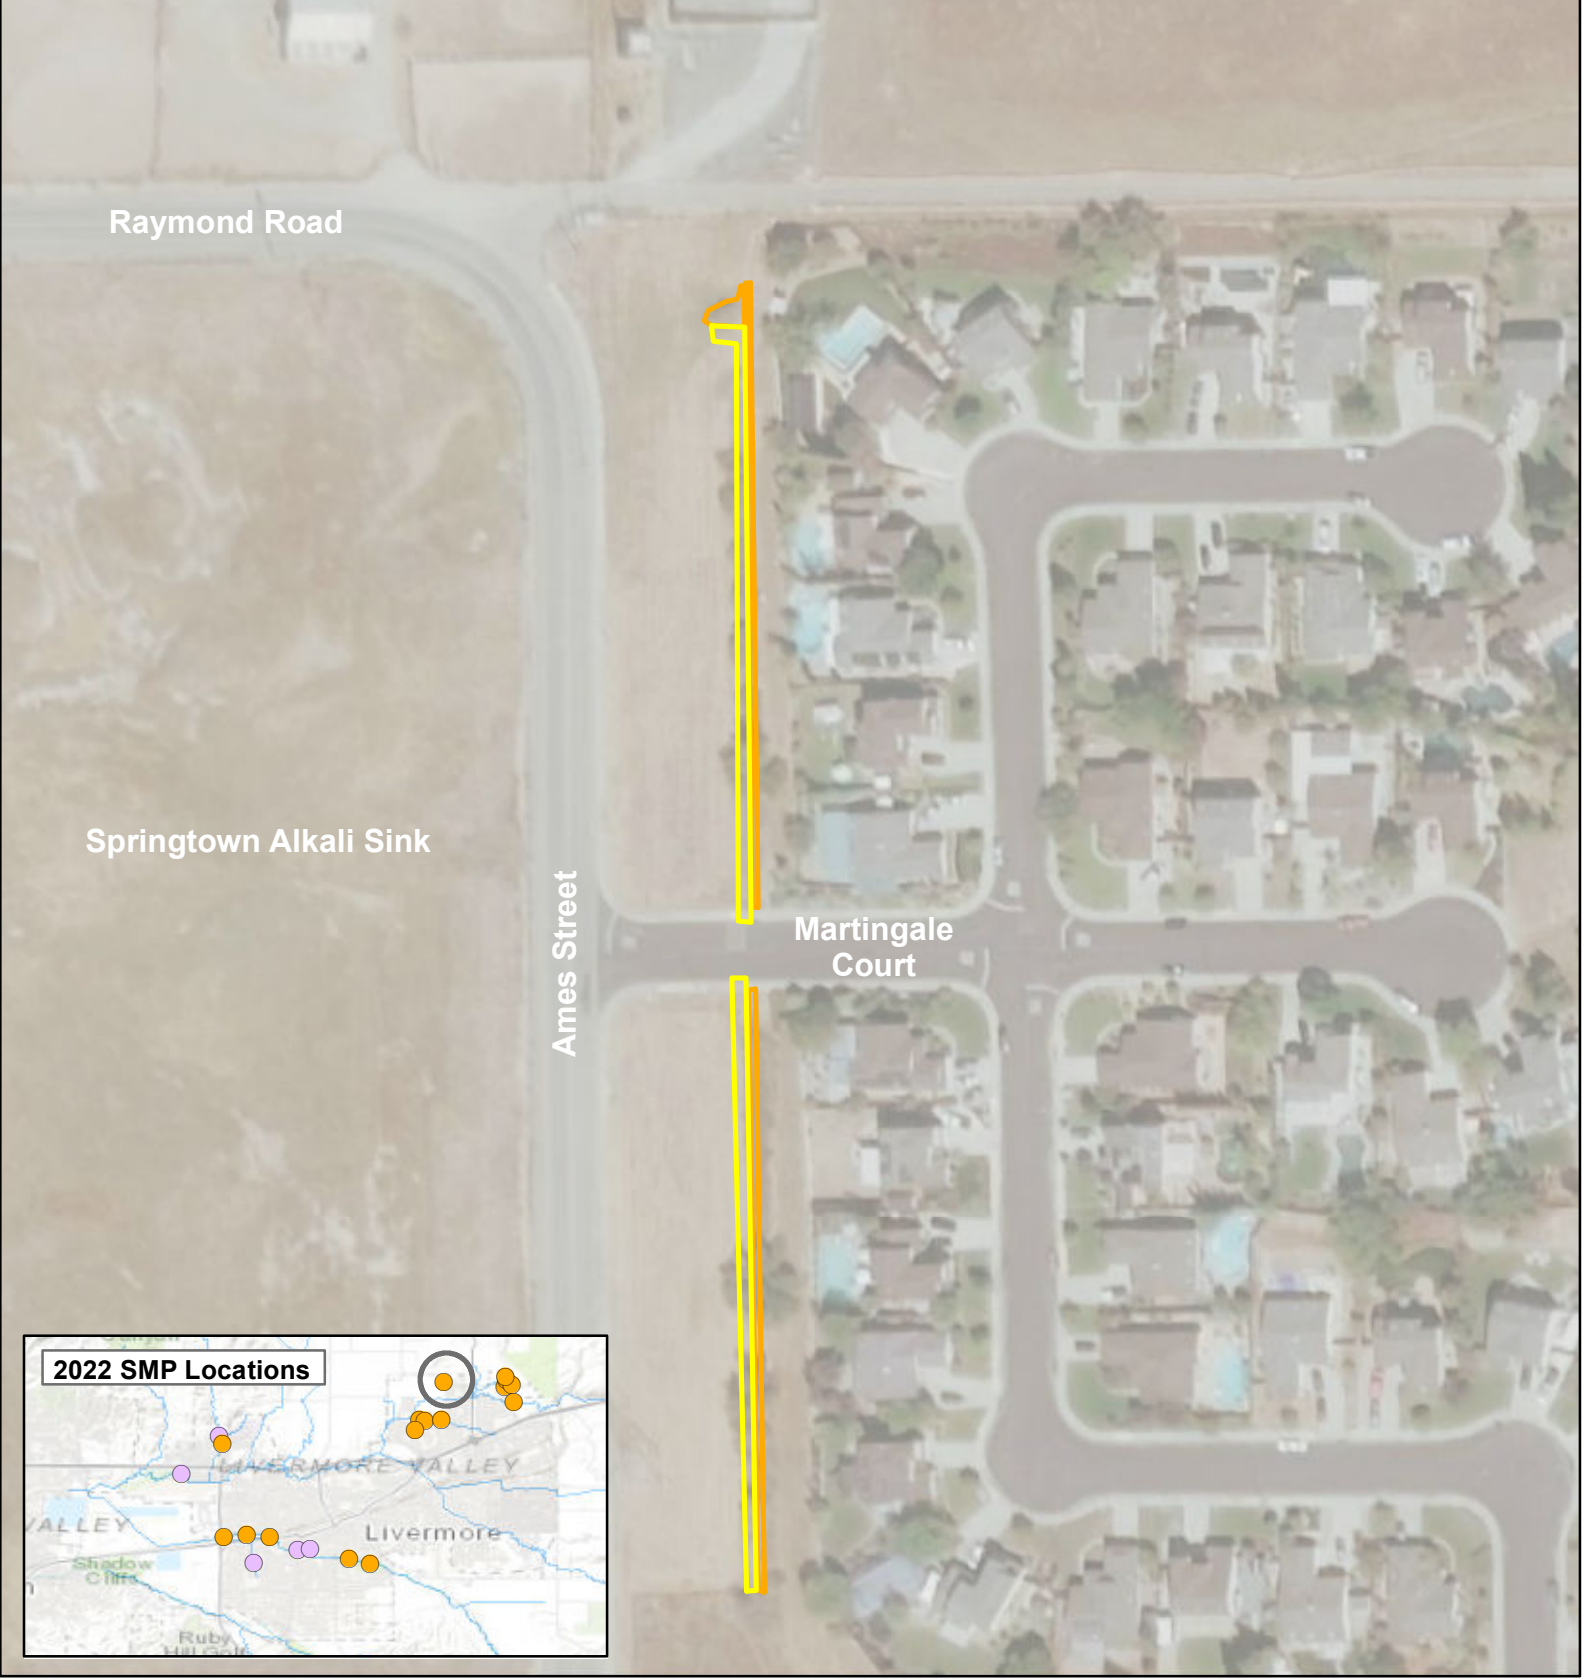
Figure A-5
Site 57a and 57b - Saddleback
City of Livermore
2022 Stream Maintenance Program
March 2022

- 57a - Access
- 57a - Temporary (Outfall Sediment and Vegetation Removal)
- 57a - Temporary (Sediment and Vegetation Removal)
- 57b - Access
- 57b - Temporary (Sediment and Vegetation Removal)

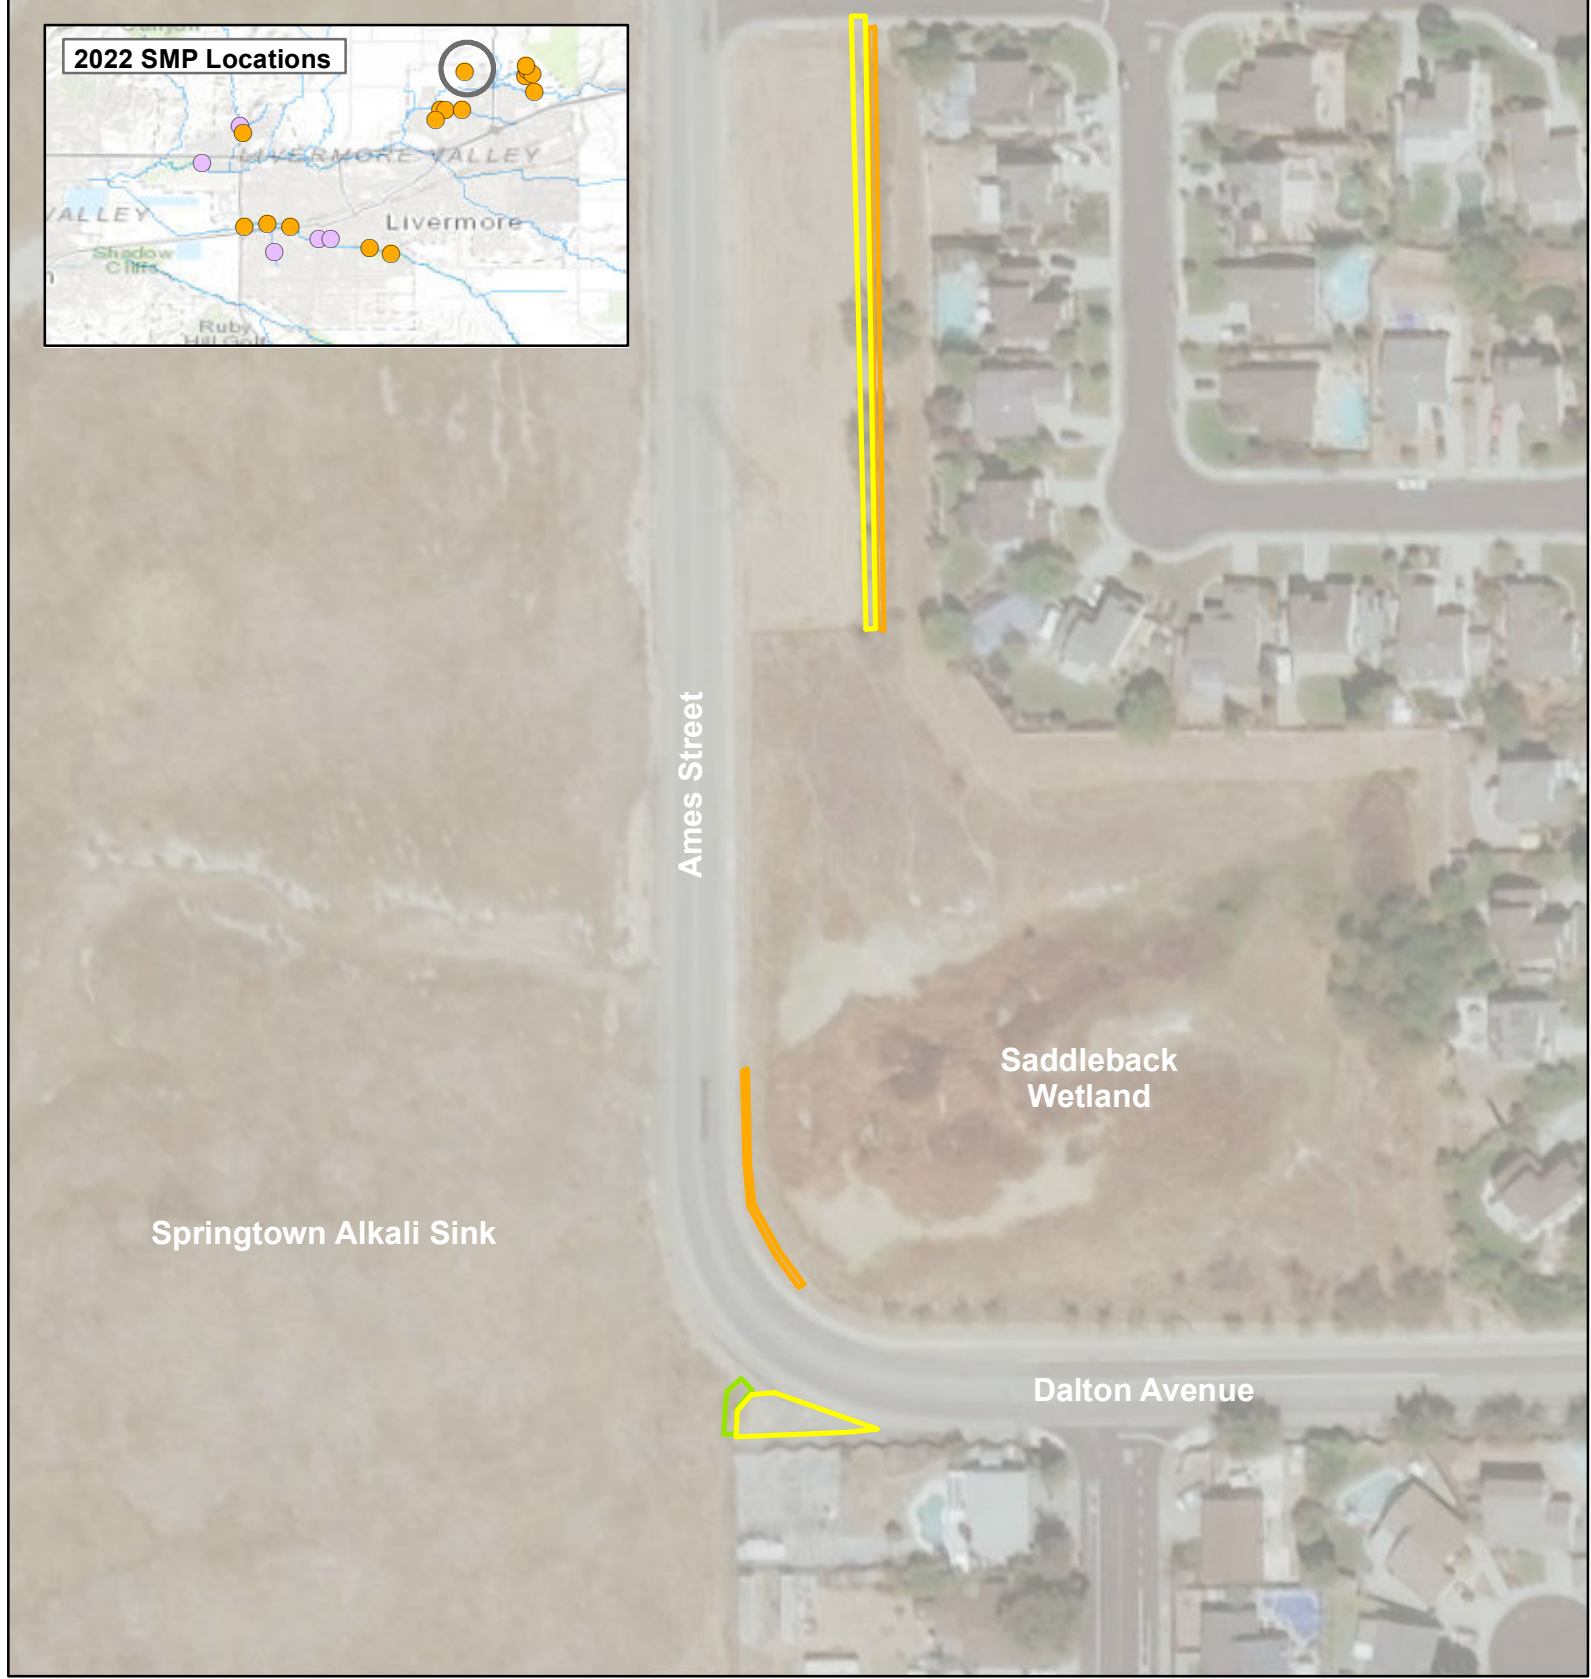
Figure A-6
Site 57b and 57c - Saddleback
 City of Livermore
 2022 Stream Maintenance Program
 March 2022

- 57b - Access
- 57b - Temporary (Sediment and Vegetation Removal)
- 57c - Access and Staging
- 57c - Temporary (Sediment)
- 57c - Temporary (Vegetation and Debris Removal)

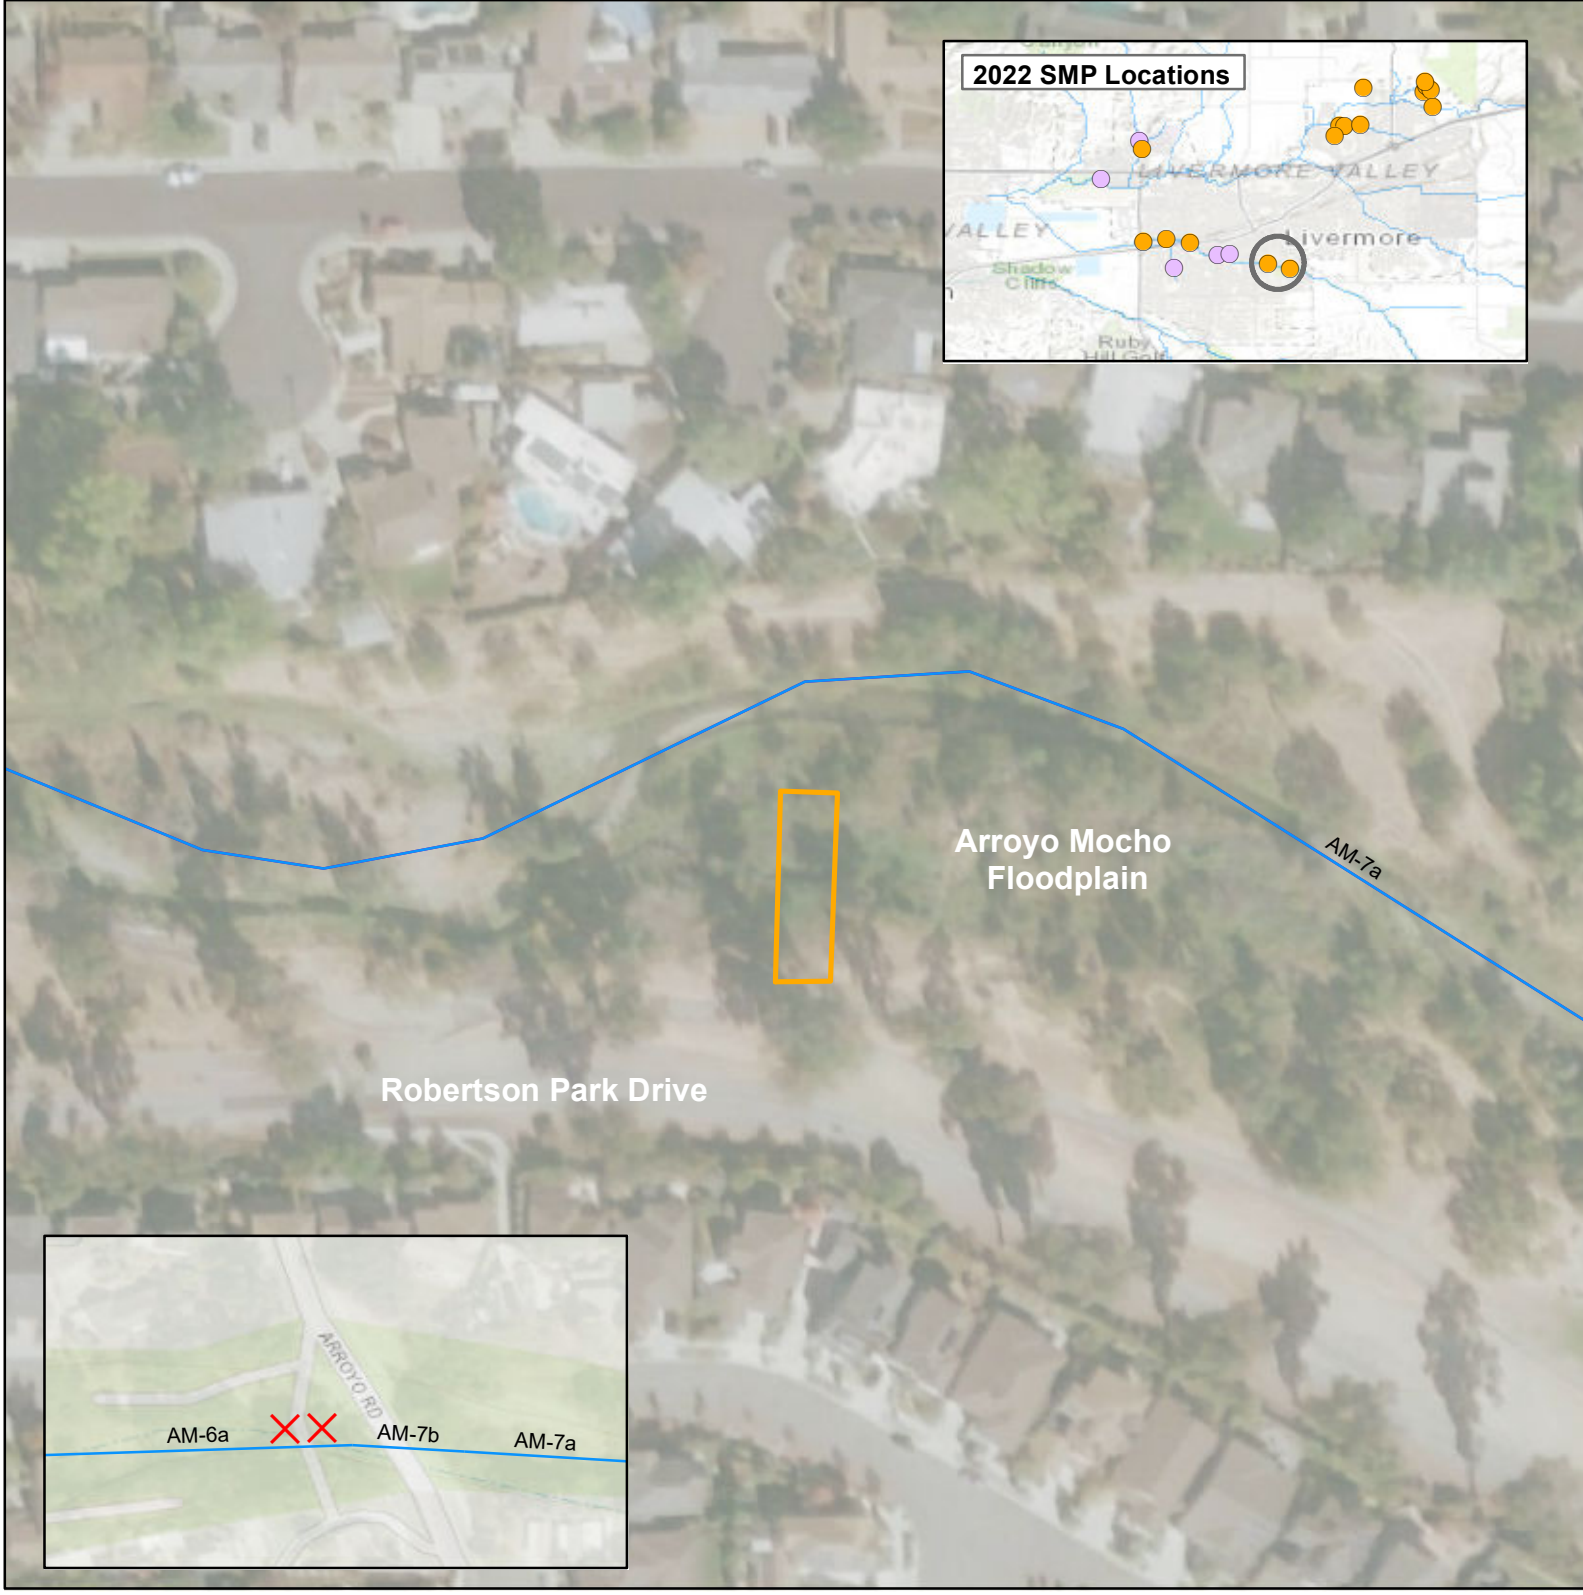
Figure A-12
Site 63 West Robertson Park
Vegetation Management at Outfall
and Arroyo Bridge

- ✗ Dead/dying cottonwood removal
- 63 - Temporary (Himalayn Blackberry and Debris Management)

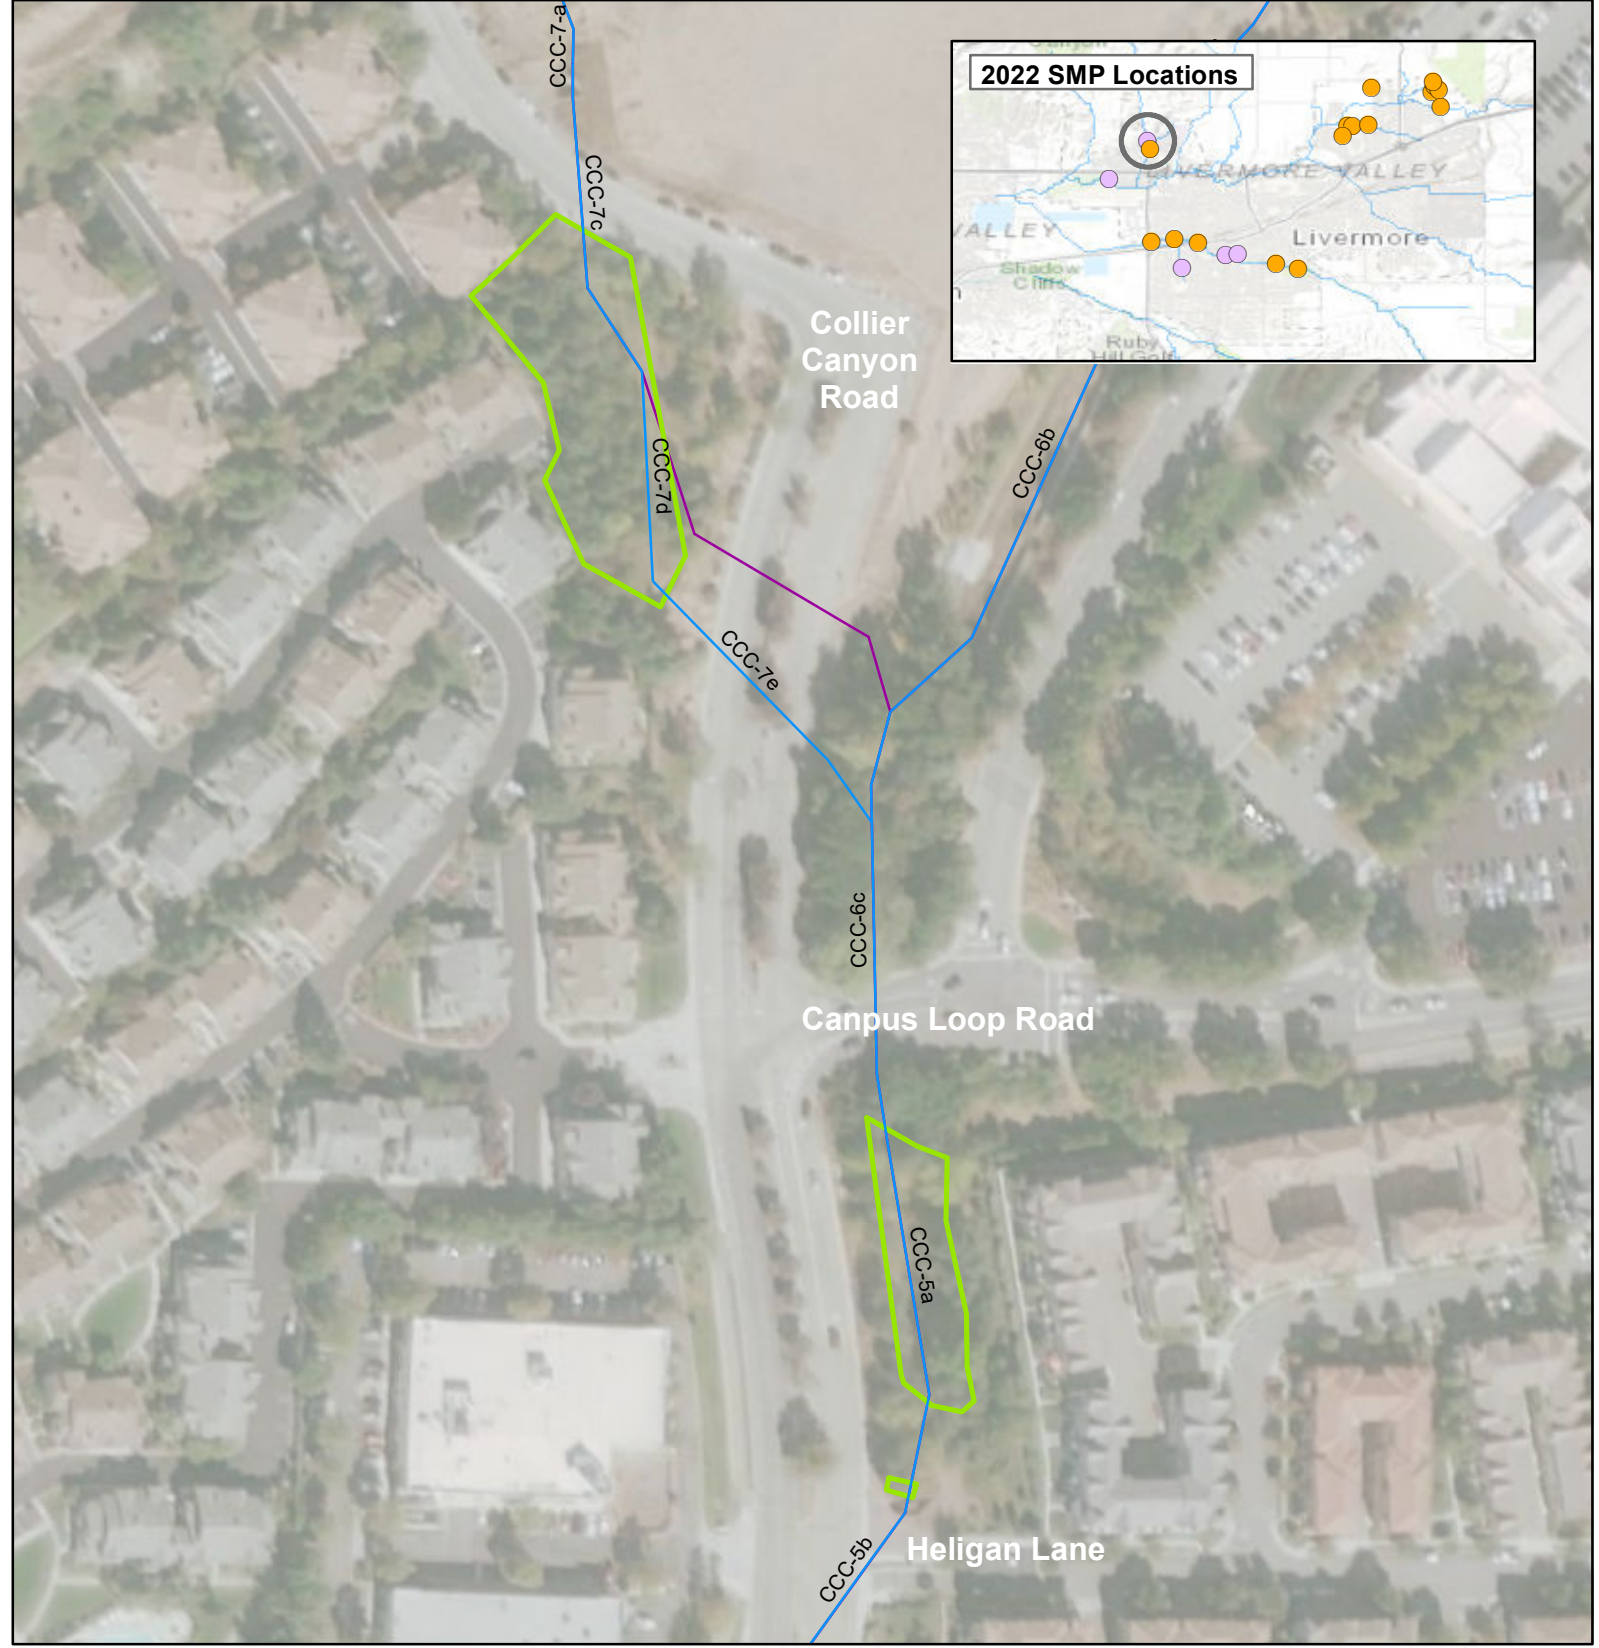
Figure A-16
Site 67 Collier Canyon Mitigation Areas
City of Livermore
2022 Stream Maintenance Program
March 2022

- 67a - Vegetation and Debris Management
- 67b - Himalyan Blackberry removal
- 67b - Vegetation and Debris Management

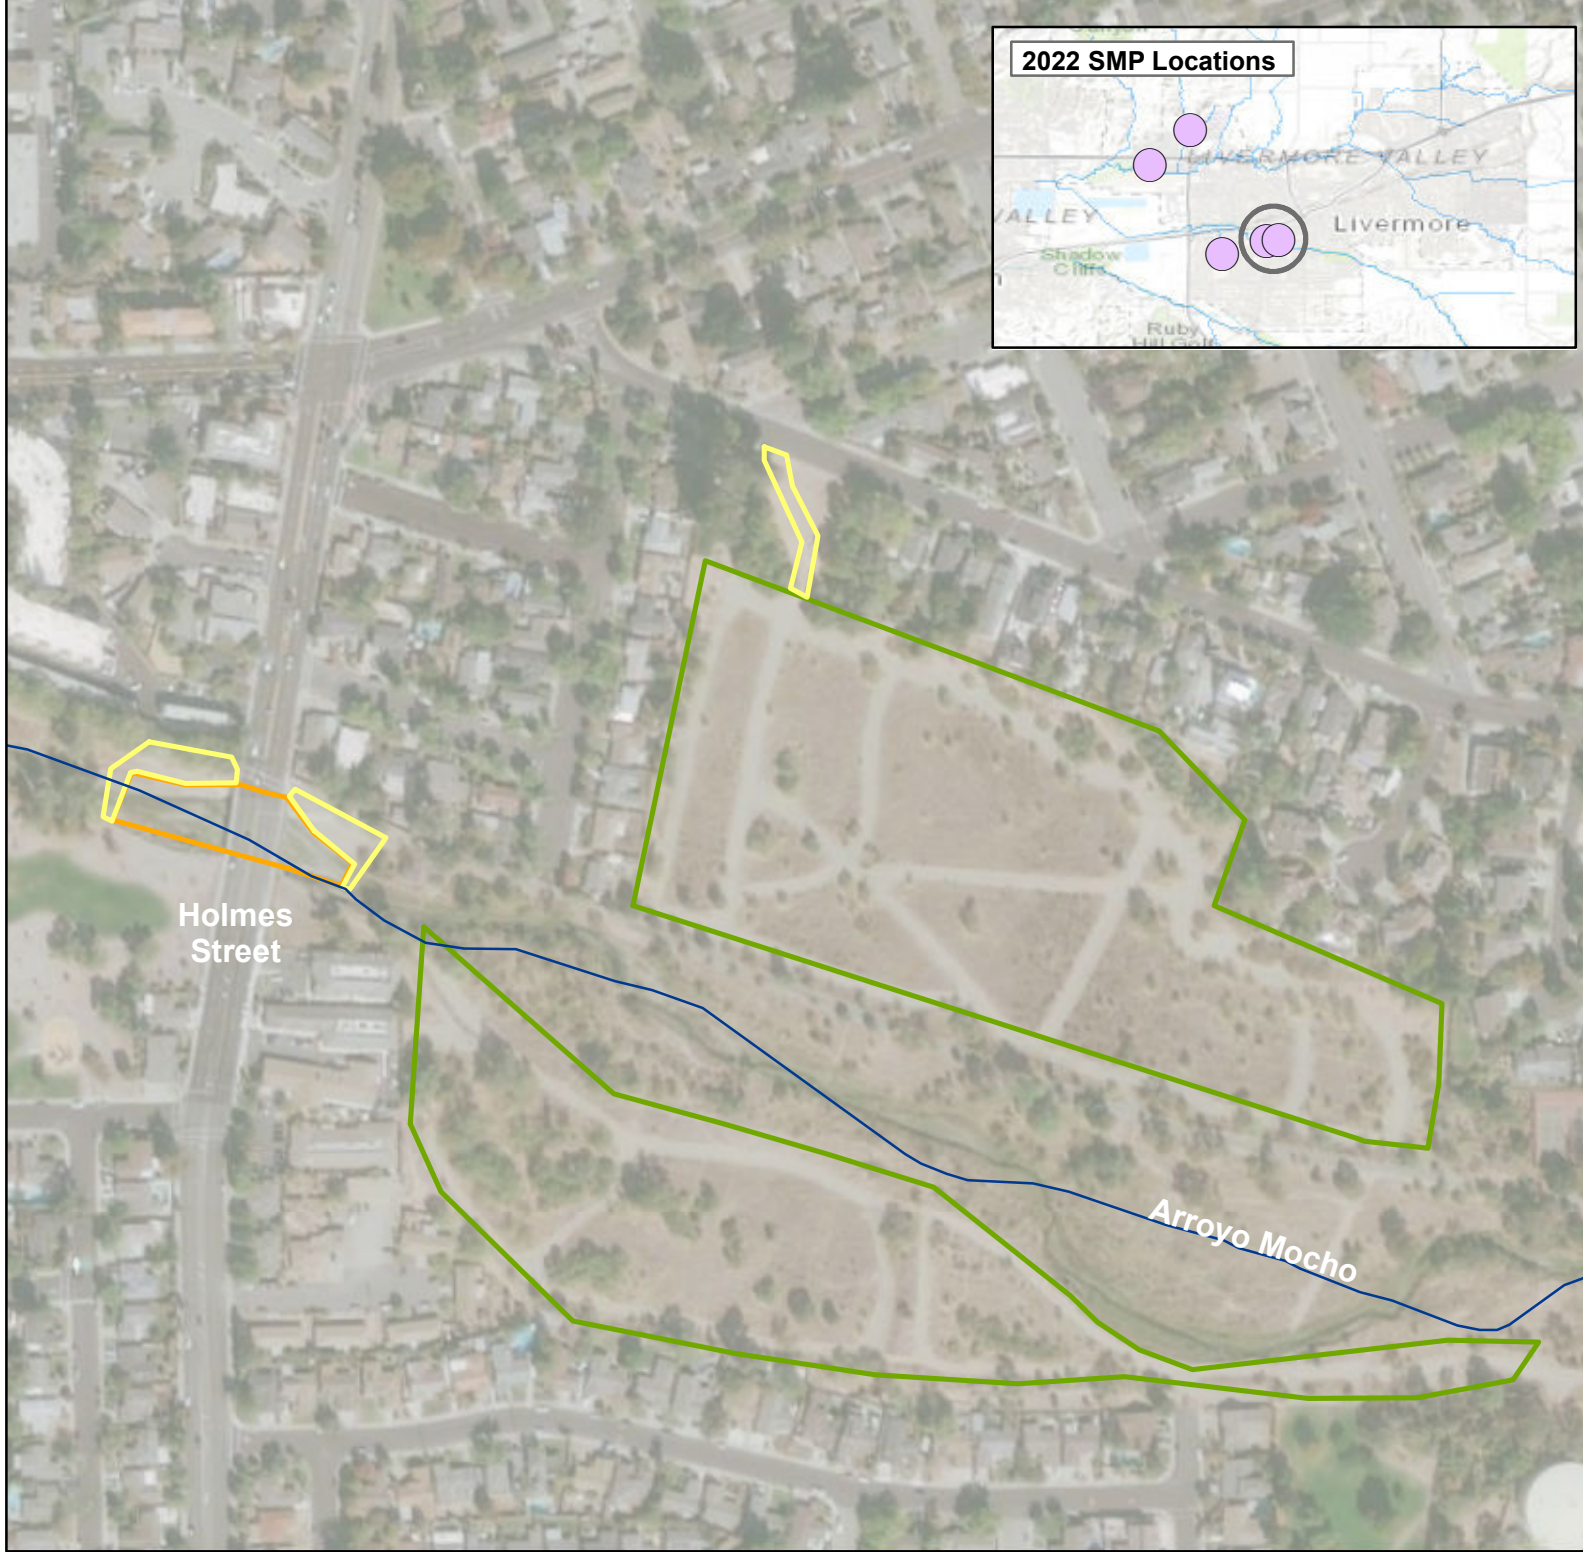
Figure A-18
YM-1 Holmes Street
YM-2 Medeiros Parkway
Arroyo Mocho

Staging and Access will occur in previously disturbed, paved trails and existing gravel roads.

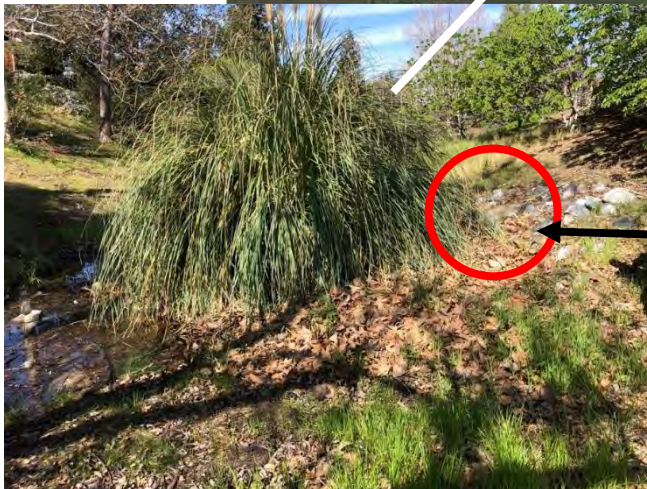
Blocked outfall

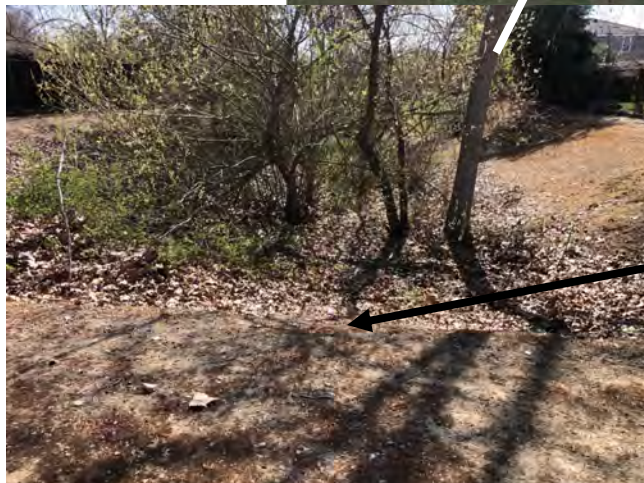
Blocked outfall

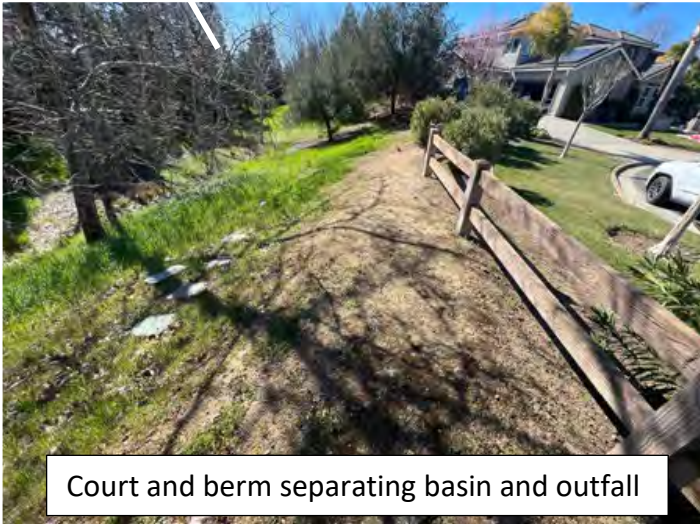
Court and berm separating basin and outfall

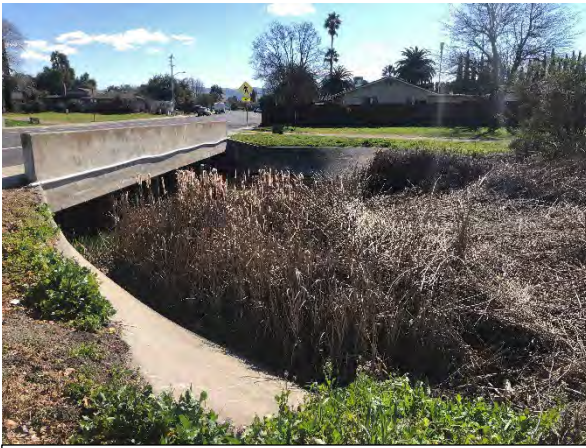
Downstream looking south

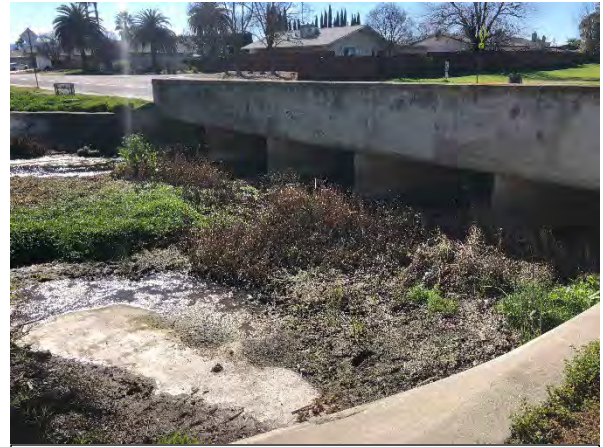
Upstream looking south

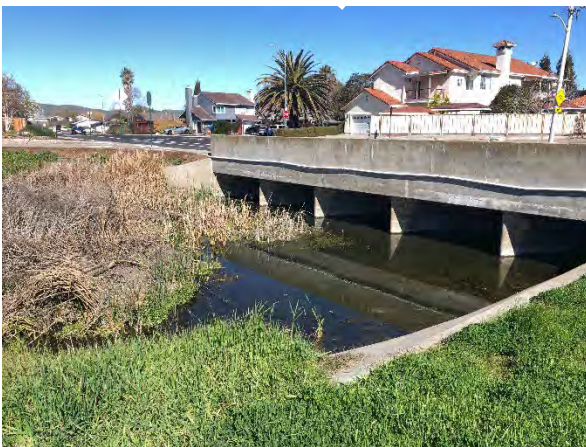
Downstream looking north

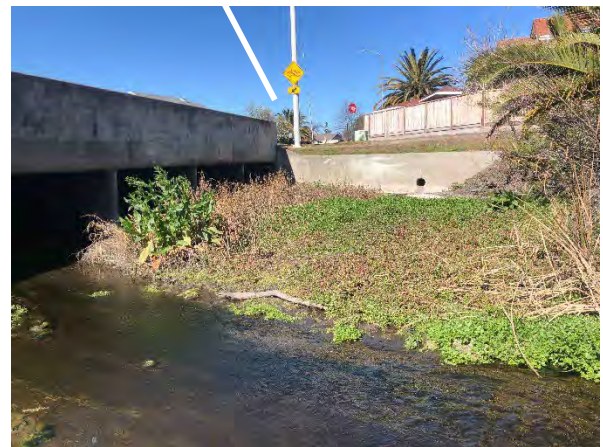
Upstream looking north

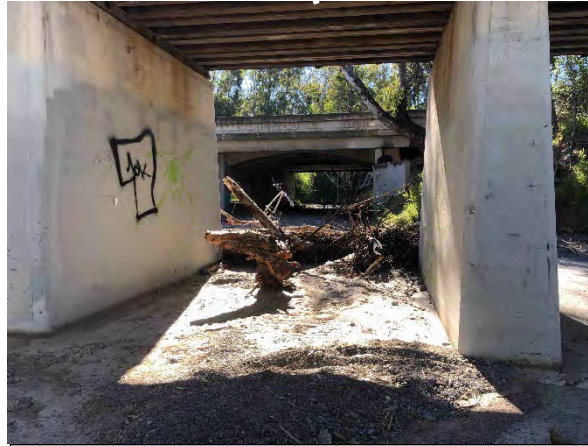
Debris caught in old railroad bridge piers, looking south
