ANNUAL NOTICE OF PROPOSED WORK FOR 2022 STREAM MAINTENANCE PROJECTS

CITY OF LIVERMORE STREAM MAINTENANCE PROGRAM

March 2022

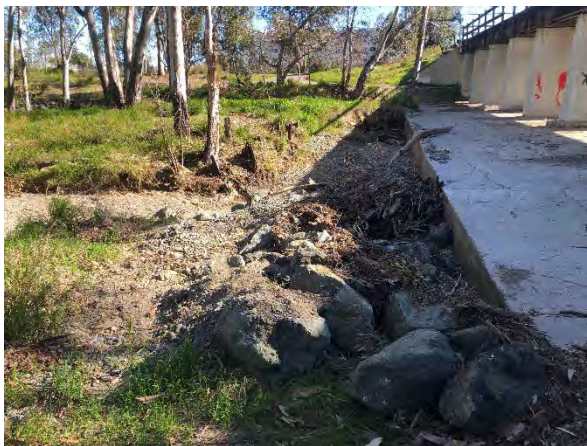
Scour pool below concrete of old railroad bridge, looking east

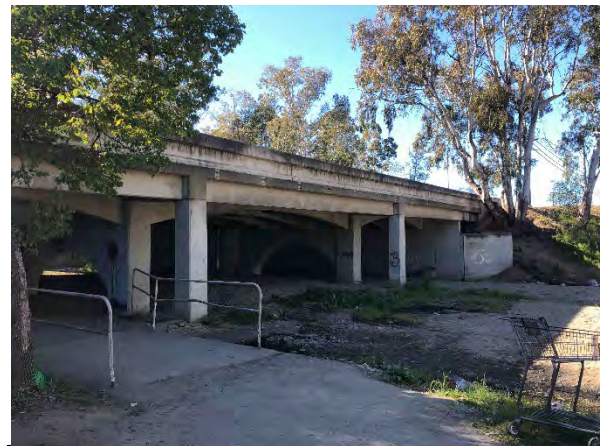
Stanley Bridge, pedestrian trail and Arroyo Mocho, looking southwest

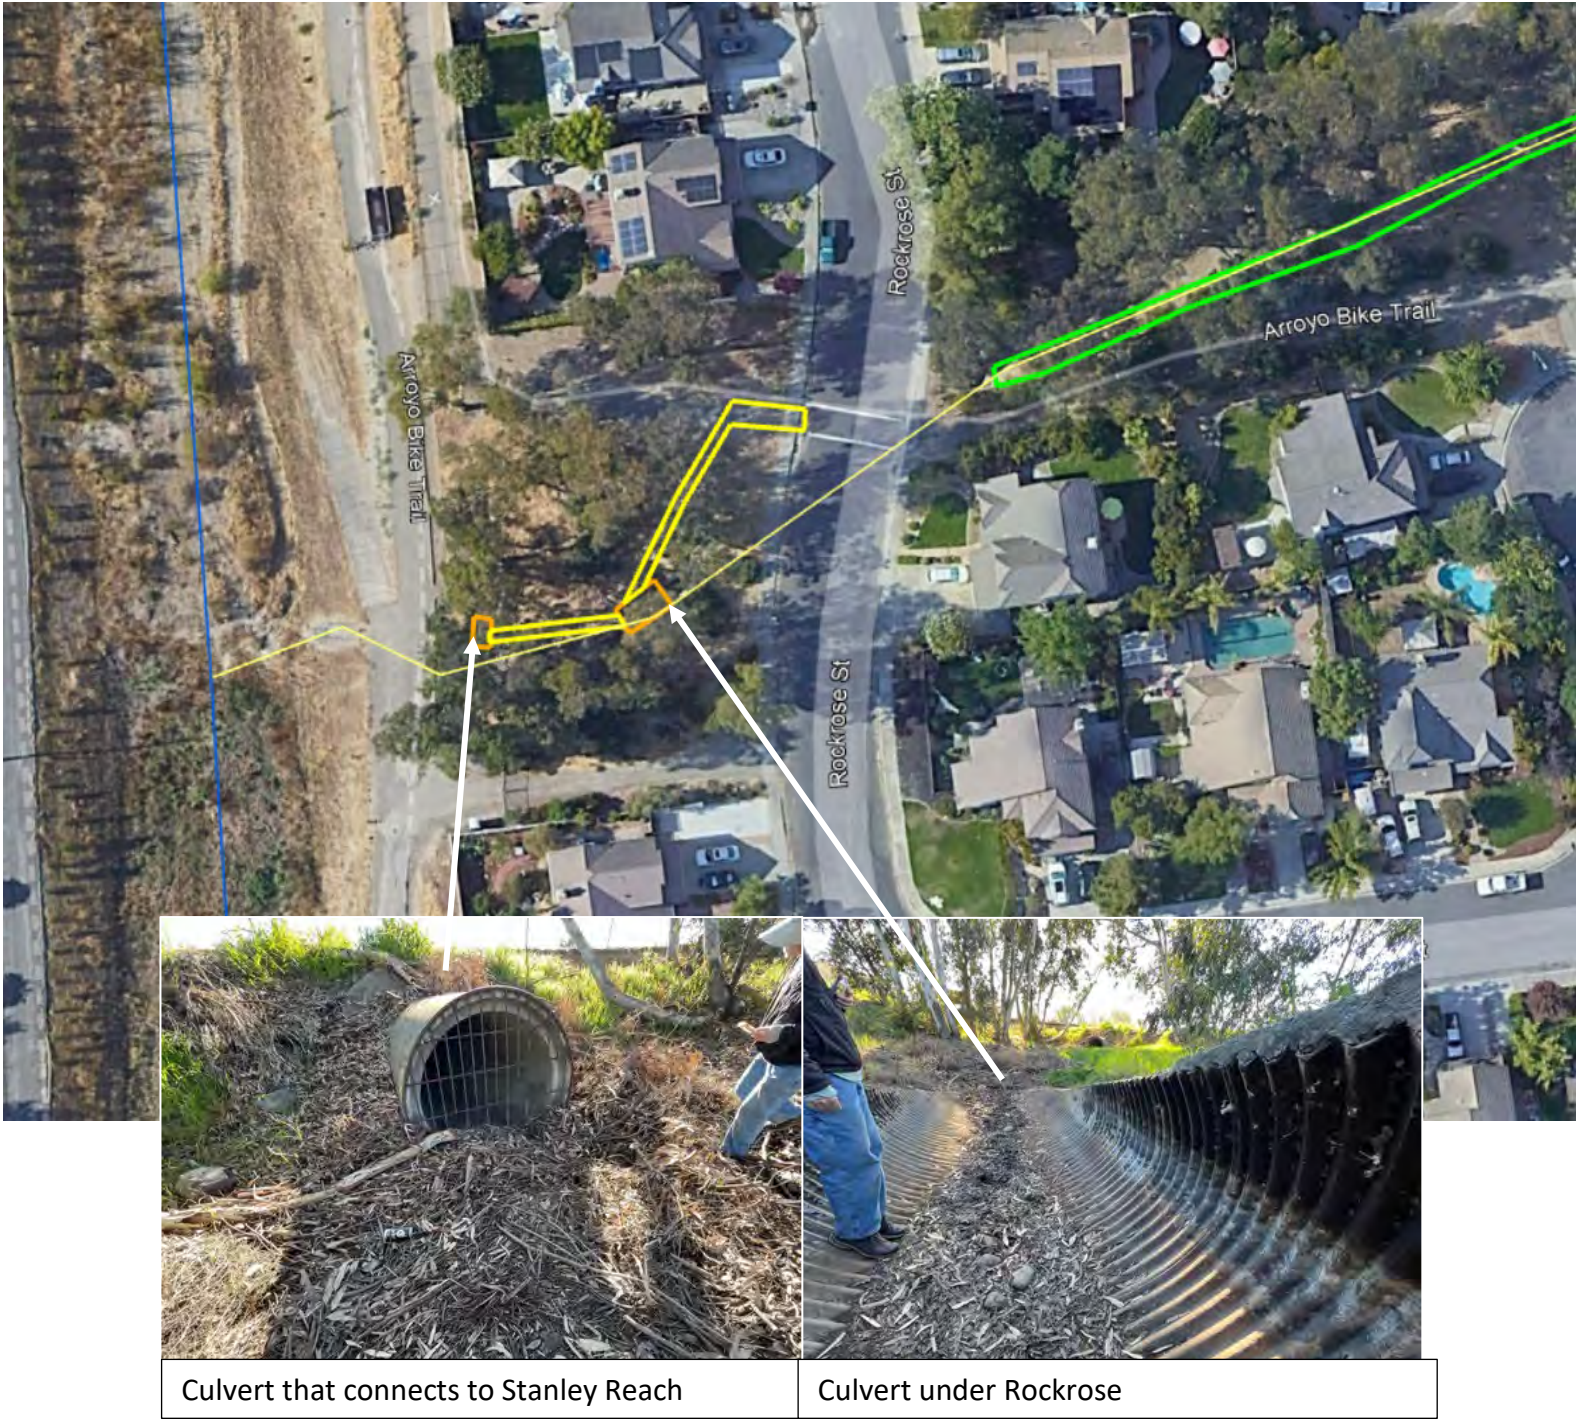
Photodocumentation Site 66- Rockrose Outfall on Arroyo Mocho Low Flow Channel

Culvert that connects to Stanley Reach	Culvert under Rockrose
--	------------------------

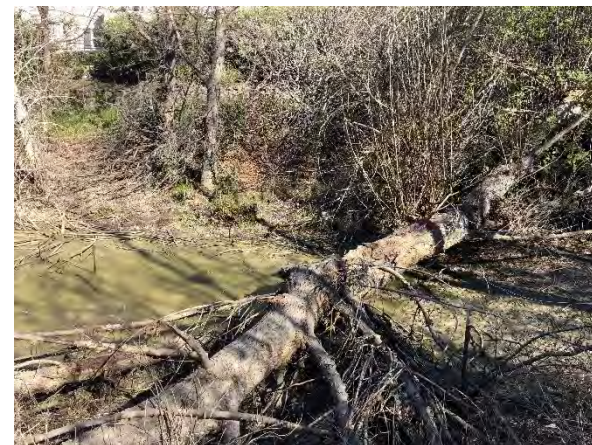
Downed tree blocking channel, diverting flow at Mitigation Area B

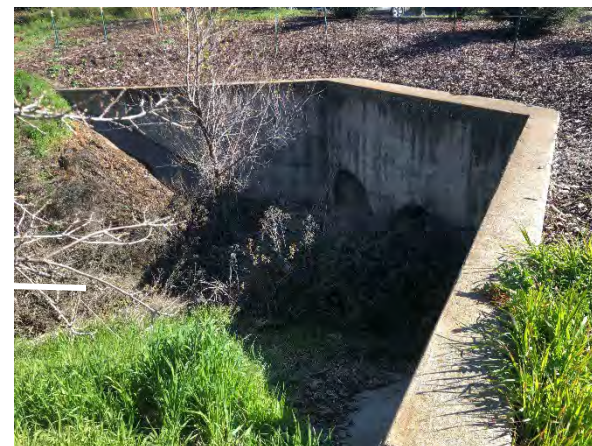
Blackberry blocking culvert inlet at downstream end of Mitigation Area B

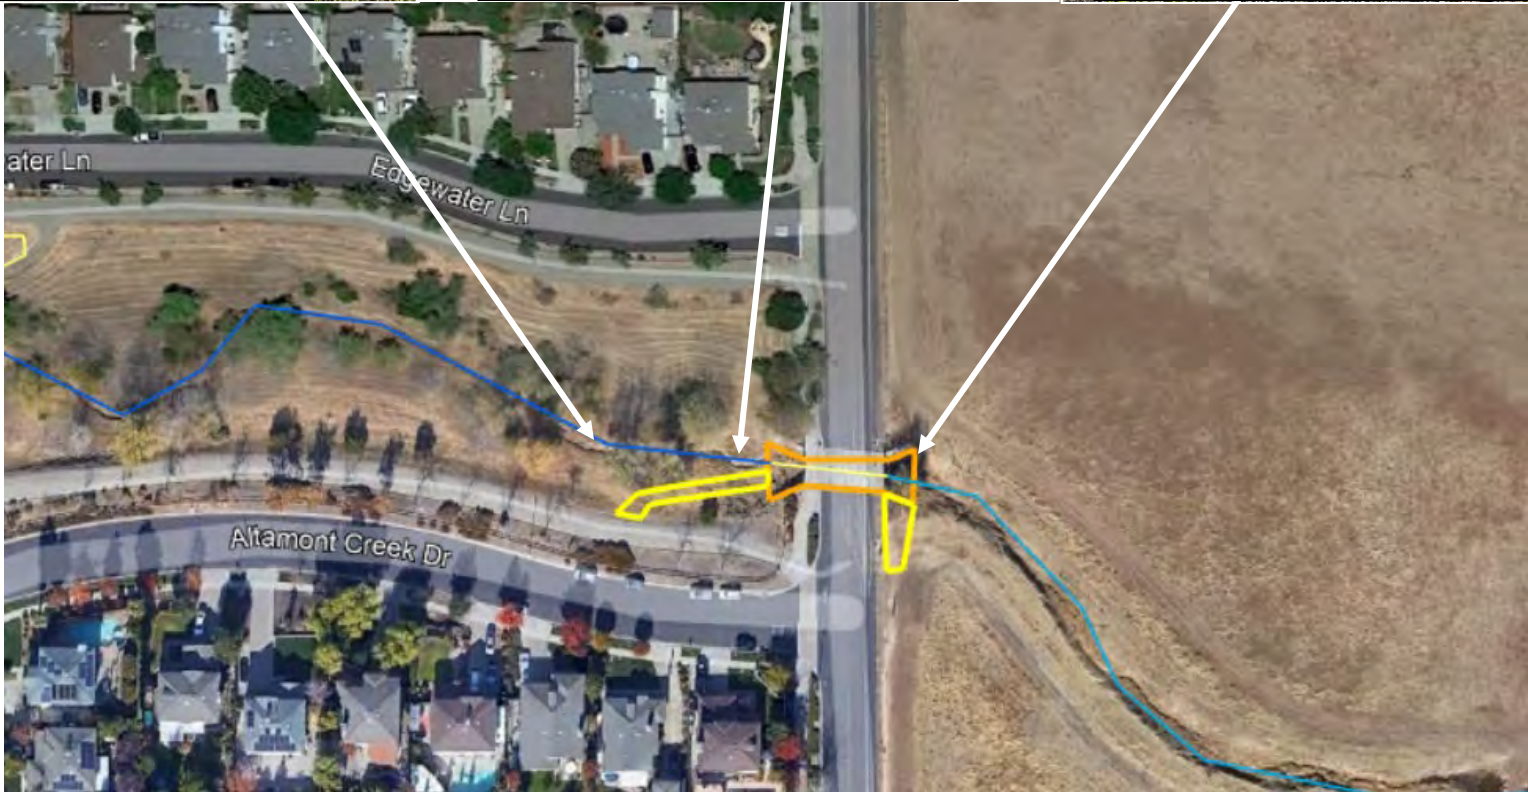
Culvert, apron, debris and willow upstream

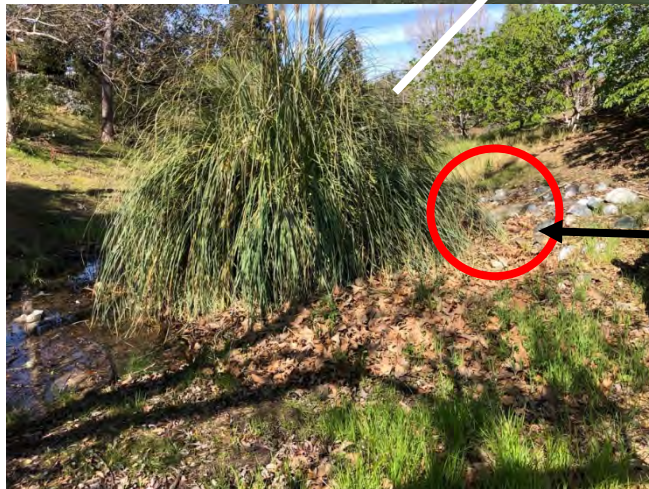
Blocked outfall

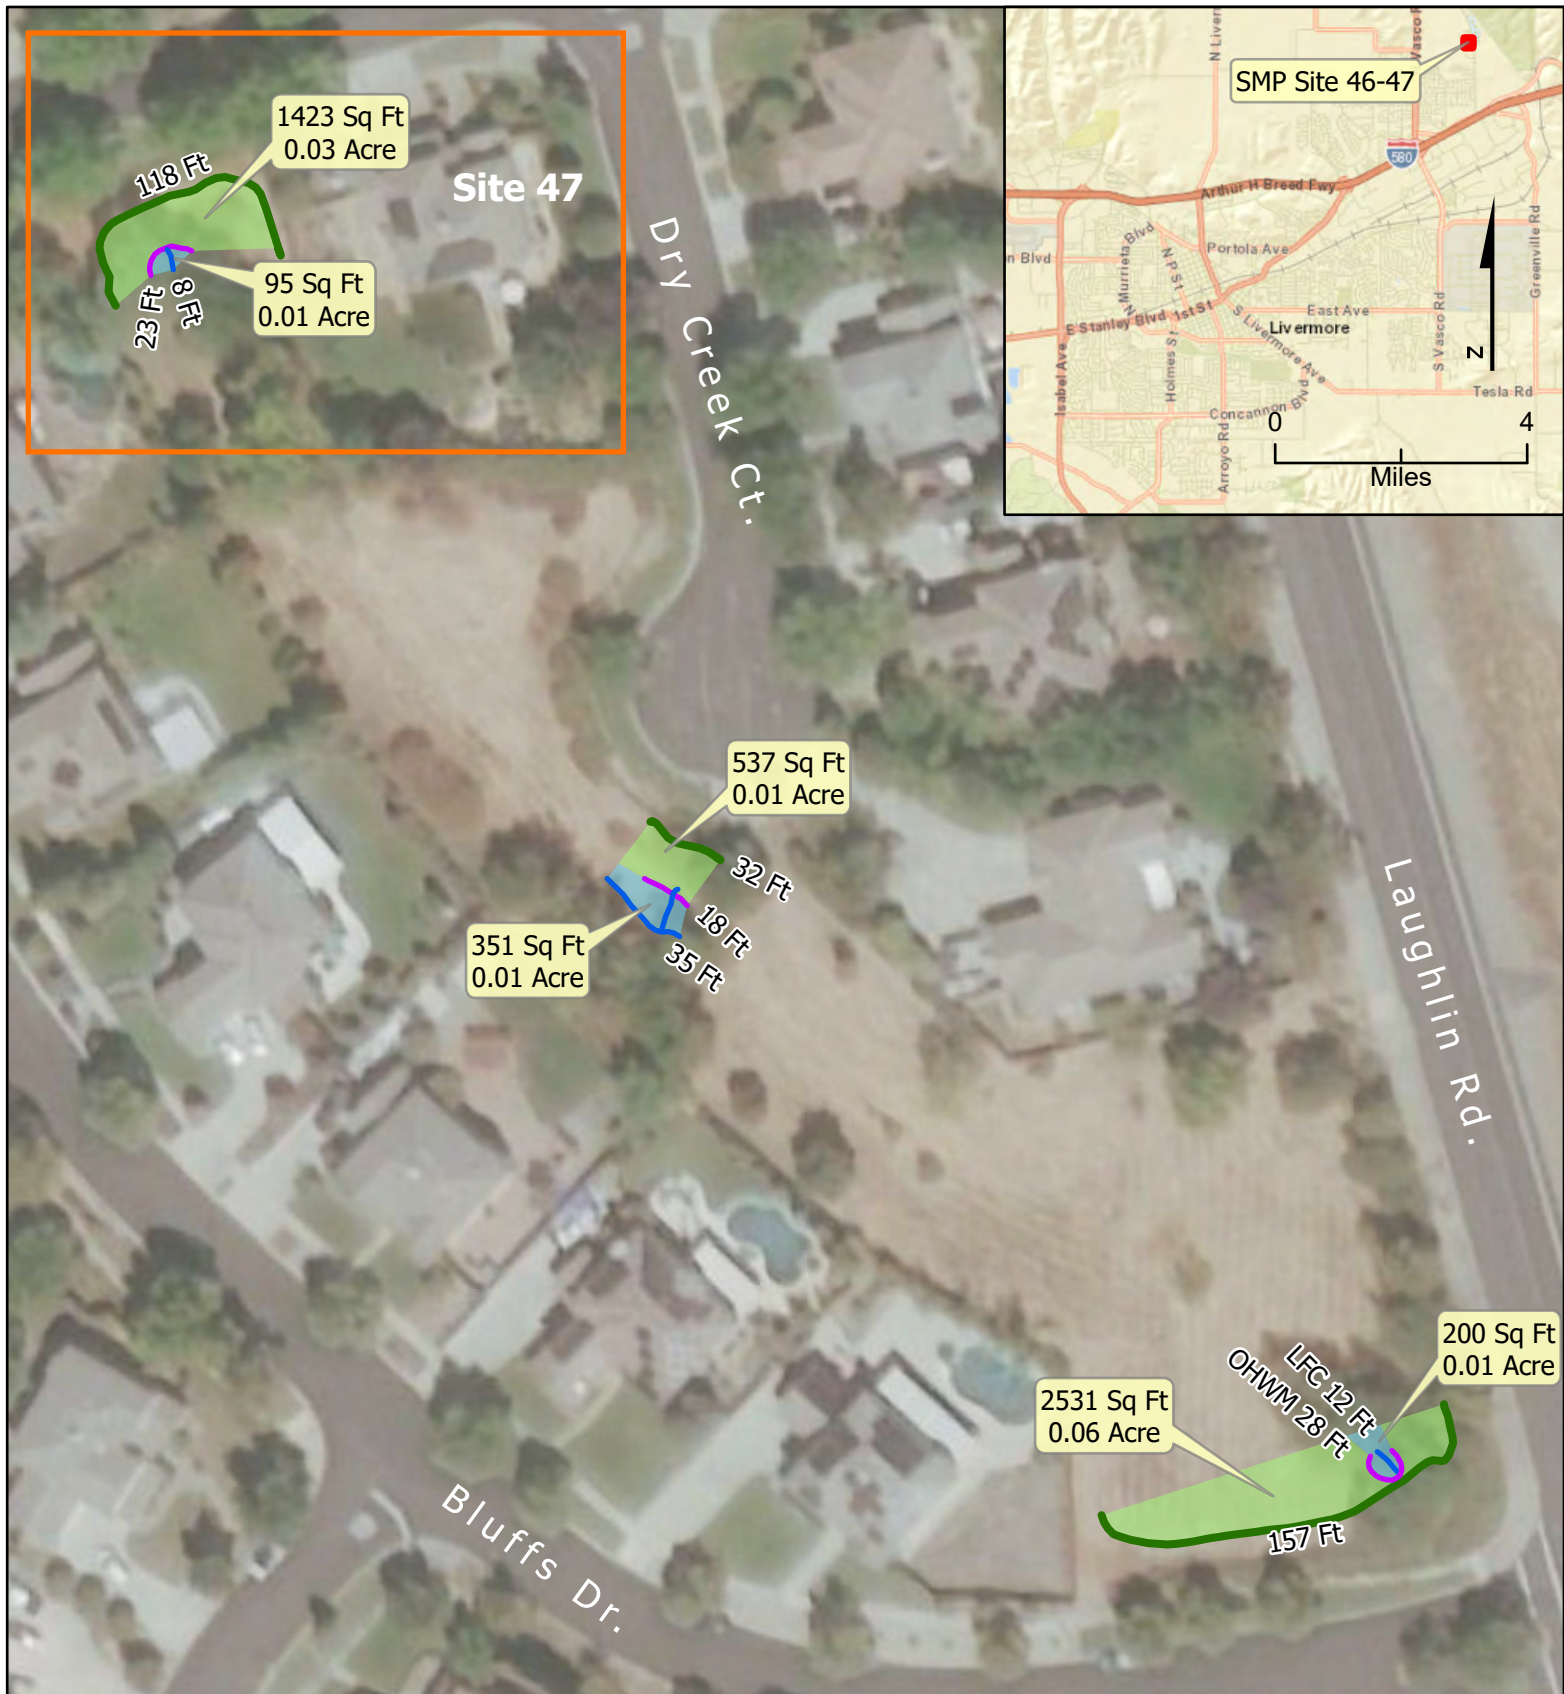
Figure 3-1 - Site 47 Lake Drive at Bear Creek Basins

Note: Mapping on Figure 3-1 to show Sites 46 and 47 in proximity to each other.

Aquatic Resource Features

- LFC
- OHWM
- TOB
- Active Floodplain
- Low Terrace

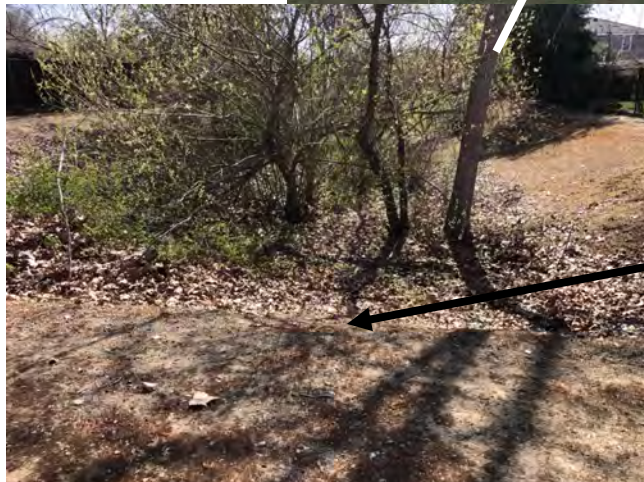
Looking south
standing above
outfall

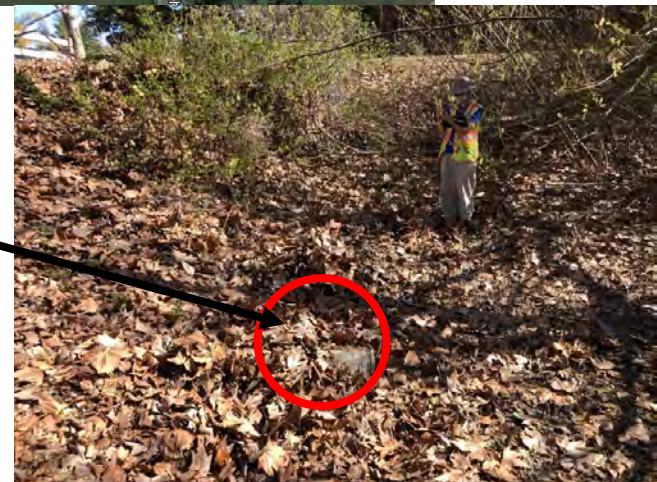
Blocked outfall

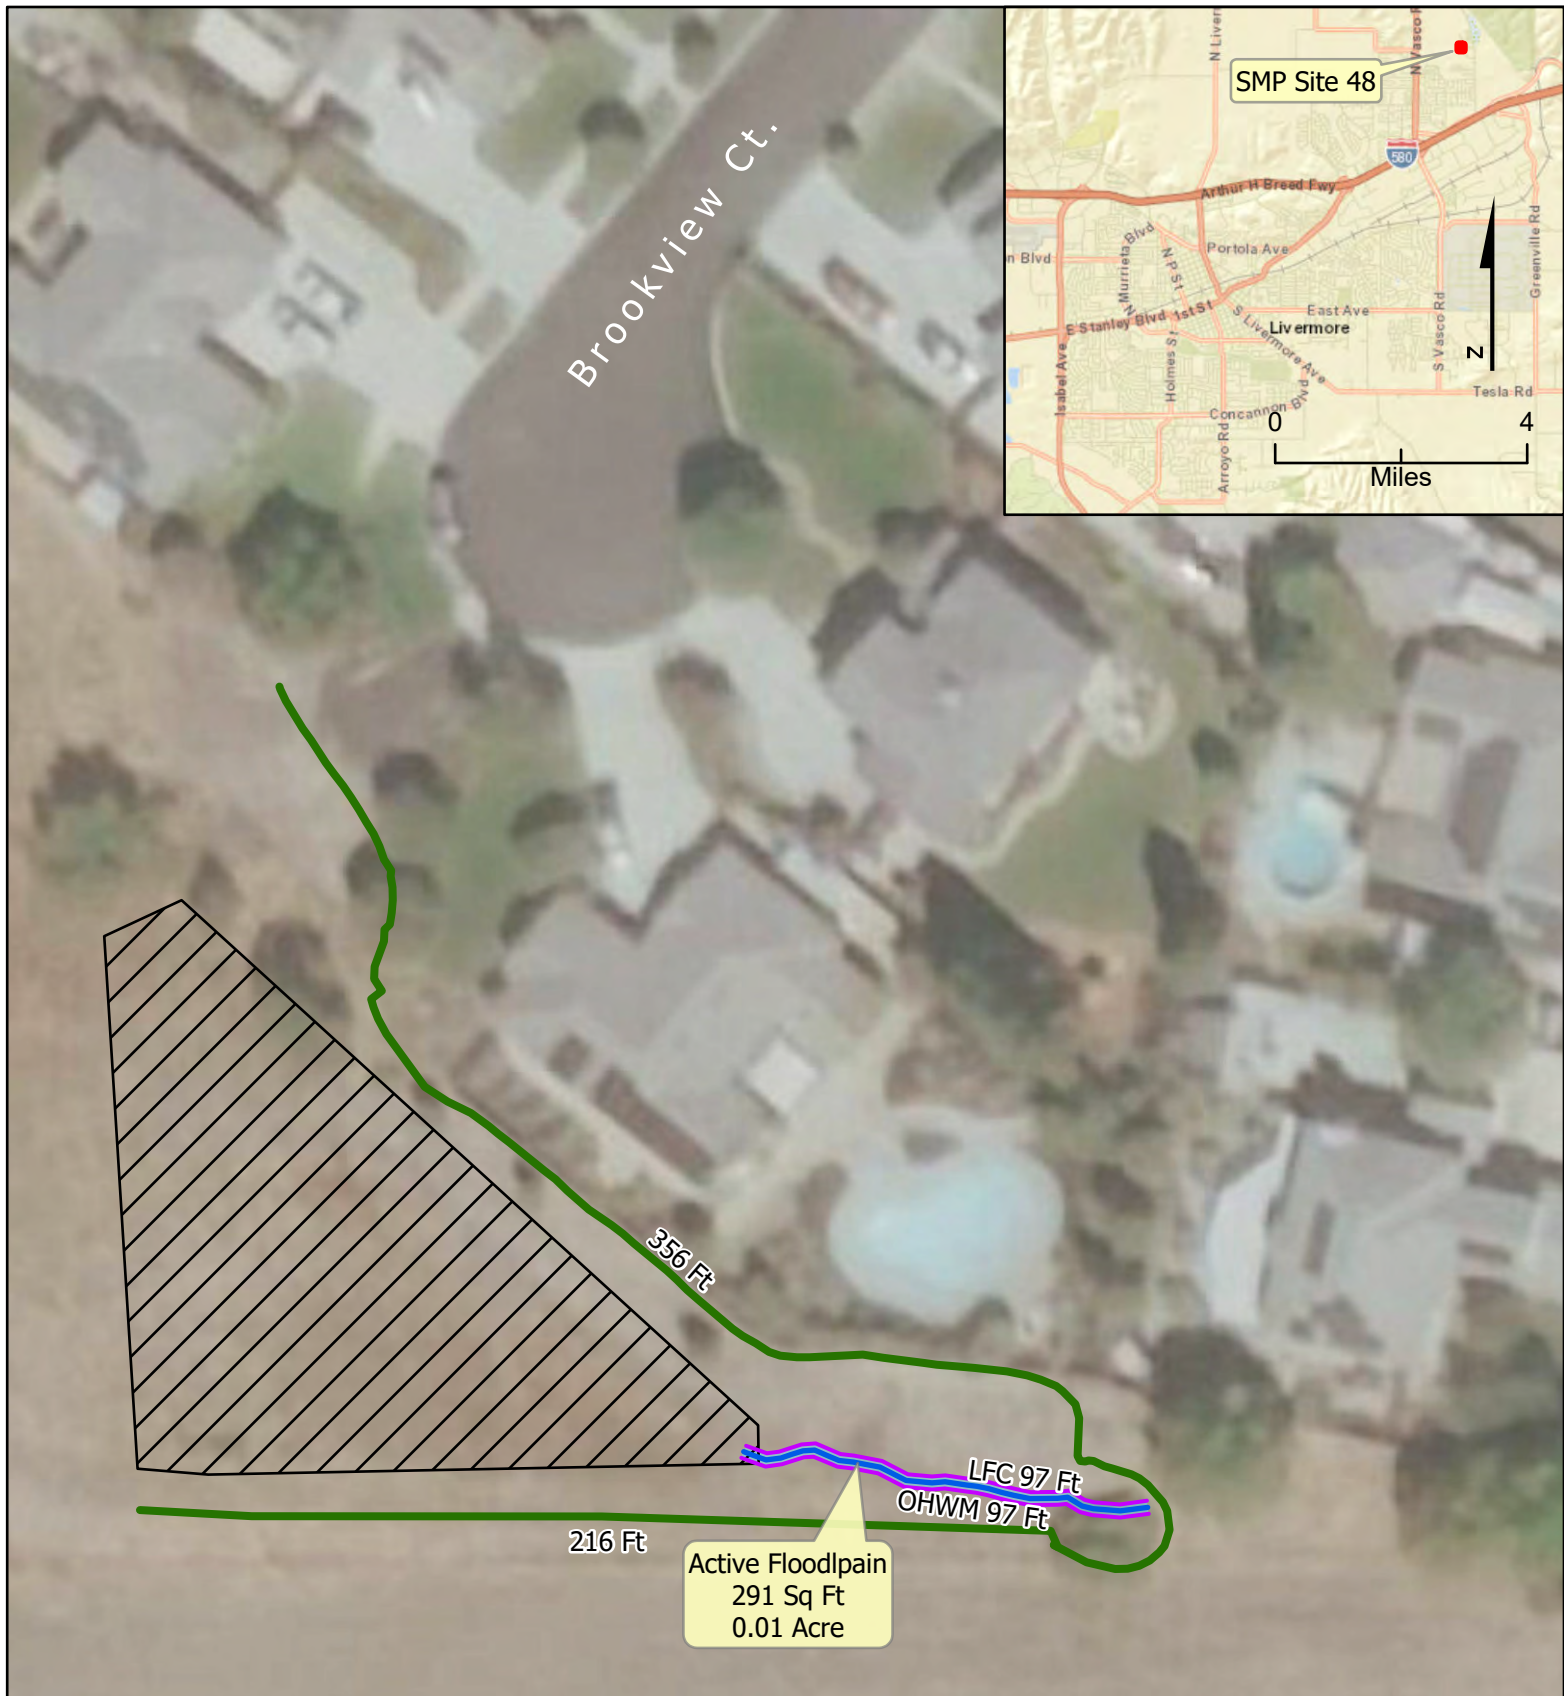
Map Reference Block for ARDA Site 48 Sediment and Vegetation Outfall Management at Meadow Glen Drive

Aquatic Resource Features

- LFC
- OHWM
- TOB
- Active Floodplain

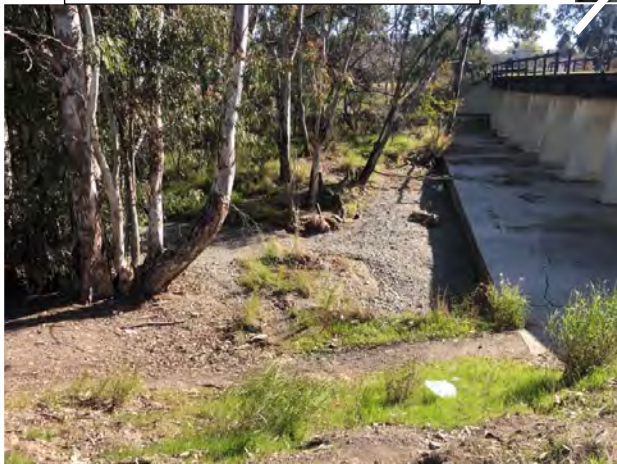
Low flow channel west side

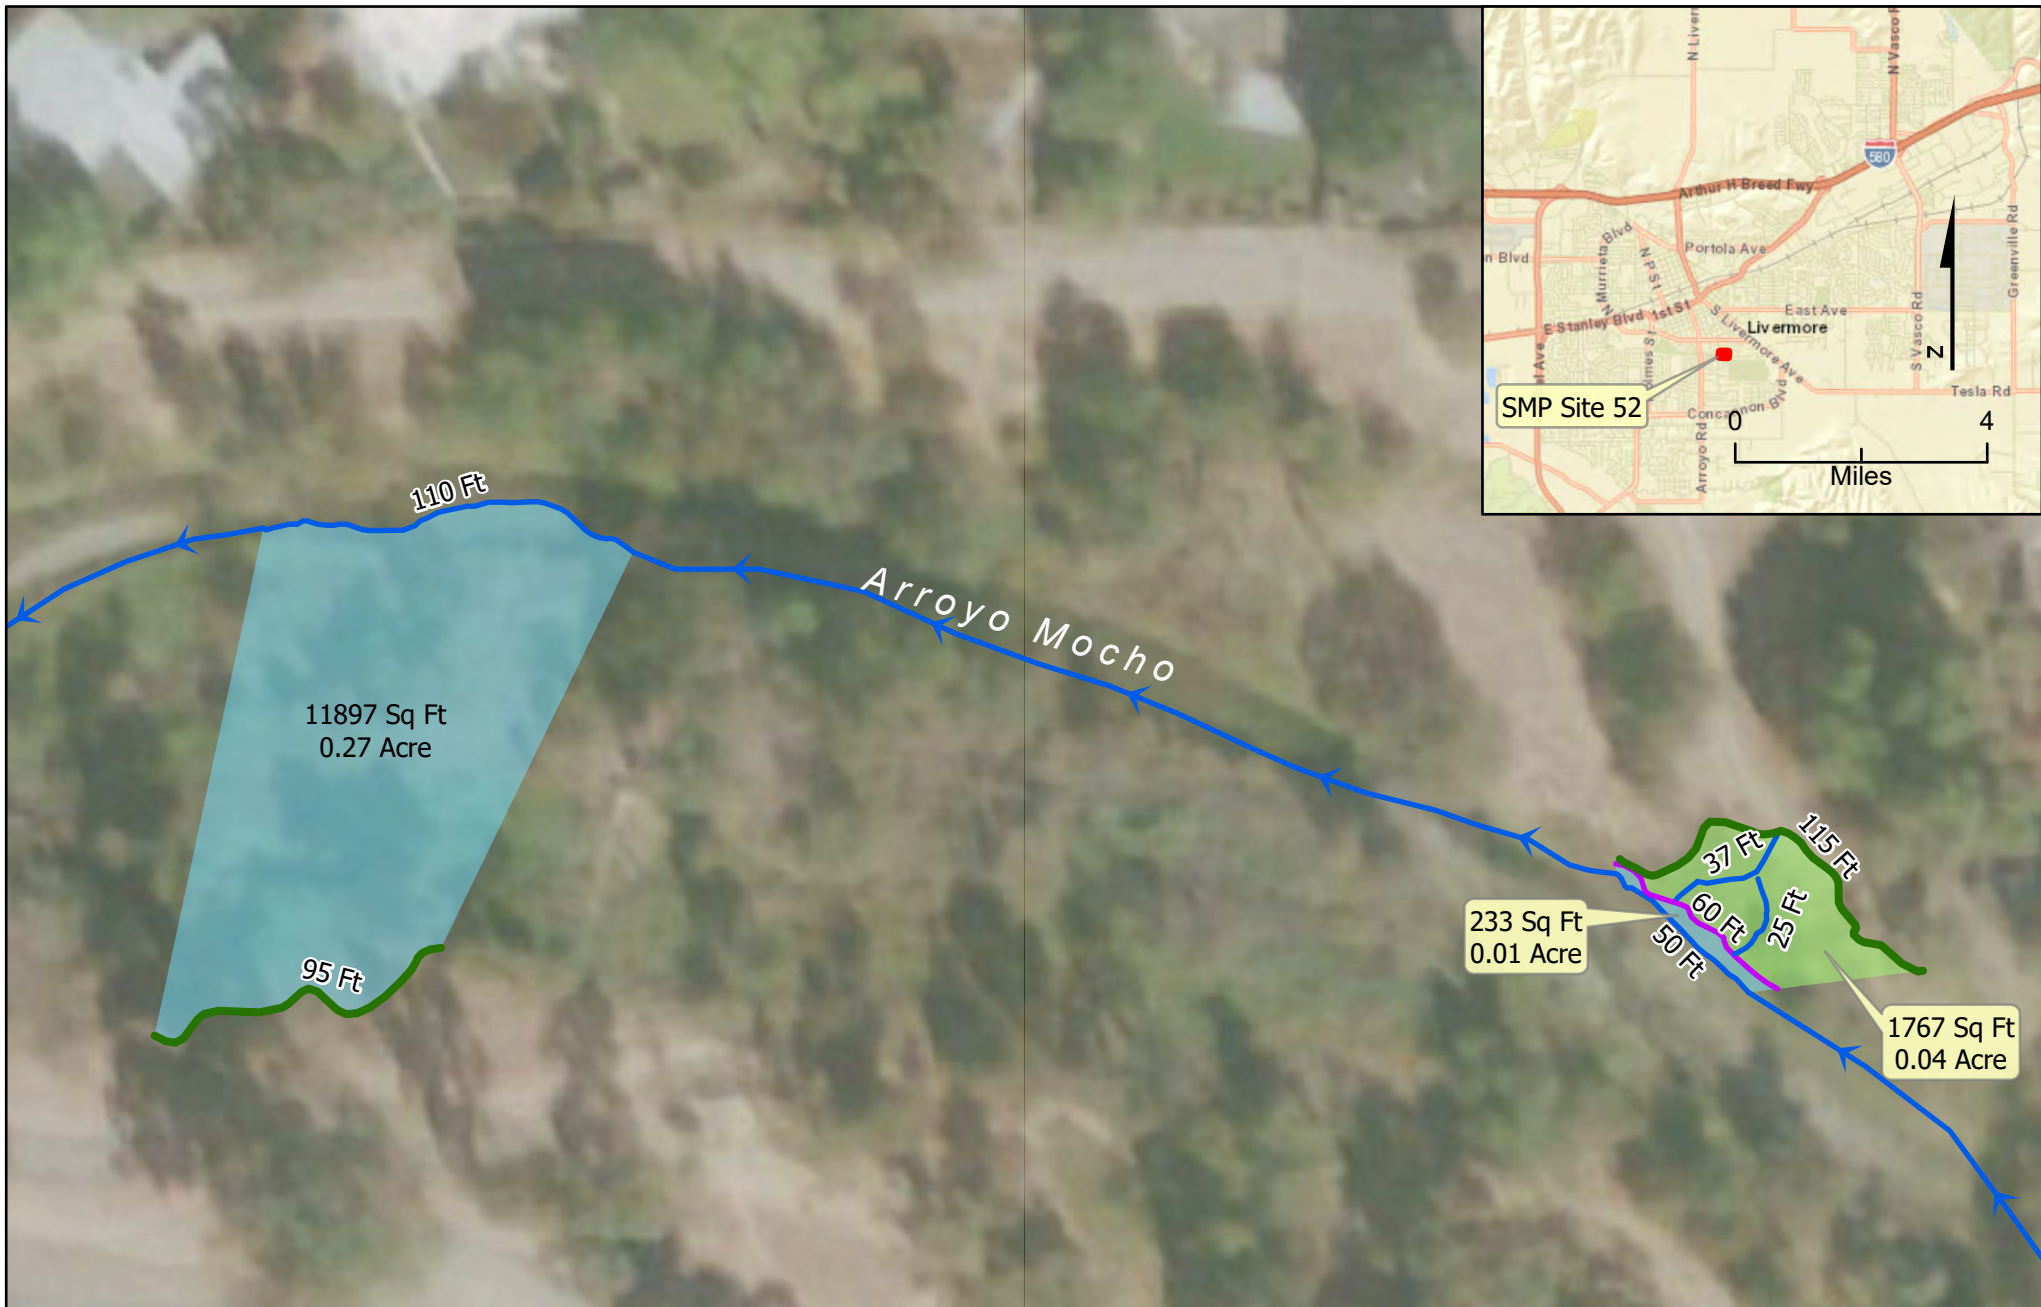
Figure 8-1 - Site 52 - Robertson Park Outfalls along Arroyo Mocho

Map Reference Block for ARD Site 52 Invasive Vegetation and Debris Management at Arroyo Mocho Outfalls

Aquatic Resource Features

- LFC
- OHWM
- TOB
- Active Floodplain
- Low Terrace

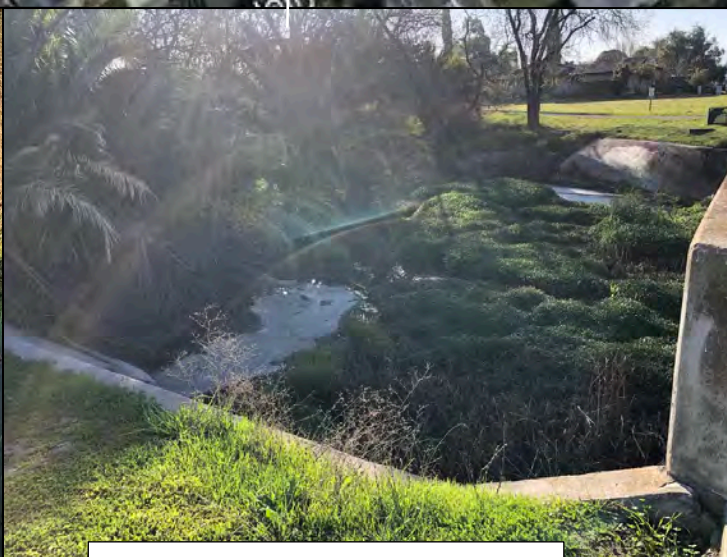
Site 54 bridge apron upstream

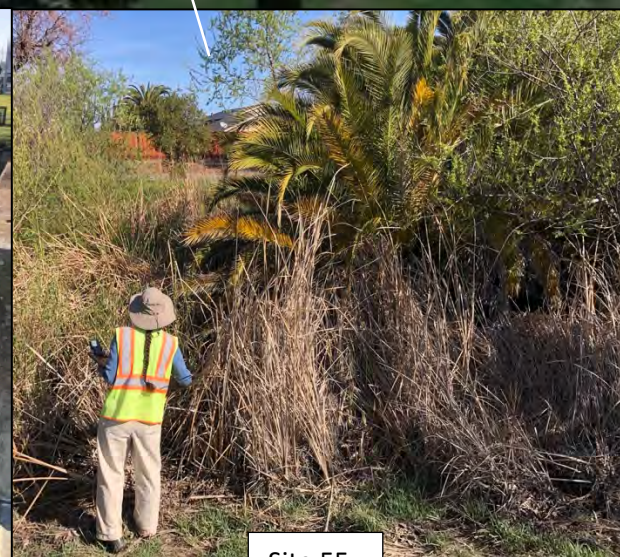
Site 55

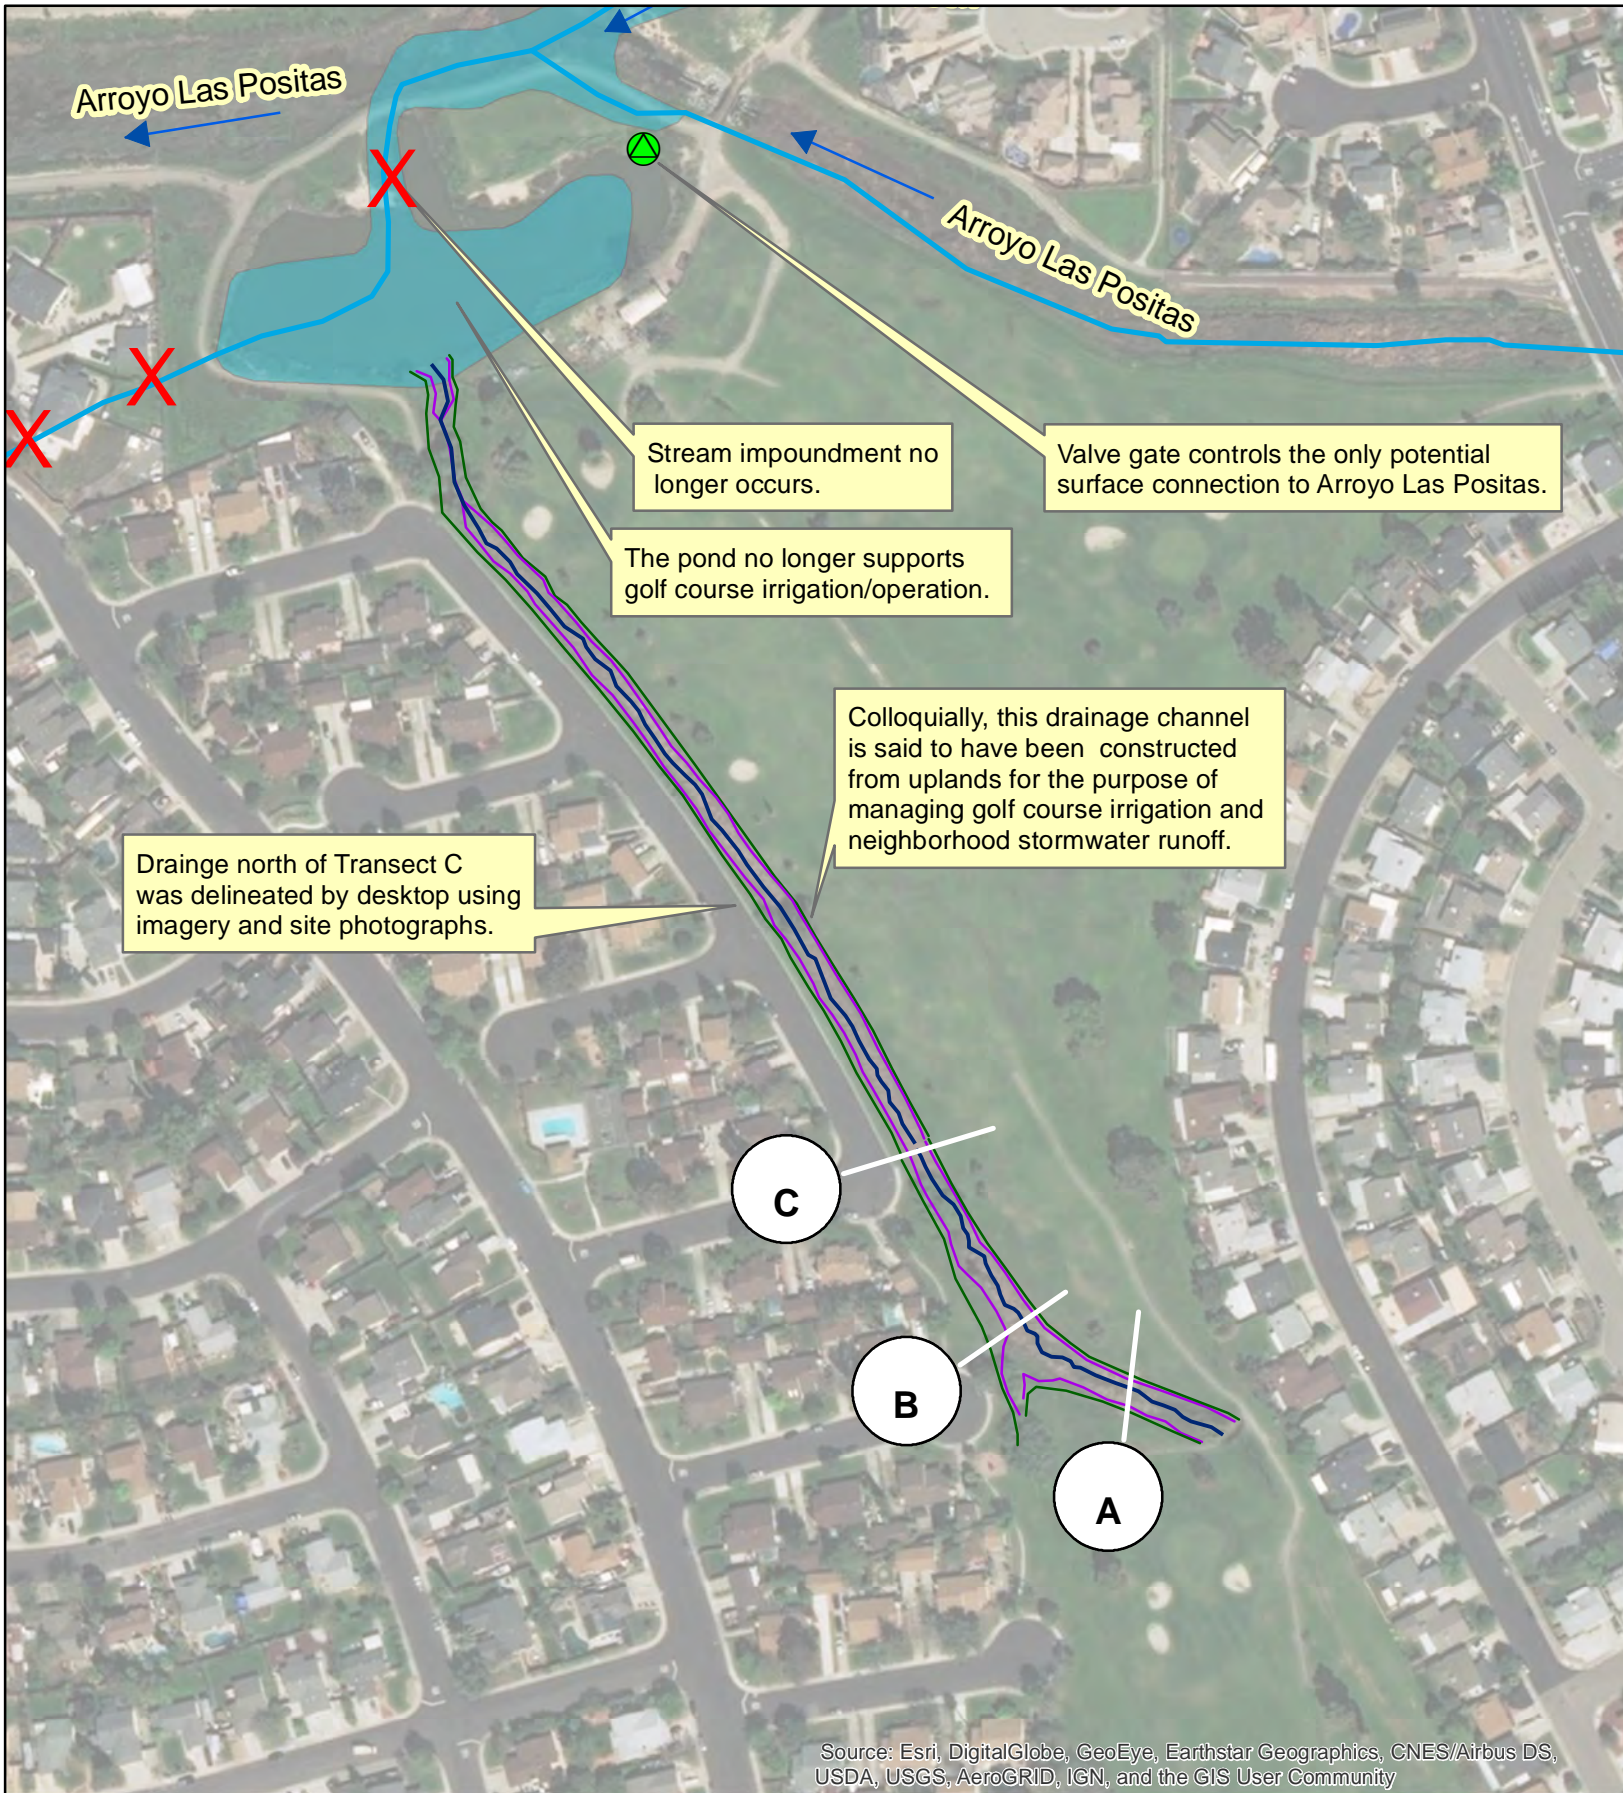
Map Reference Block for Site 41 Golf Drive Creek

○ Drainage Transects A-C

— Wetland Tributary

An Open Water low-flow channel was observed at the time of the delineation. It was narrow for its entire observed length, approximately 2 feet wide. The rest of the channel supported a dense growth of bulrush and cattails. Streamside vegetation included rooted willow trees and willowherb. The transition to Low Terrace just above the OHWM was an abrupt transition to thistles, mustards, and wild oats, with an occasional coyote brush. The remainder of the area to Top of Bank was ornamental lawn.

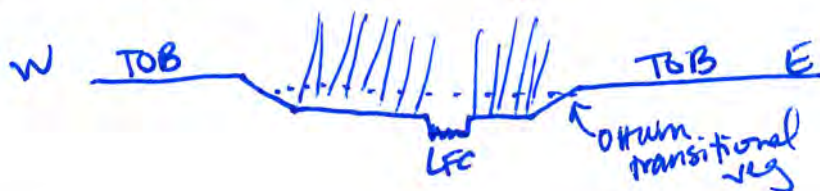
Project ID: Gladious Cross section ID: ADate: 2.20.2020 Time: 11:45Cross section drawing:

The LT on the west bank would be comprised of upland grasses between the TOB & OTWM. On the east bank there is an abrupt transition from emergent channel veg to top of bank.

OHWMGPS point: UTM 0610816, 4174695Indicators:

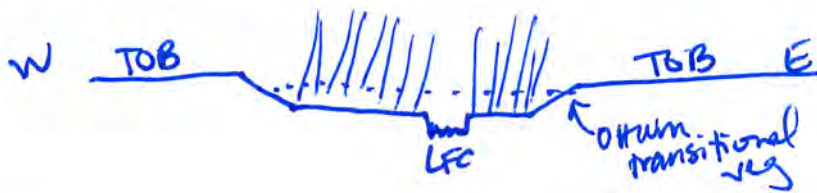
Project ID: Gladiolus Cross section ID: ADate: 2.20.2020 Time: 11:45Cross section drawing:

Small {2' open water channel amid emergent vegetation.

OHWMGPS point: UTM 0610816, 4174695Indicators:

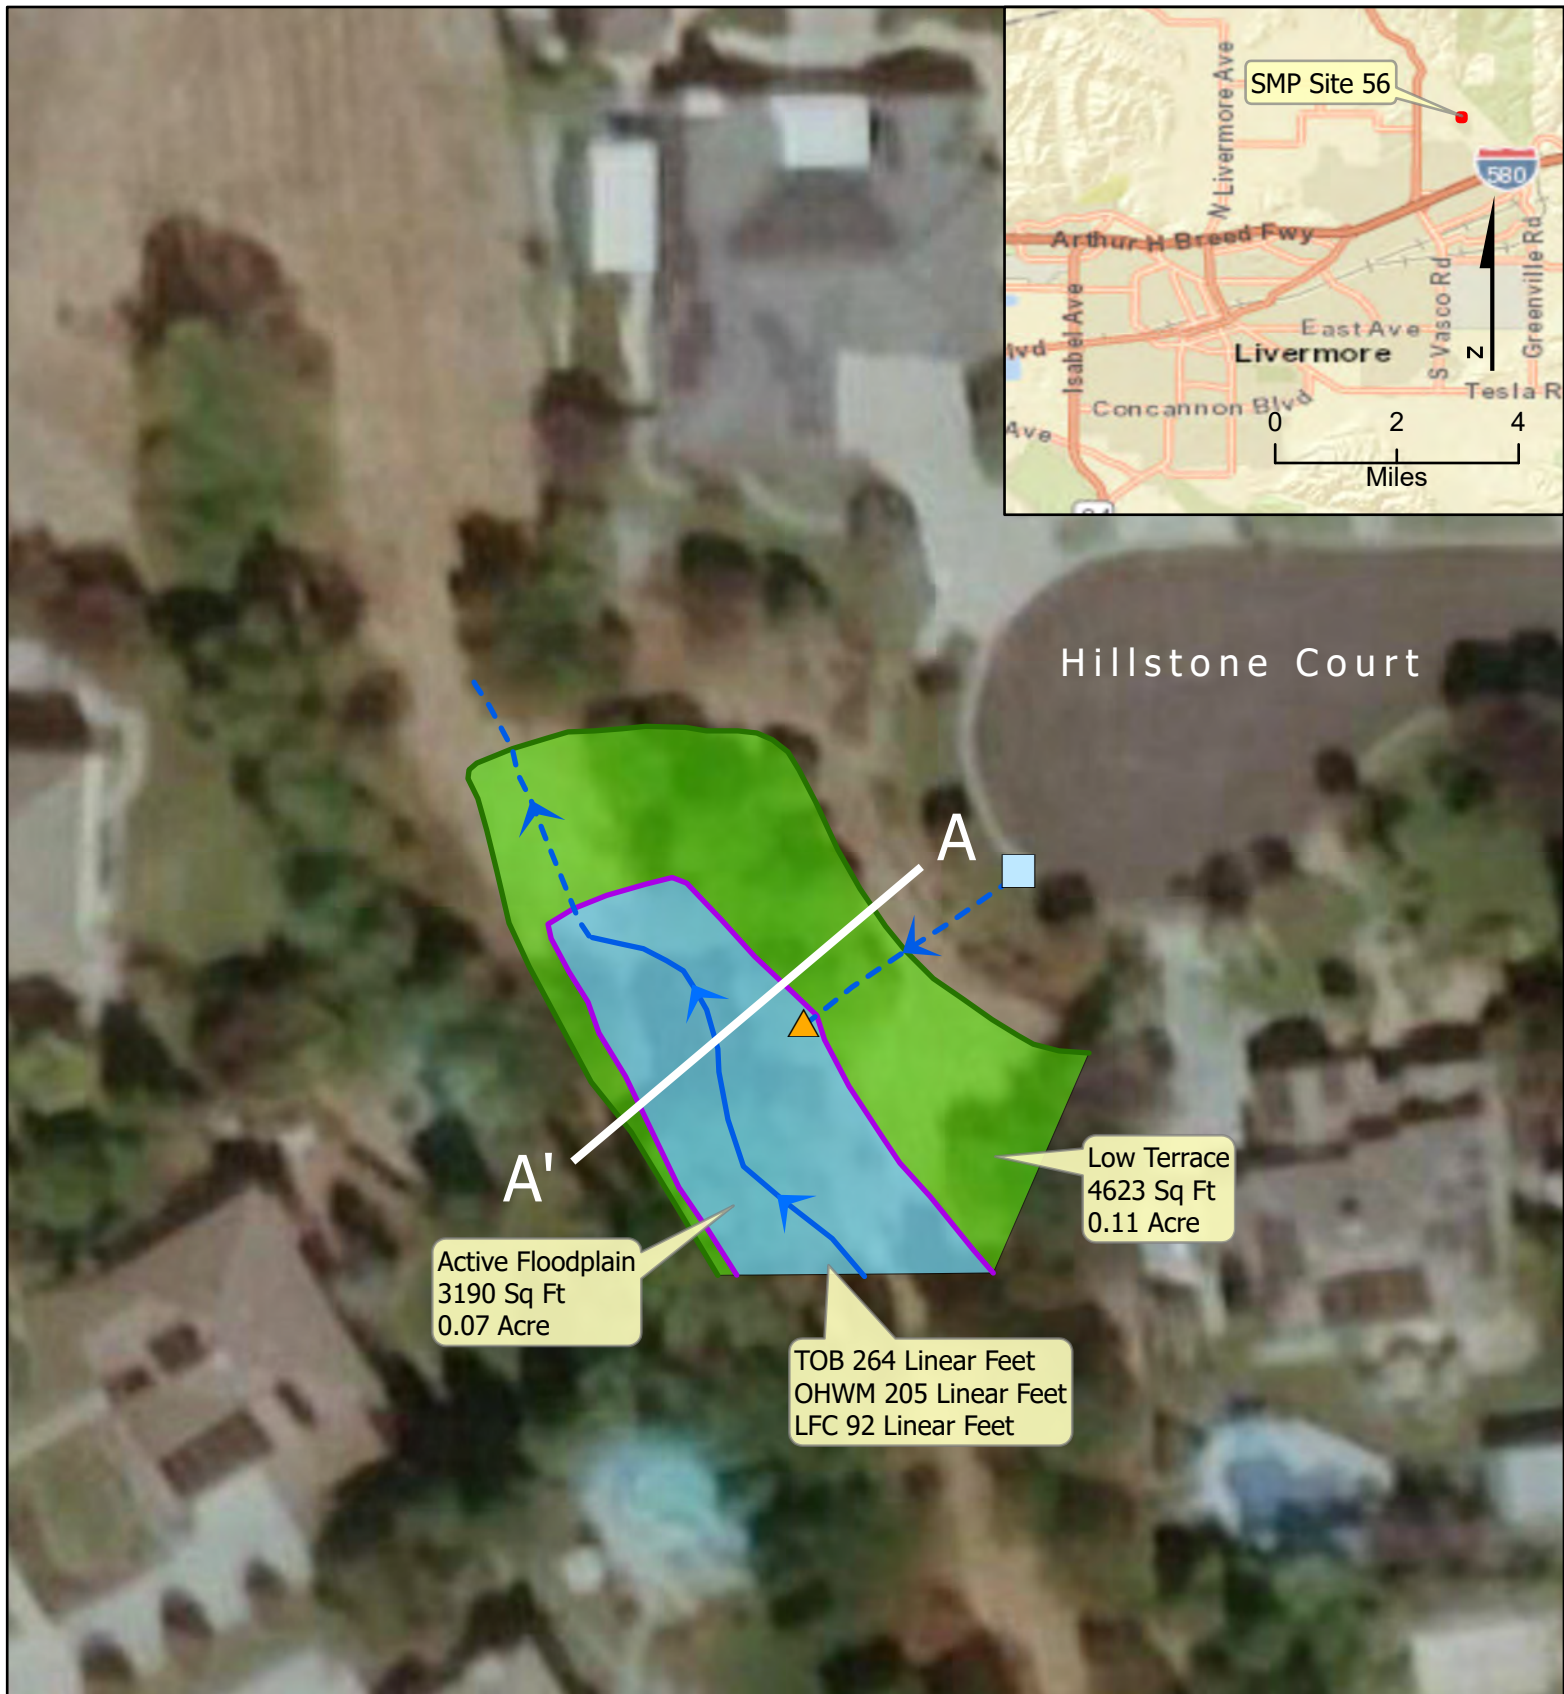
Map Reference Block for ARD Site 56 Hillstone Court Outfall at Bear Creek Basins

- Drainage Inlet
- Culvert Outfall
- Underground Drainage
- LFC - 29 Feet Wide
- OHWM - 37 Feet Wide
- TOB - 64 Feet Wide

- Low Terrace
- Active Floodplain
