ANNUAL NOTICE OF PROPOSED WORK FOR 2022 STREAM MAINTENANCE PROJECTS

CITY OF LIVERMORE STREAM MAINTENANCE PROGRAM

March 2022

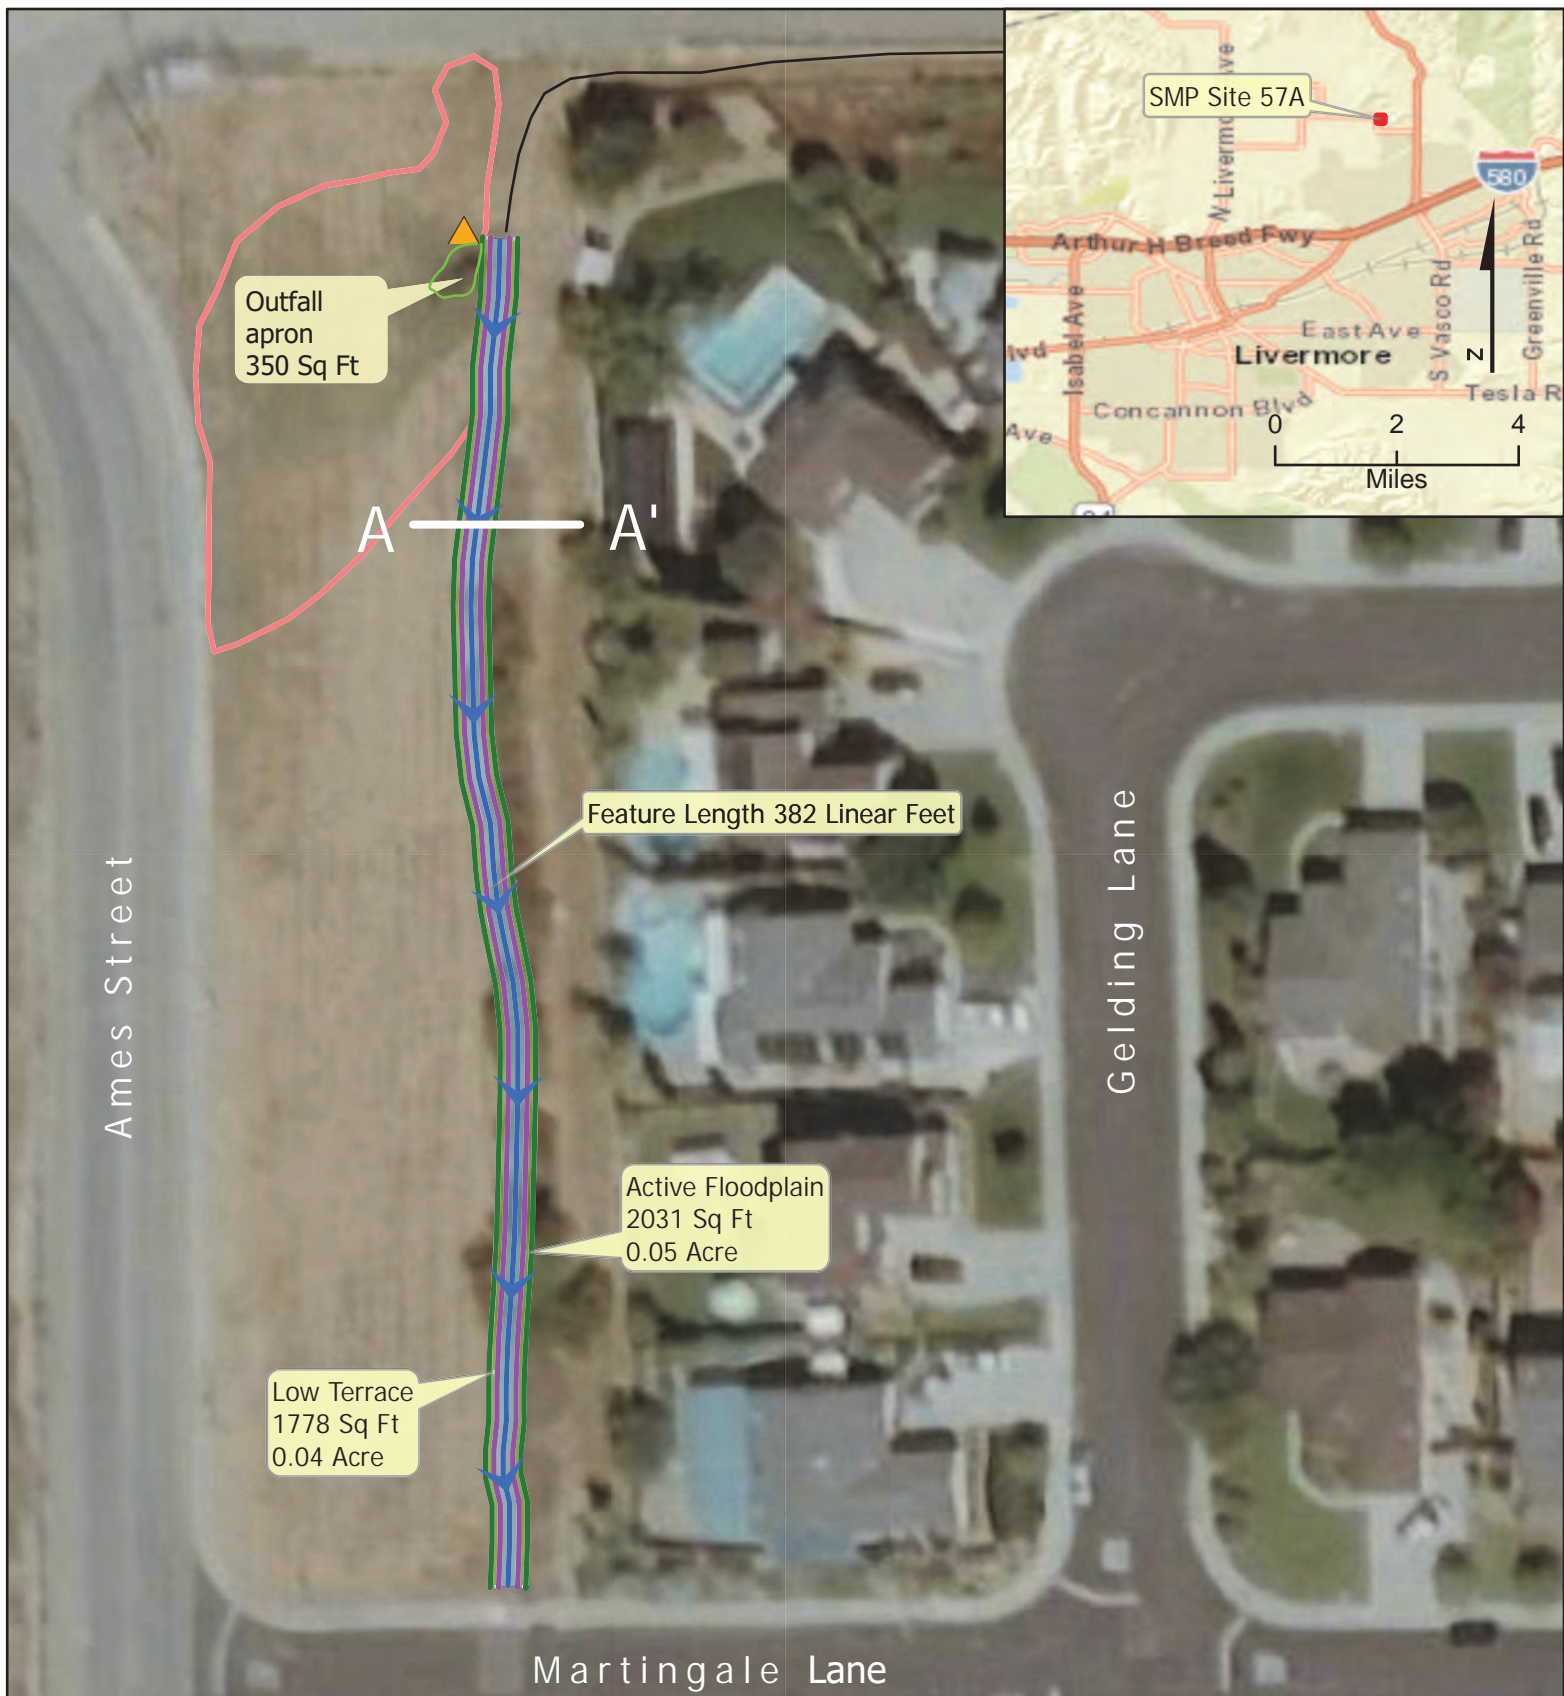
Figure 3-1 Site 57A - Saddleback Grassed Swale
Raymond Road to Martingale Lane

Map Reference Block for ARD Site 57 A/B/C Saddleback Features

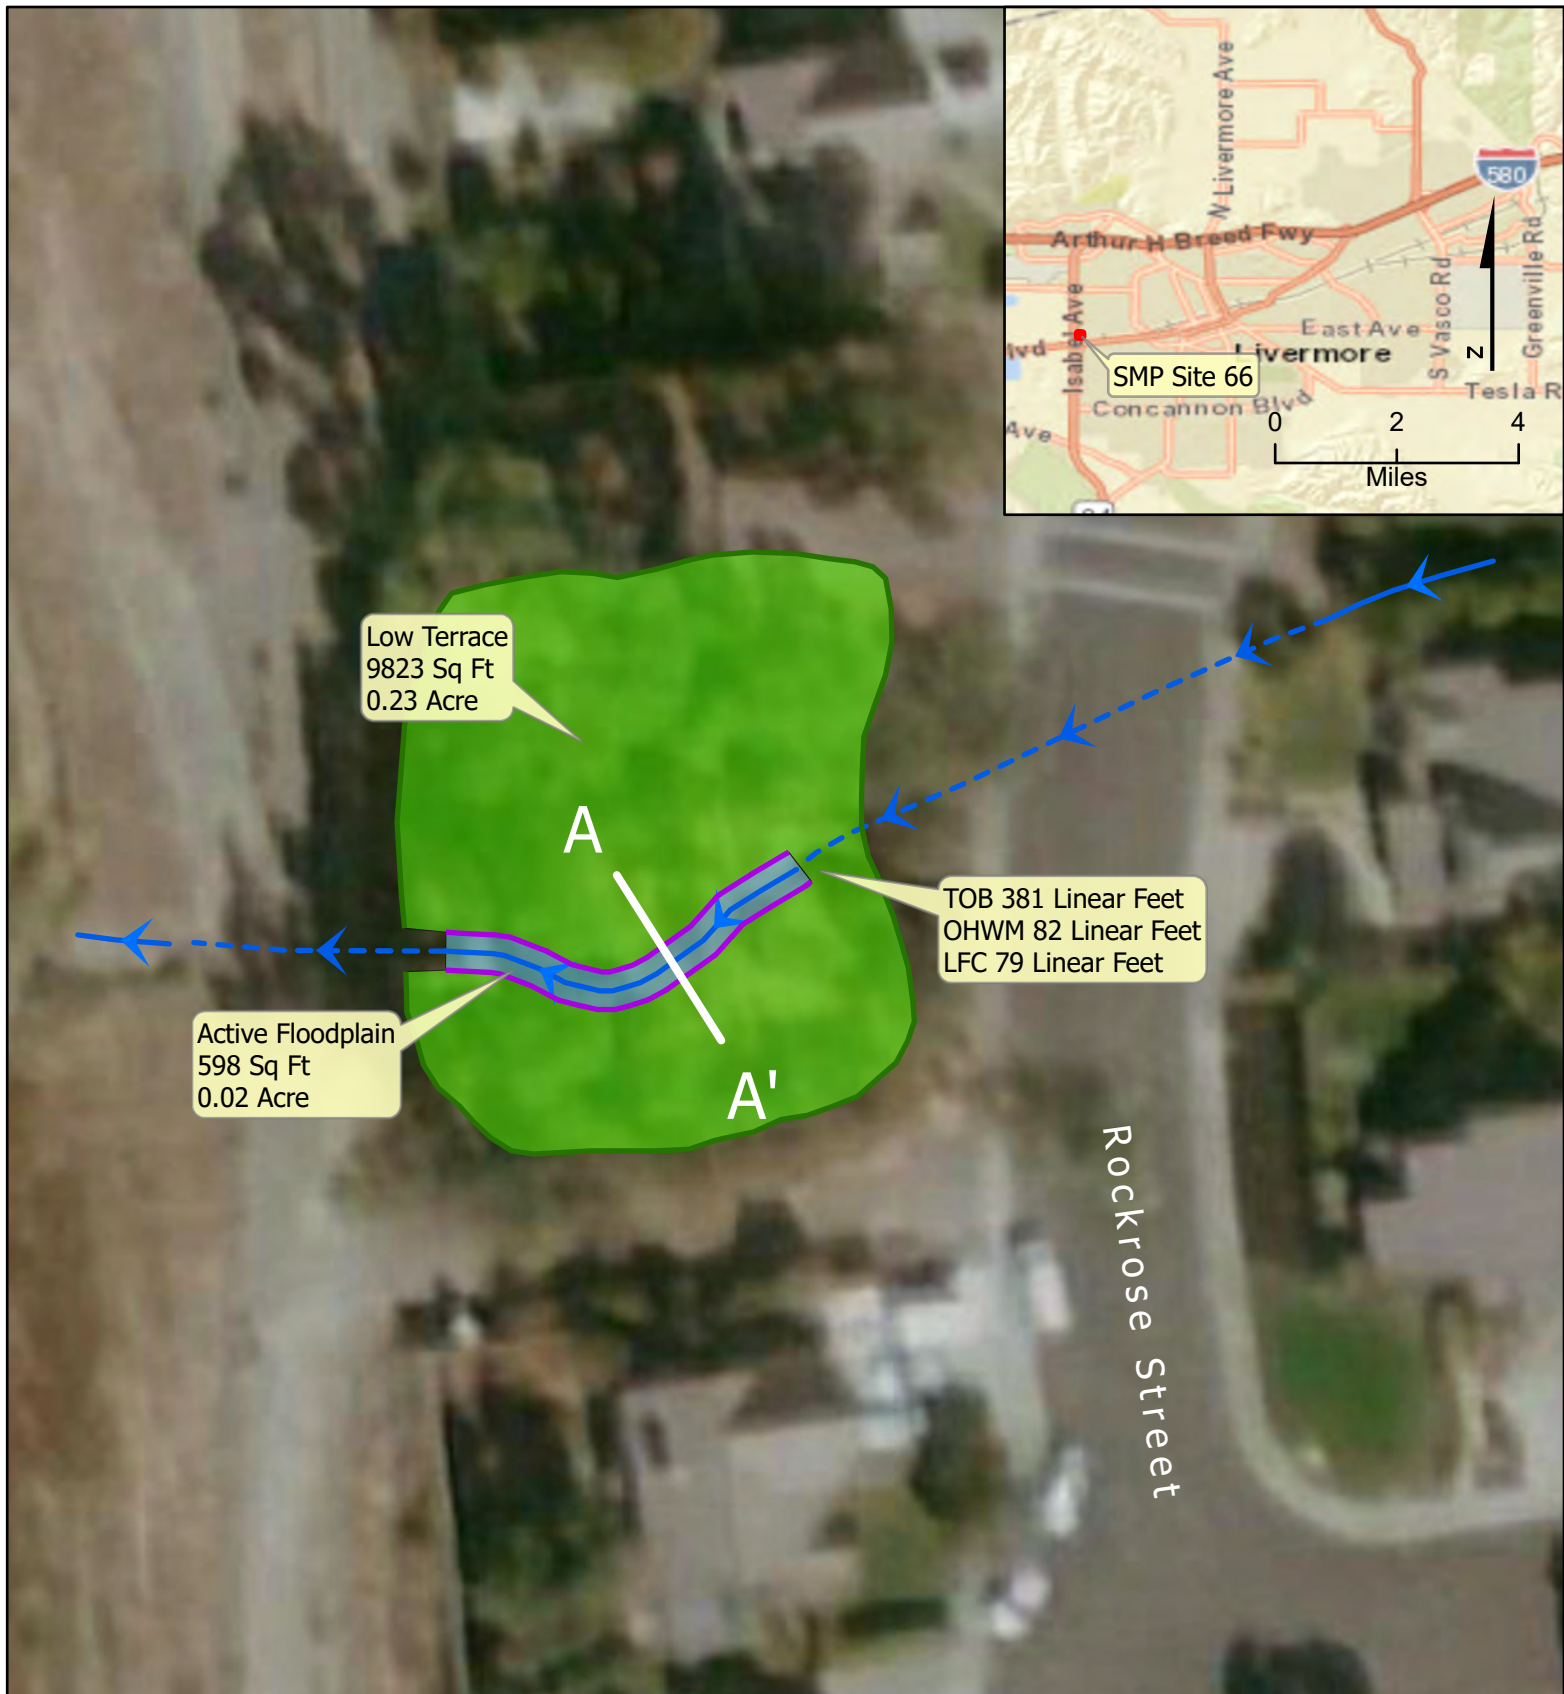
**Figure 6-1 Site 66 - Rockrose Outfall
Arroyo Mocho Low Flow Channel**
City of Livermore - Stream Maintenance Program

The ARDA is a 0.25-acre area encompassing an open stretch of Arroyo Mocho Low Flow Channel between two lengthy culverts. An iron grate across the downstream culvert acts as an effective debris catchment. The channel bottom measures ~60 feet wide X ~100 feet long and is surrounded by pedestrian trails on the west, north, and south, and by Rockrose Street on the east. The mature overstory is non-native eucalyptus, but young restoration plantings of coast live oak, toyon, manzanita, and blueblossom (*Ceanothus* sp.) were observed. There is no in-stream vegetation and the channel, which is marked by flow patterns in downed wood and leafy debris, is ~5.5 feet wide. While the basin floor offers a wide area for flows to pond, there is no evidence that the ordinary flows extend beyond a floodplain ~7.5 feet wide.

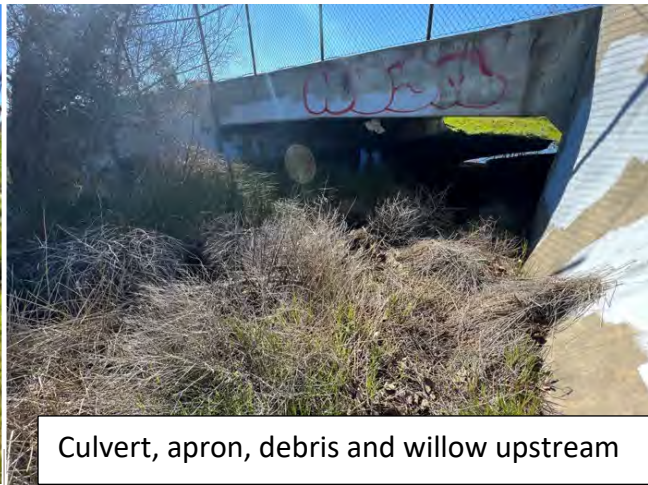
Culvert, apron, debris and willow upstream

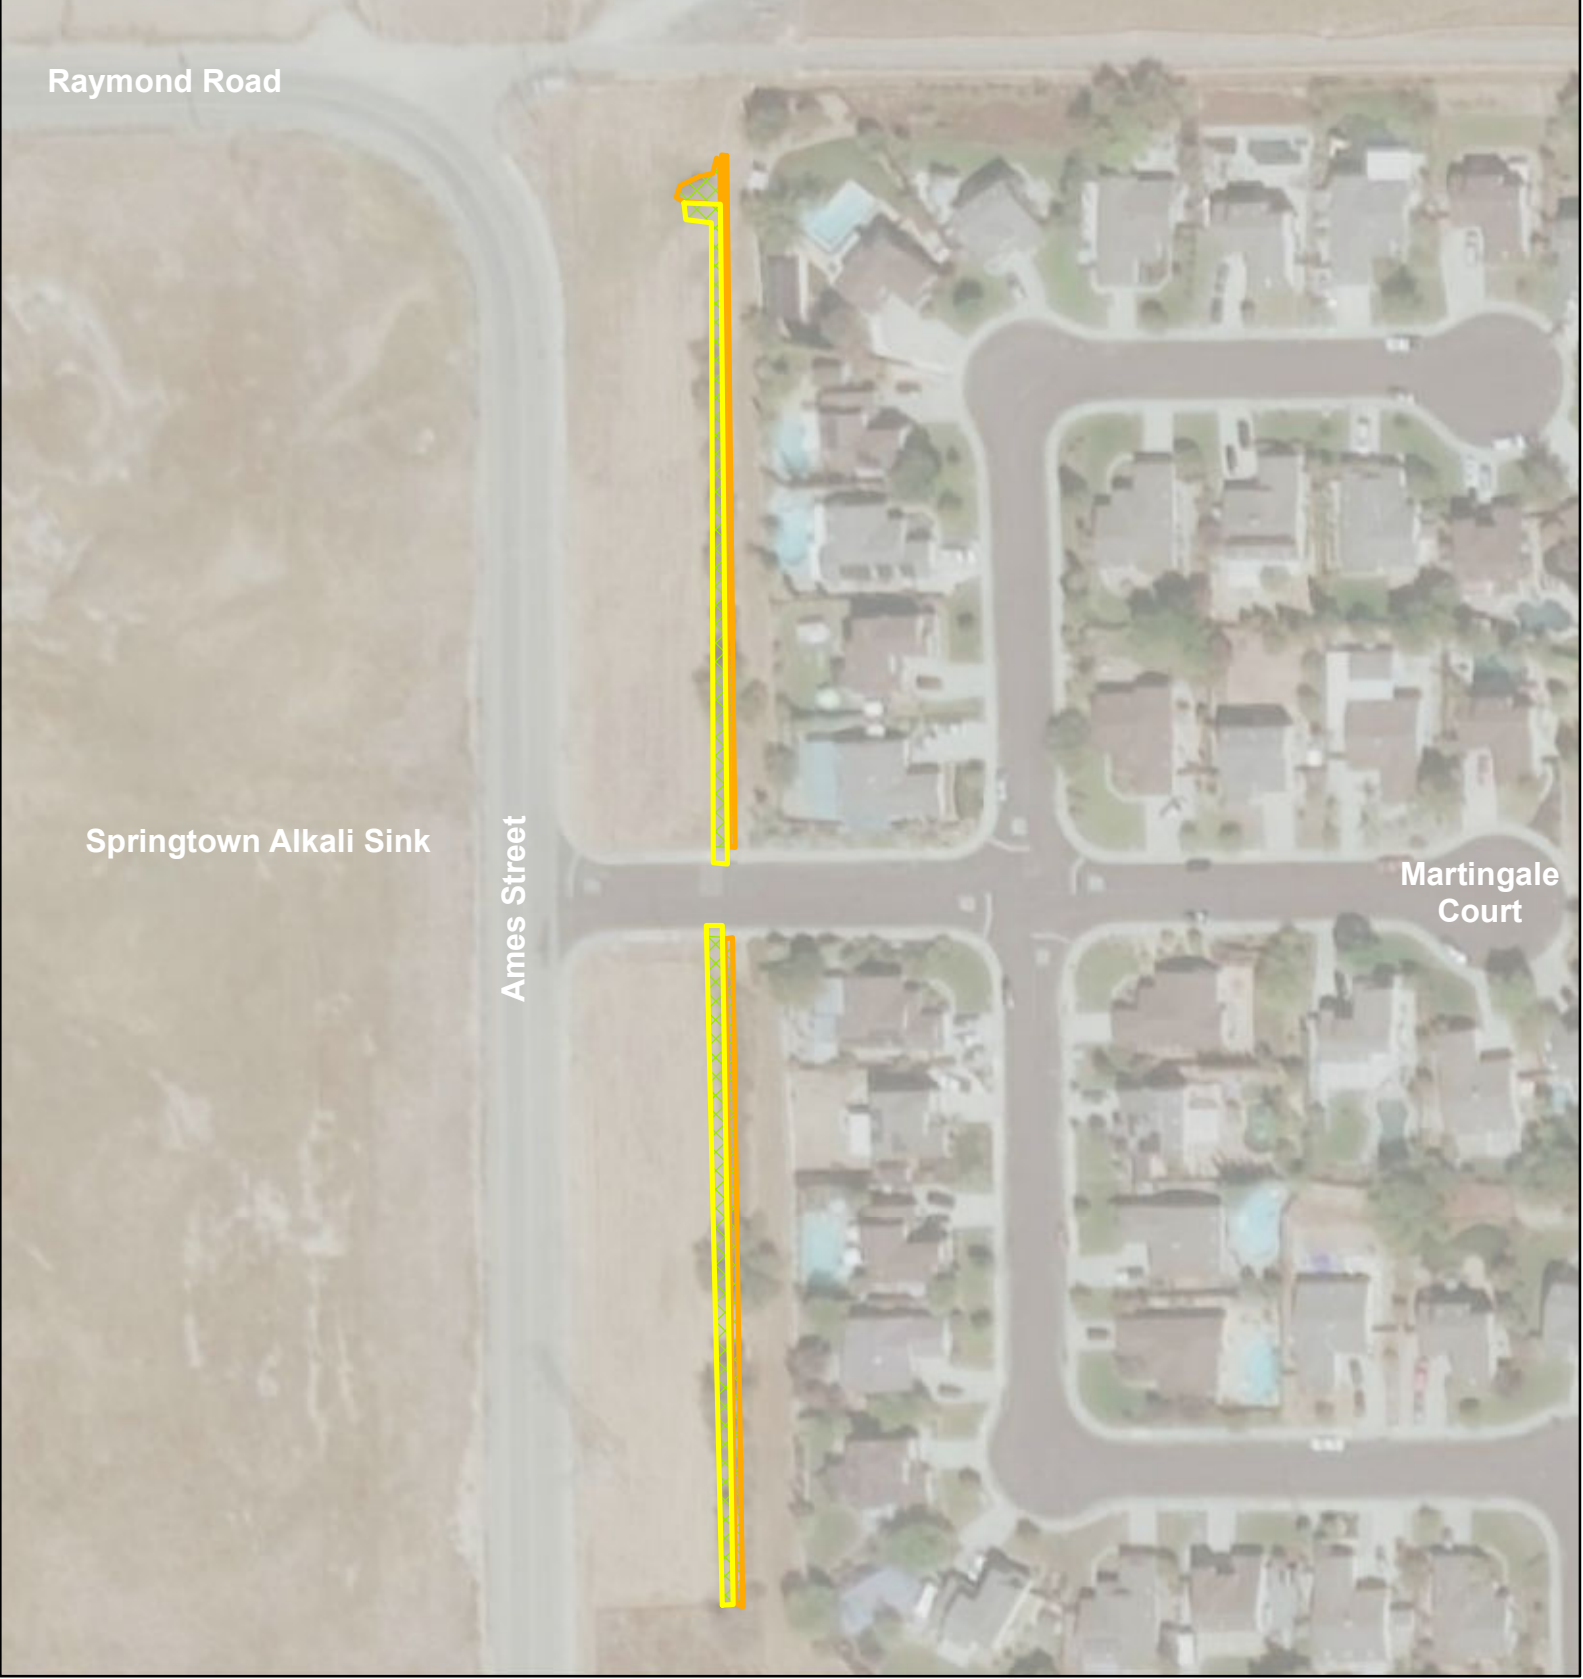
Figure A-2
Site 57a and 57b - Saddleback
City of Livermore
2022 Stream Maintenance Program
March 2022

- 57a - Access
- 57a - Temporary (Outfall Sediment and Vegetation Removal)
- 57a - Temporary (Sediment and Vegetation Removal)
- 57b - Access
- 57b - Temporary (Sediment and Vegetation Removal)
- Upland CRLF and CTS

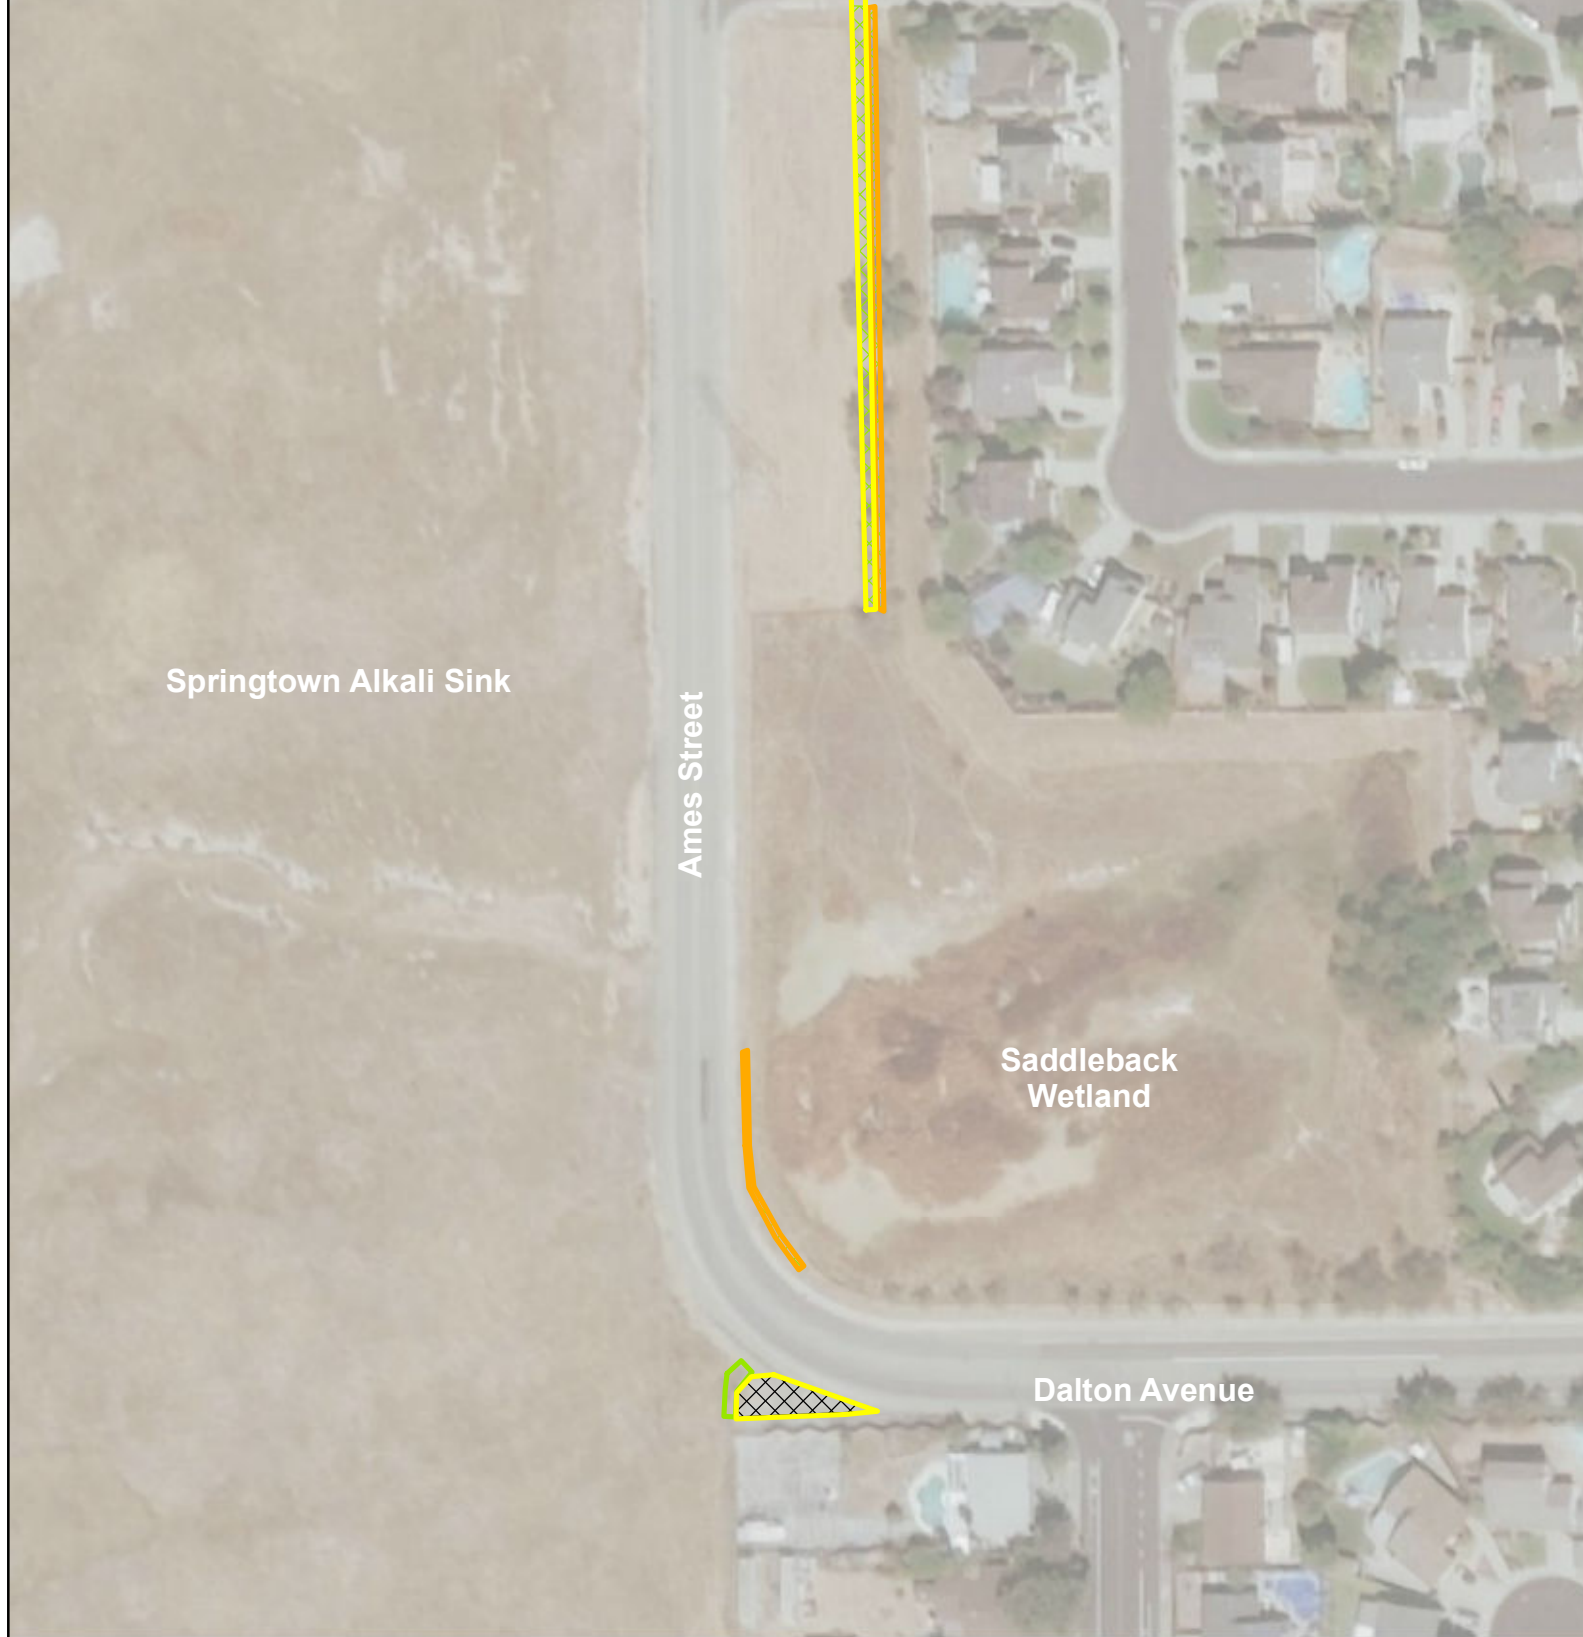
Figure A-3
Site 57b and 57c - Saddleback

- 57b - Access
- 57b - Temporary (Sediment and Vegetation Removal)
- 57c - Access and Staging
- 57c - Temporary (Sediment)
- 57c - Temporary (Vegetation and Debris Removal*)
- Existing Disturbed Area
- Upland CRLF and CTS

*57c - Vegetation and debris removal does not include ground disturbance

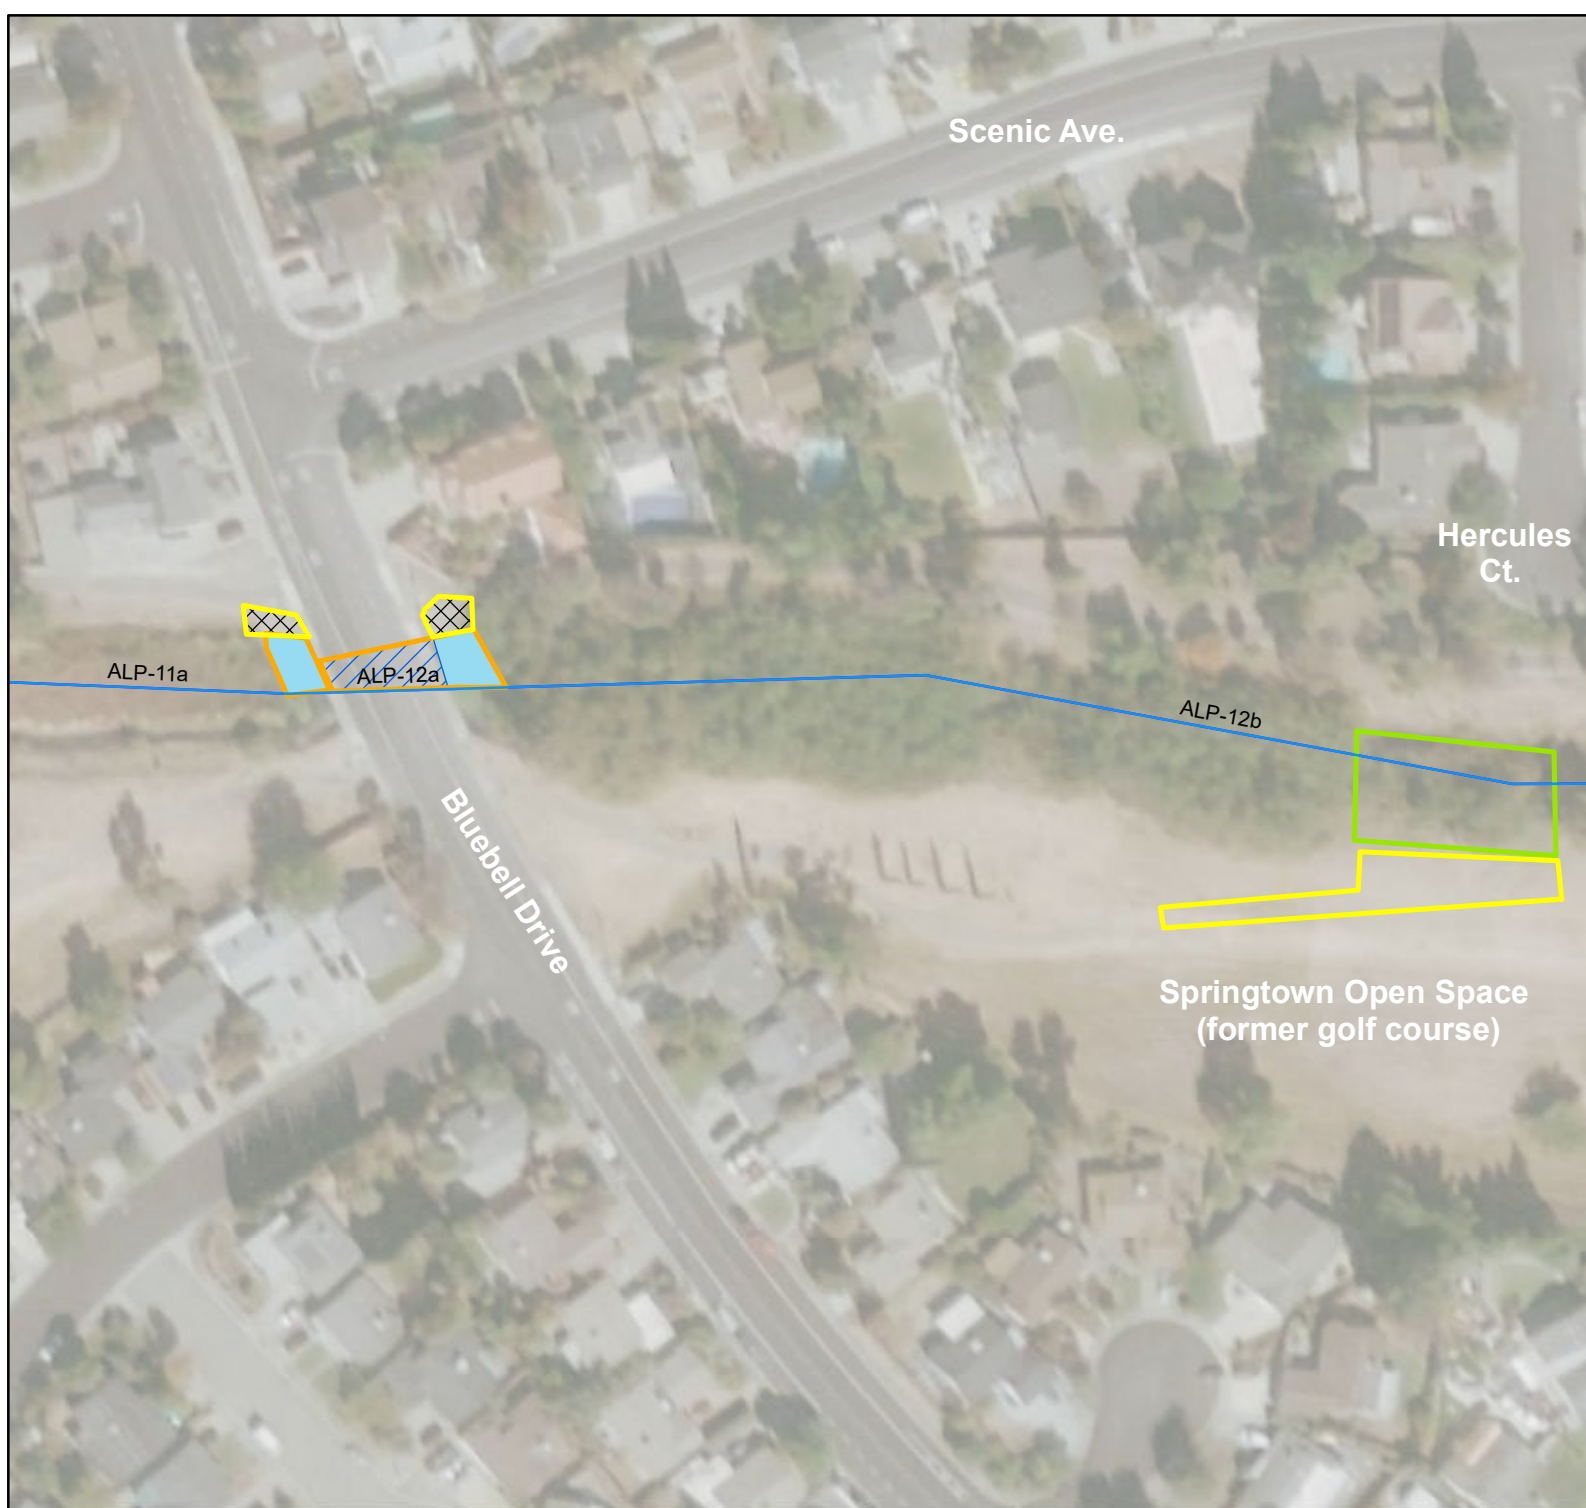
Figure A-5
Site 59b Hercules Court, Site 60 Bluebell Drive

- 59 - Access and Staging
- 59b - Hercules Court Willow limbing and debris removal
- 60 - Access Downstream
- 60 - Access Upstream
- 60 - Downstream Sediment and Vegetation Removal
- 60 - Upstream Sediment and Vegetation Removal
- Existing Disturbed Area
- Non Breeding Aquatic
- Open Water Breeding

*59 - Vegetation and debris removal does not include ground disturbance

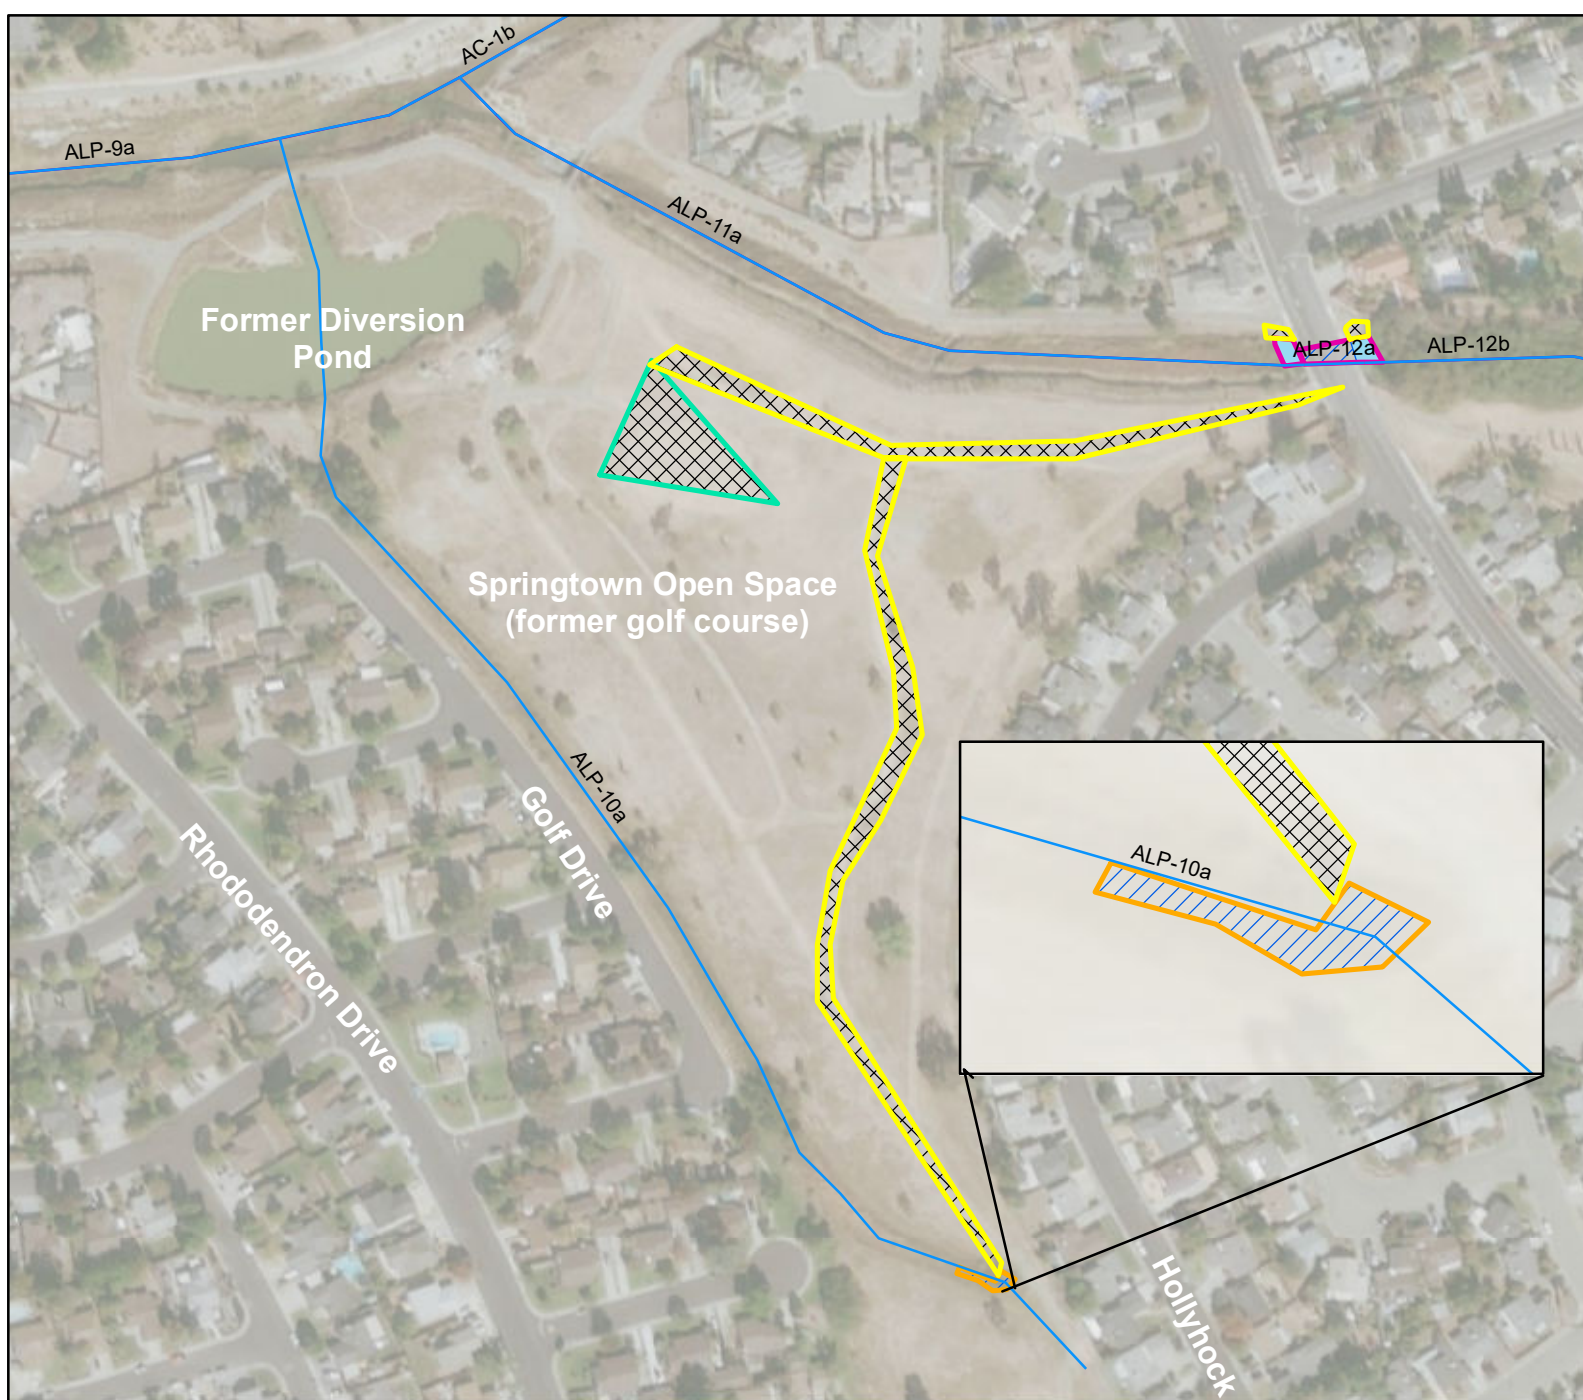
Figure A-6
Site 61 Springtown Open Space Outfall
 City of Livermore
 2022 Stream Maintenance Program
 March 2022

- 60 - Access Downstream
- 60 - Access Upstream
- 60 - Downstream Sediment and Vegetation Removal
- 60 - Upstream Sediment and Vegetation Removal
- 61 - Access
- 61 - Temporary (Sediment and Vegetation Removal)
- Access to Drying Location
- Drying Location (Sites 58, 60, 61)
- Existing Access Road
- Existing Disturbed Area
- Non Breeding Aquatic
- Open Water Breeding

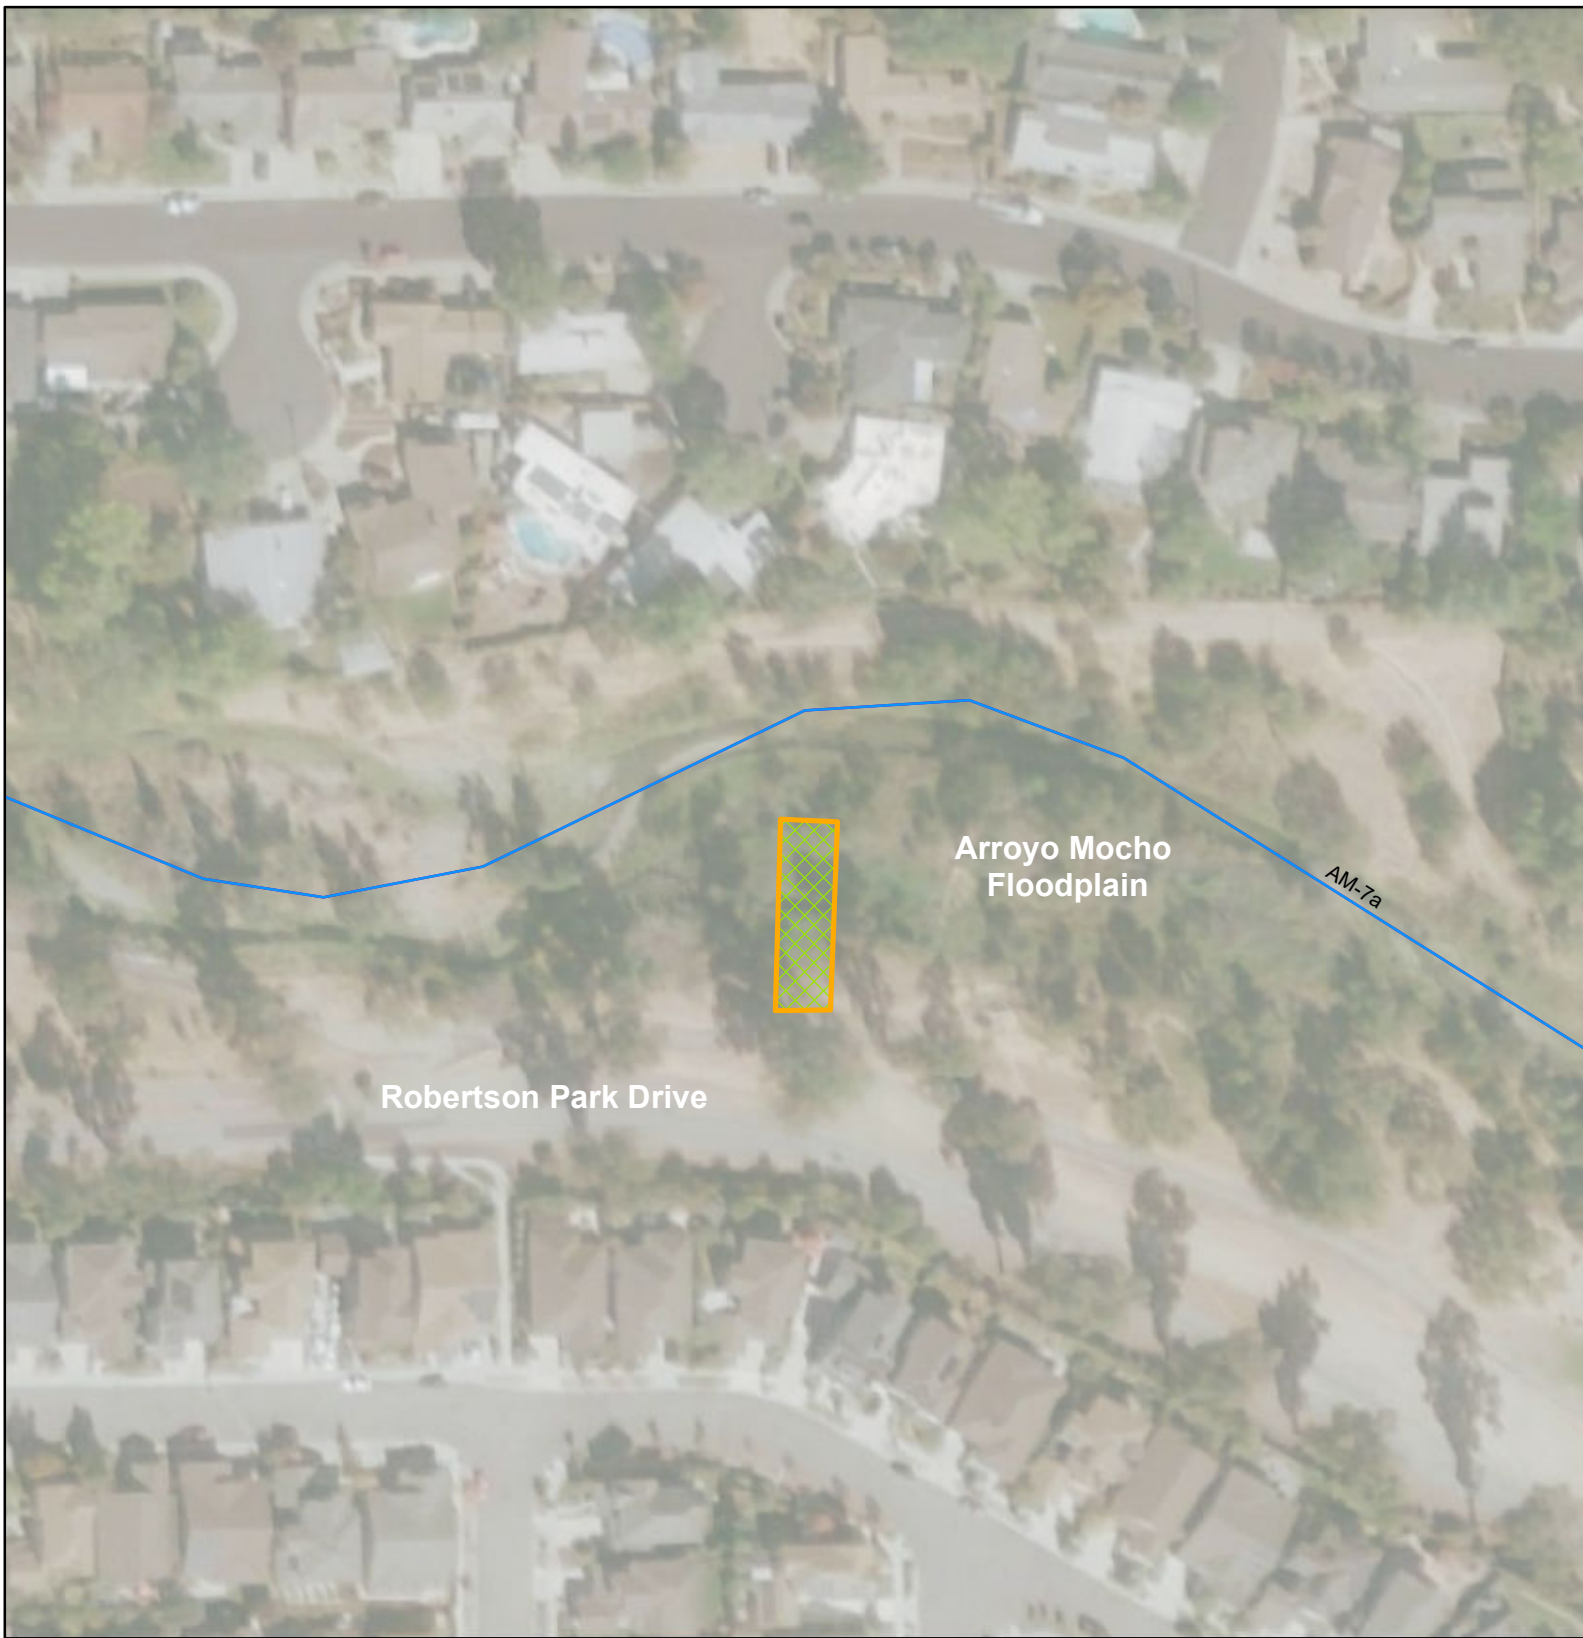
Figure A-8
Site 63 West Robertson Park
Vegetation Management at Outfall

- 63 - Temporary (Himalayn Blackberry and Debris Management)
- Upland Dispersal (CRLF)

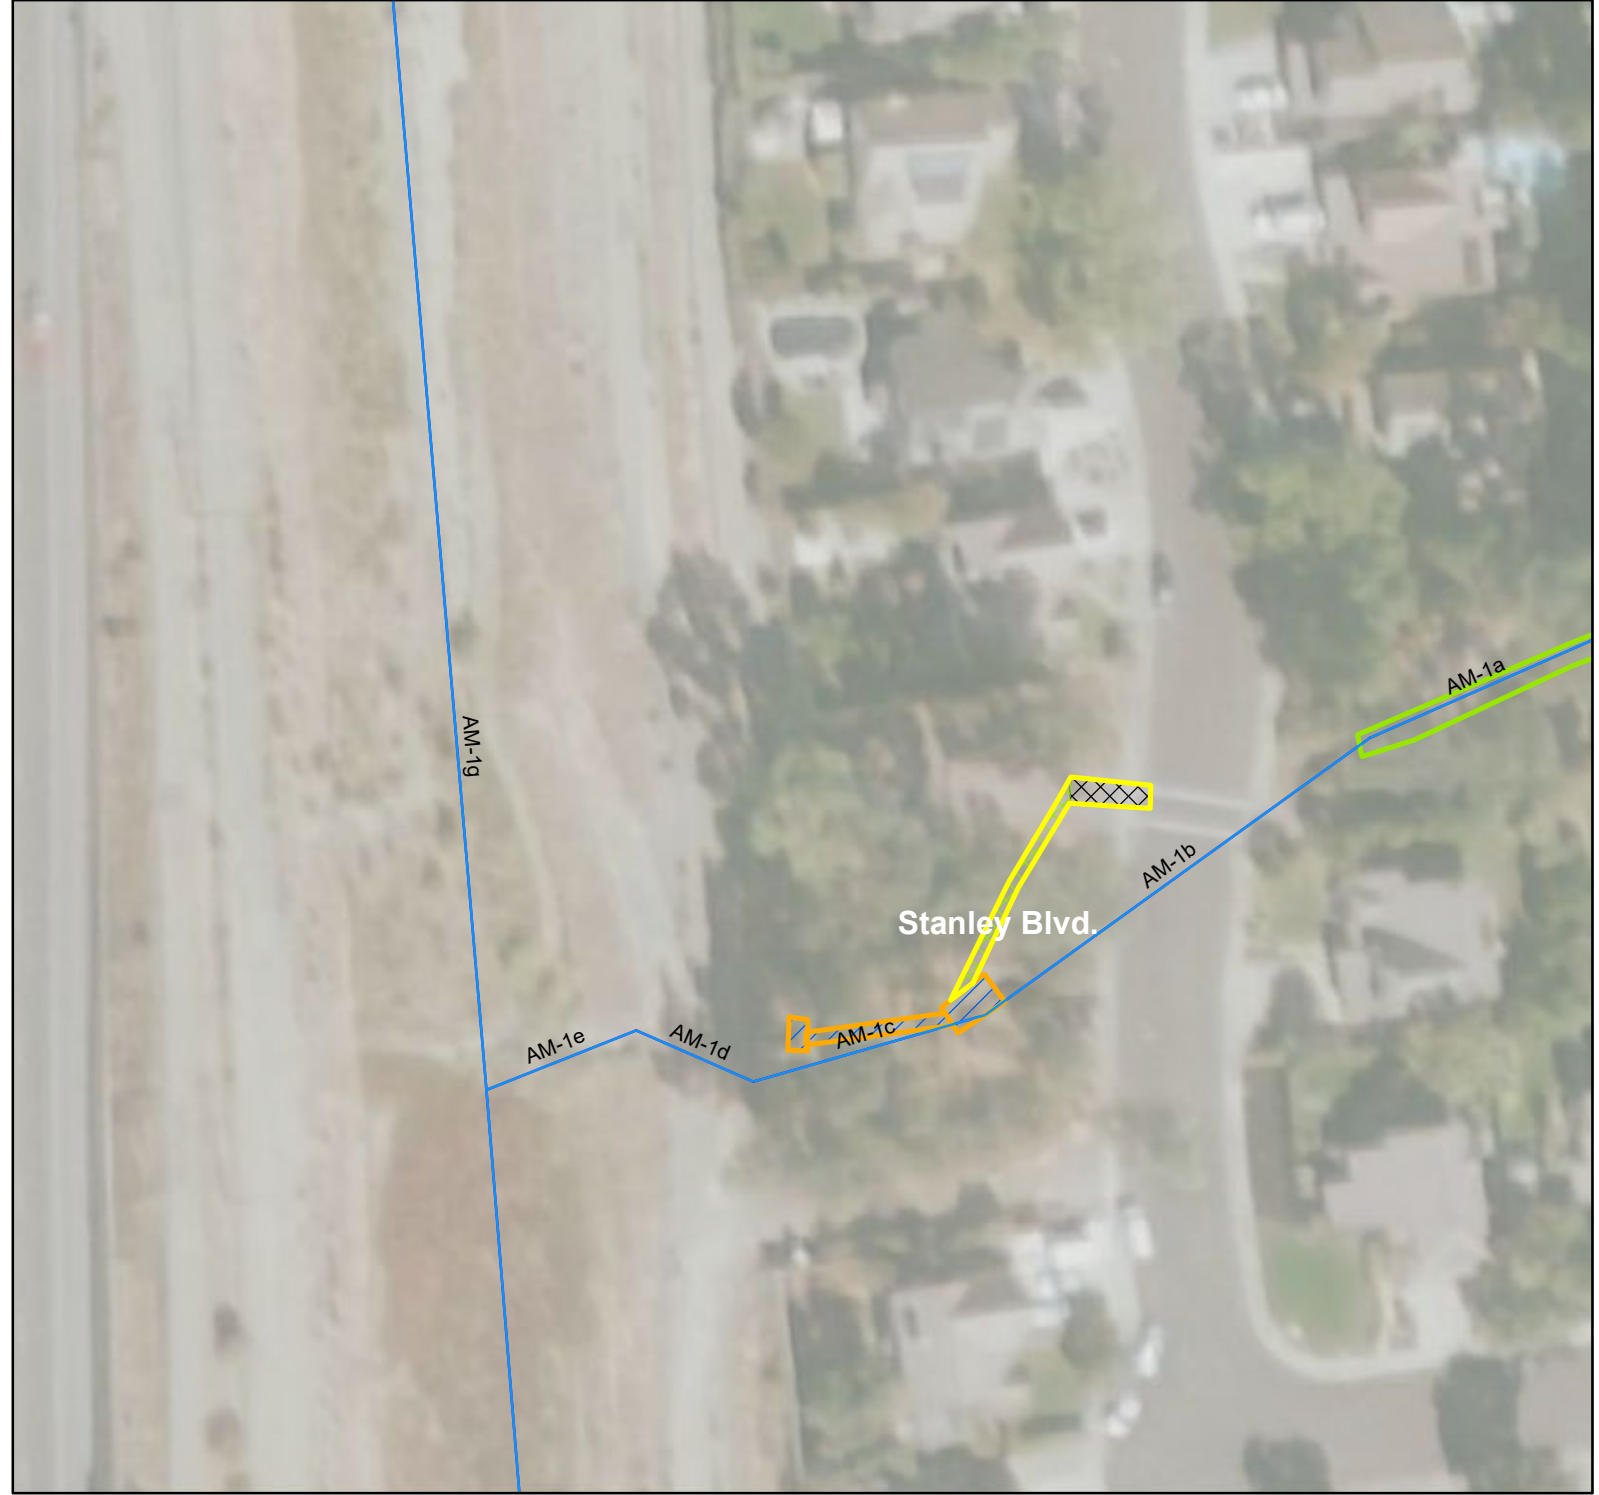
Figure A-10
Site 65 Arroyo Mocho Low Flow Channel
Site 66 Rockrose Street
 City of Livermore
 2022 Stream Maintenance Program
 March 2022

- 65 - Summertree Dr. to Rockrose*
- 66 - Access and Staging
- 66 - Temporary (In stream Equipment Access)
- 66 - Temporary (Sediment and Debris Removal)
- Existing Disturbed Area
- Non Breeding Aquatic
- Upland Dispersal (CRLF)

* 65 includes vegetation management only without ground disturbance

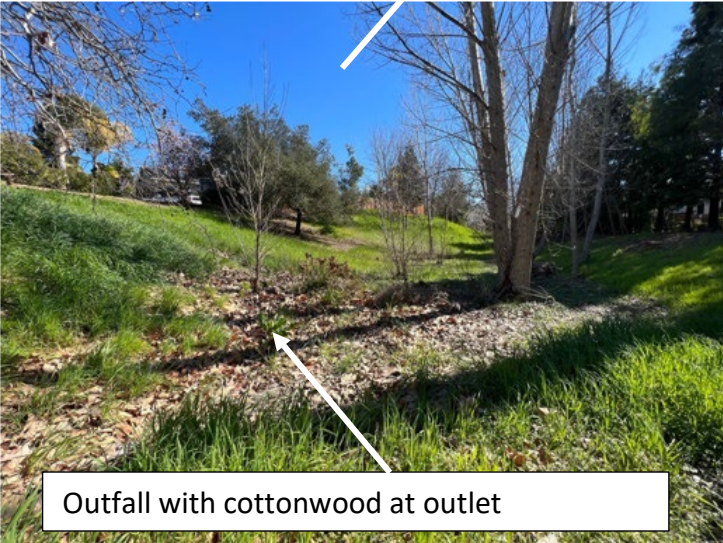
Outfall with cottonwood at outlet

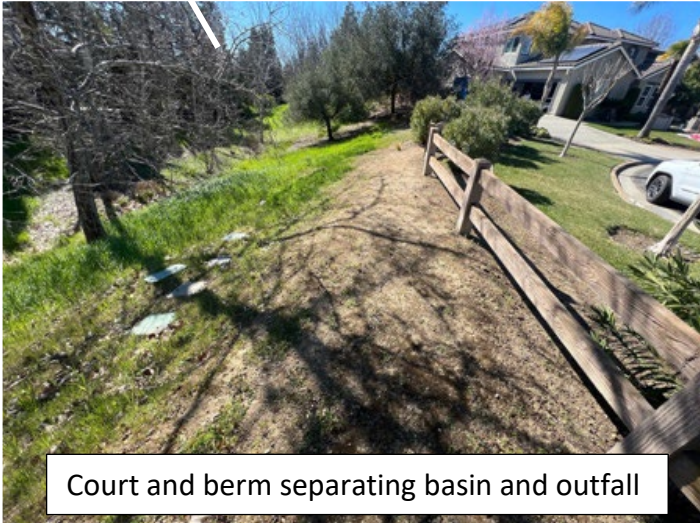
Court and berm separating basin and outfall

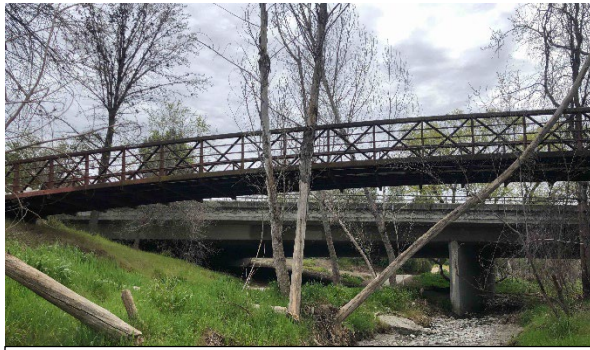
Dead cottonwoods downstream of Arroyo pedestrian bridge, photo taken looking east

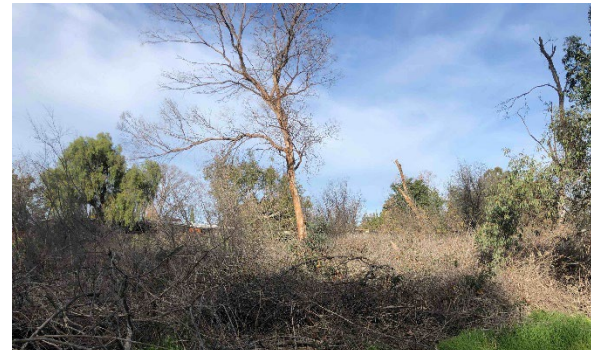
Blackberry thicket on floodplain looking south from Arroyo Mocho streambed

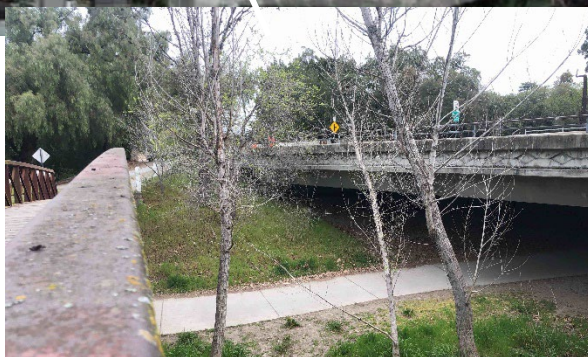
Dead cottonwoods upstream of Arroyo pedestrian bridge, photo taken looking north

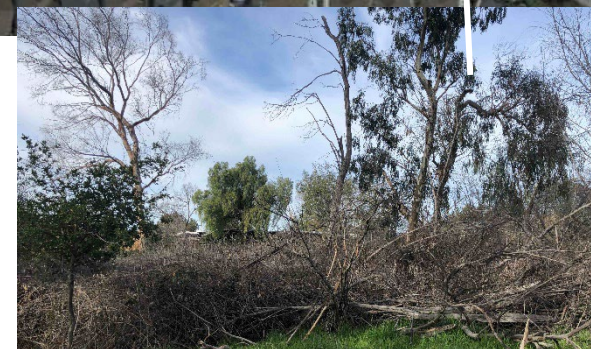
Blackberry thicket on floodplain looking north from Arroyo Mocho bike trail
