ANNUAL NOTICE OF PROPOSED WORK FOR 2022 STREAM MAINTENANCE PROJECTS

CITY OF LIVERMORE STREAM MAINTENANCE PROGRAM

March 2022

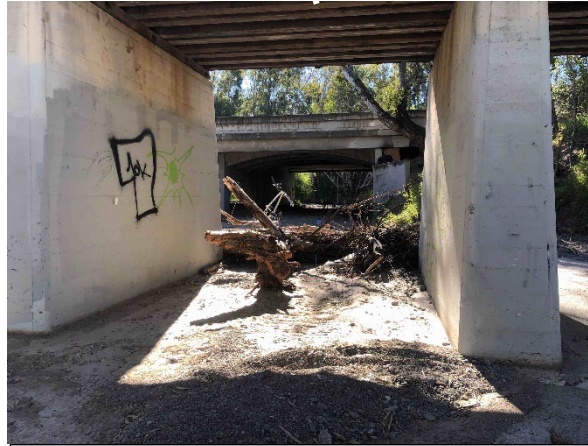
Debris caught in old railroad bridge piers, looking south

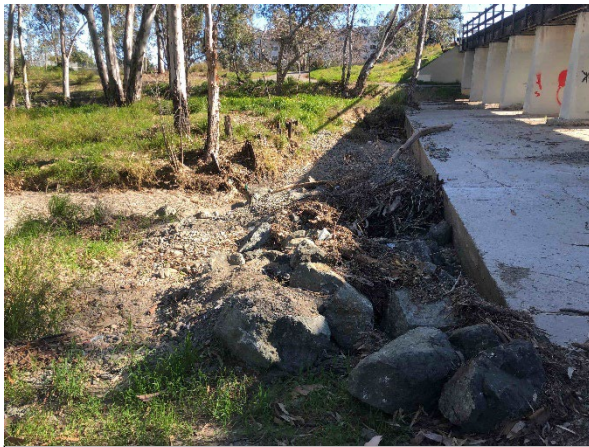
Scour pool below concrete of old railroad bridge, looking east

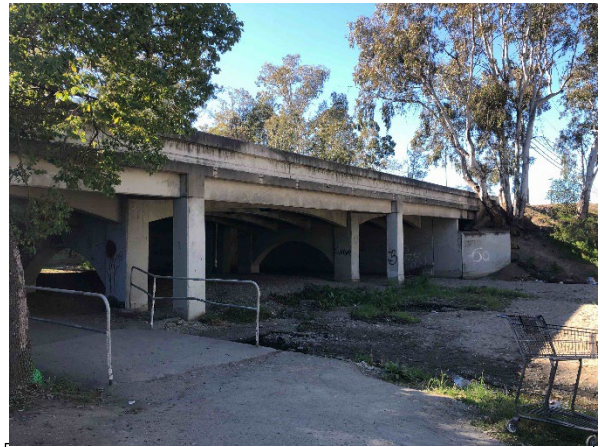
Stanley Bridge, pedestrian trail and Arroyo Mocho, looking southwest

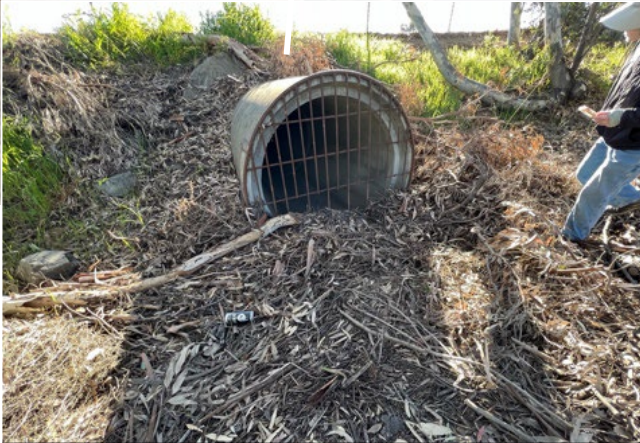
Culvert that connects to Stanley Reach

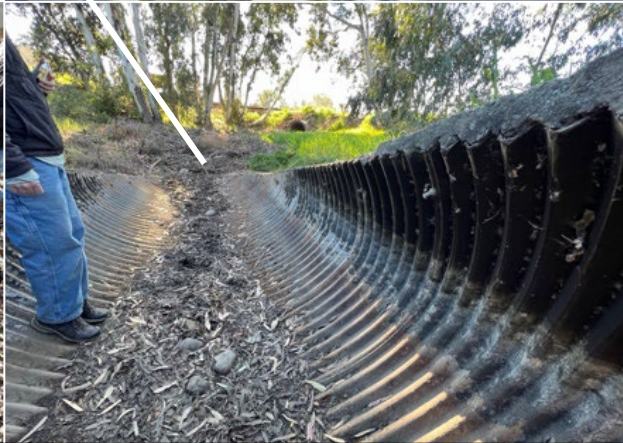
Culvert under Rockrose

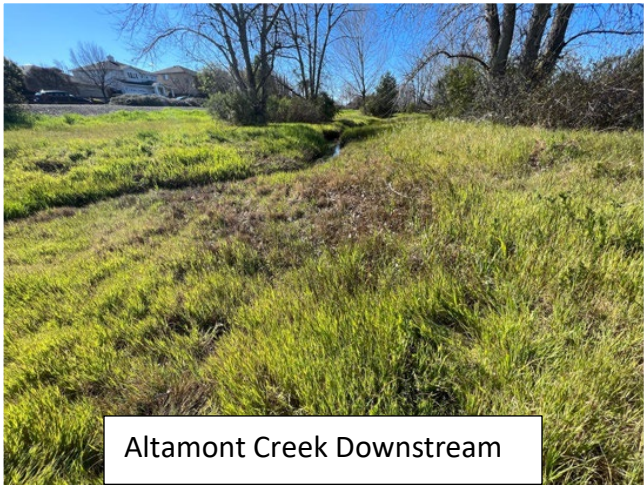
Altamont Creek Downstream

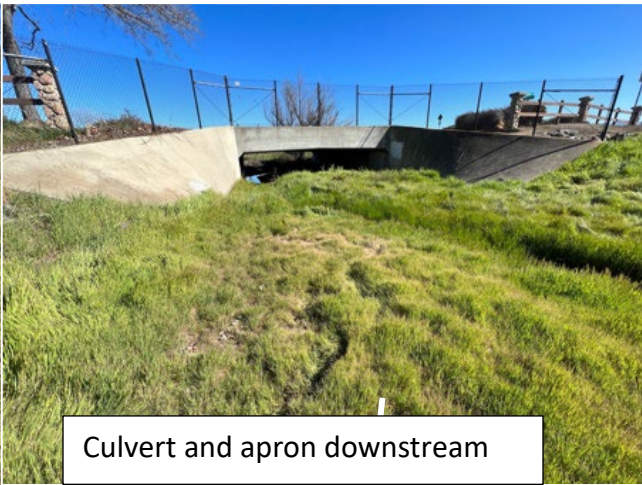
Culvert and apron downstream

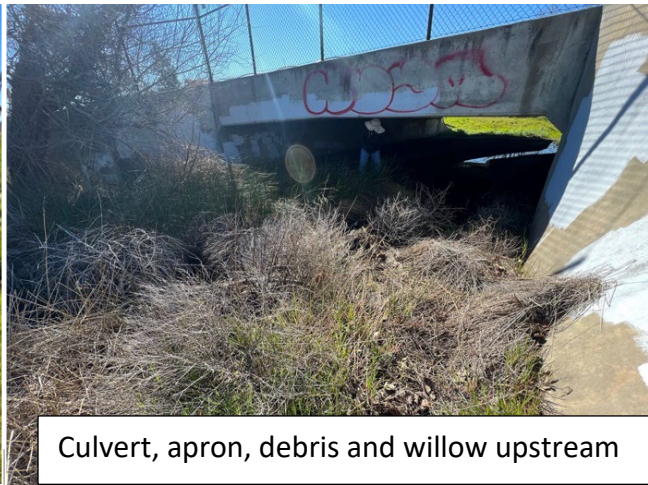
Culvert, apron, debris and willow upstream
